# MISCELLANEA INGV

A photo and video collection on the  
surface faulting: the Mw 7.8  
Kahramanmaraş (Turkey) earthquake  
of February 6, 2023

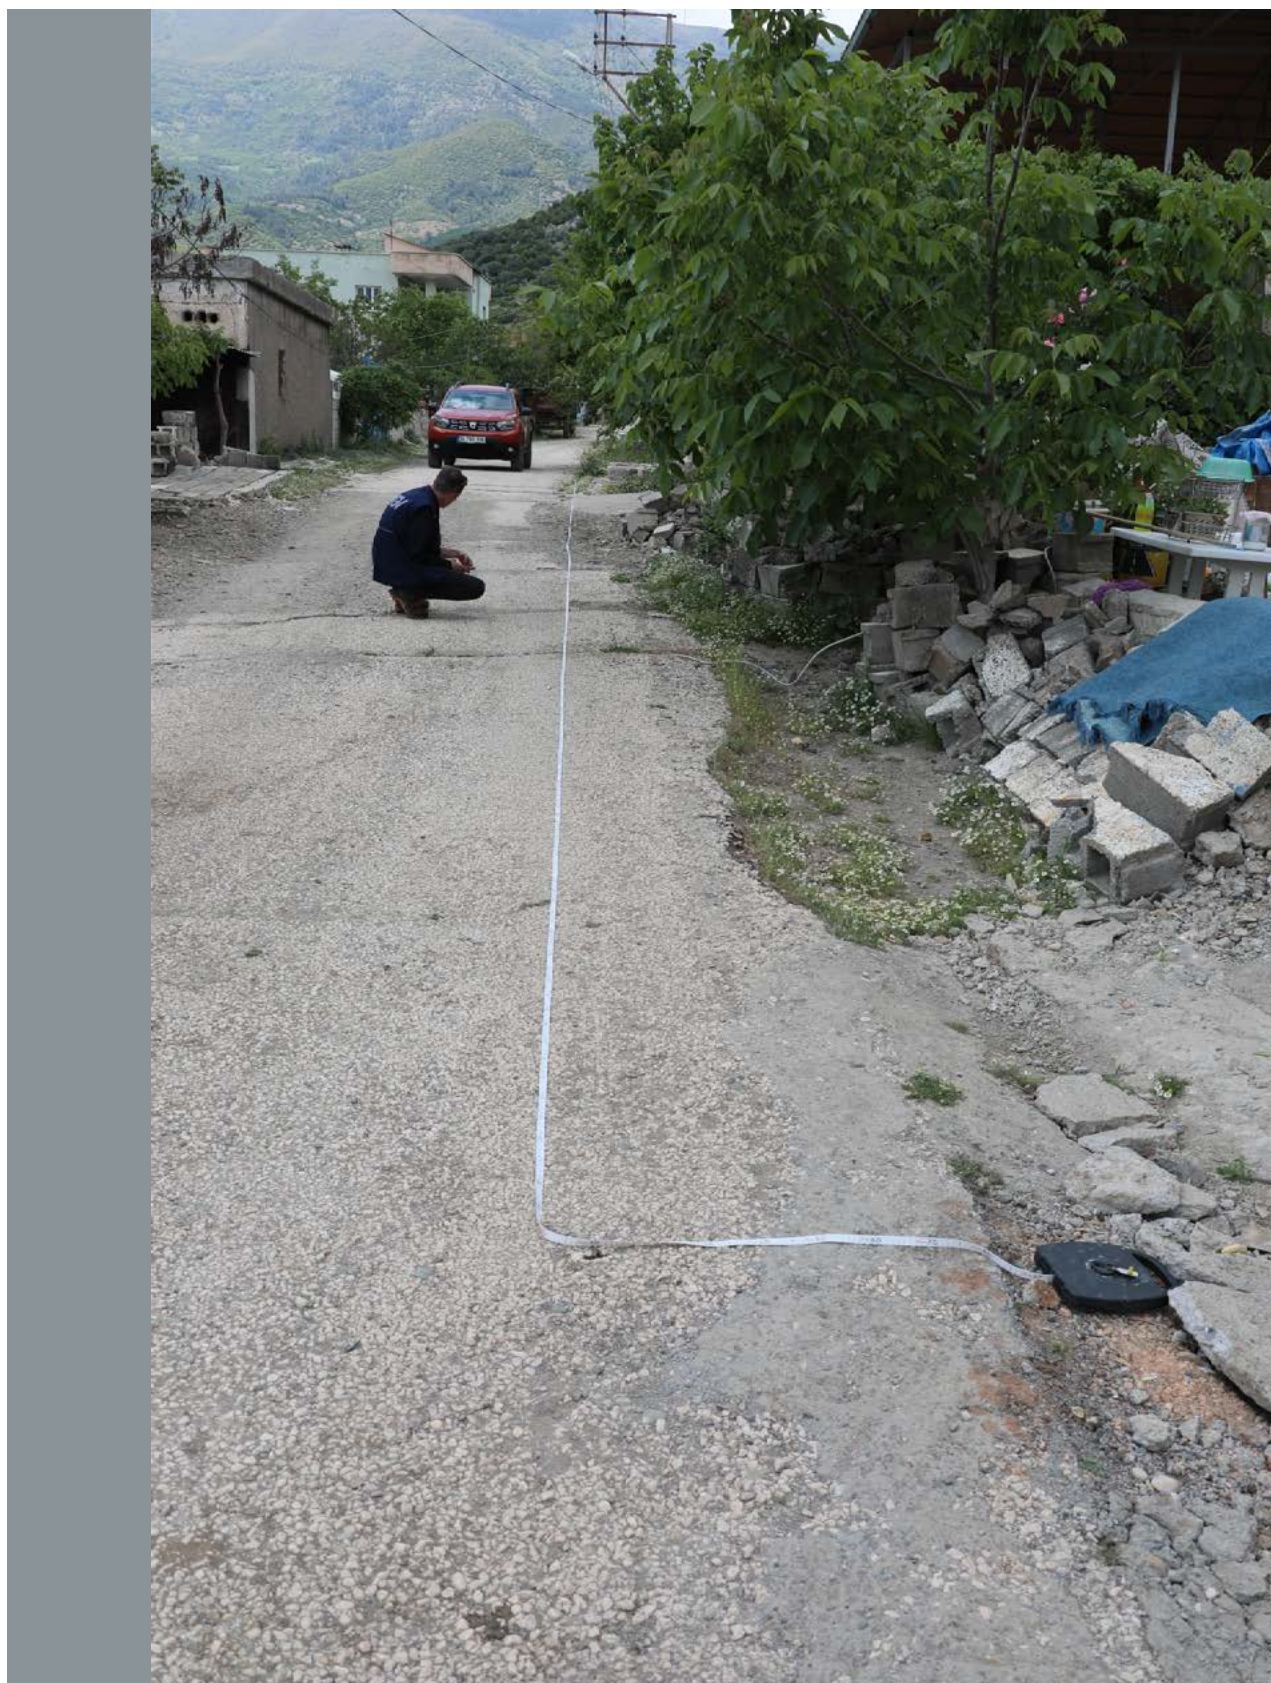
**Photo 1** (37.127789°N, 36.667270°E) – The fault trace runs through the village of Kozdere (Islahiye district, Gaziantep province), offsetting roads with more than one meter of displacement. Although repairs restored most of the infrastructure affected by the faulting, its surface traces were still documented throughout the village. Here, a clear example of a tar road displaced by distributed deformation, which as a whole exhibits a purely left-lateral net offset of 90 cm.

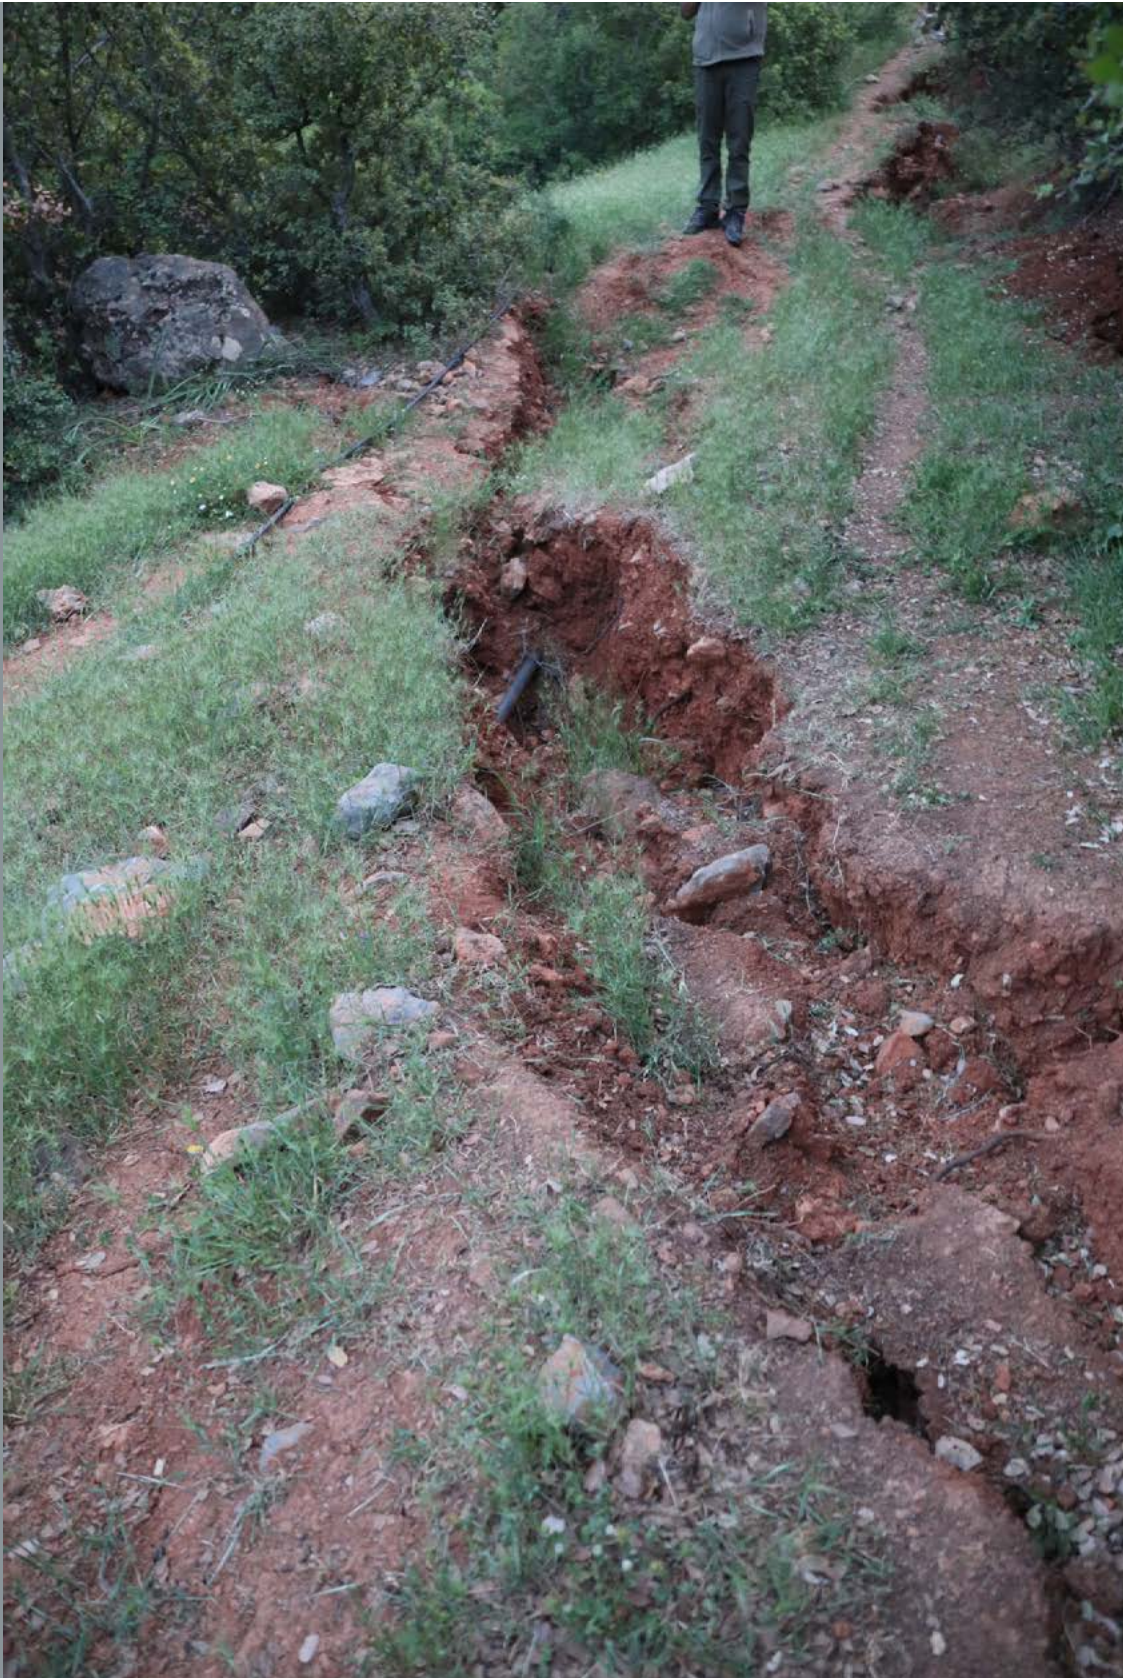
**Photo 2** (37.139741°N, 36.679528°E) – Features of a typical coseismic rupture pattern: en-echelon right-stepping transtensional Riedel shears (with 50 cm of opening component) and a left-stepping push-up (person on it), exhibiting a 70 cm offset.

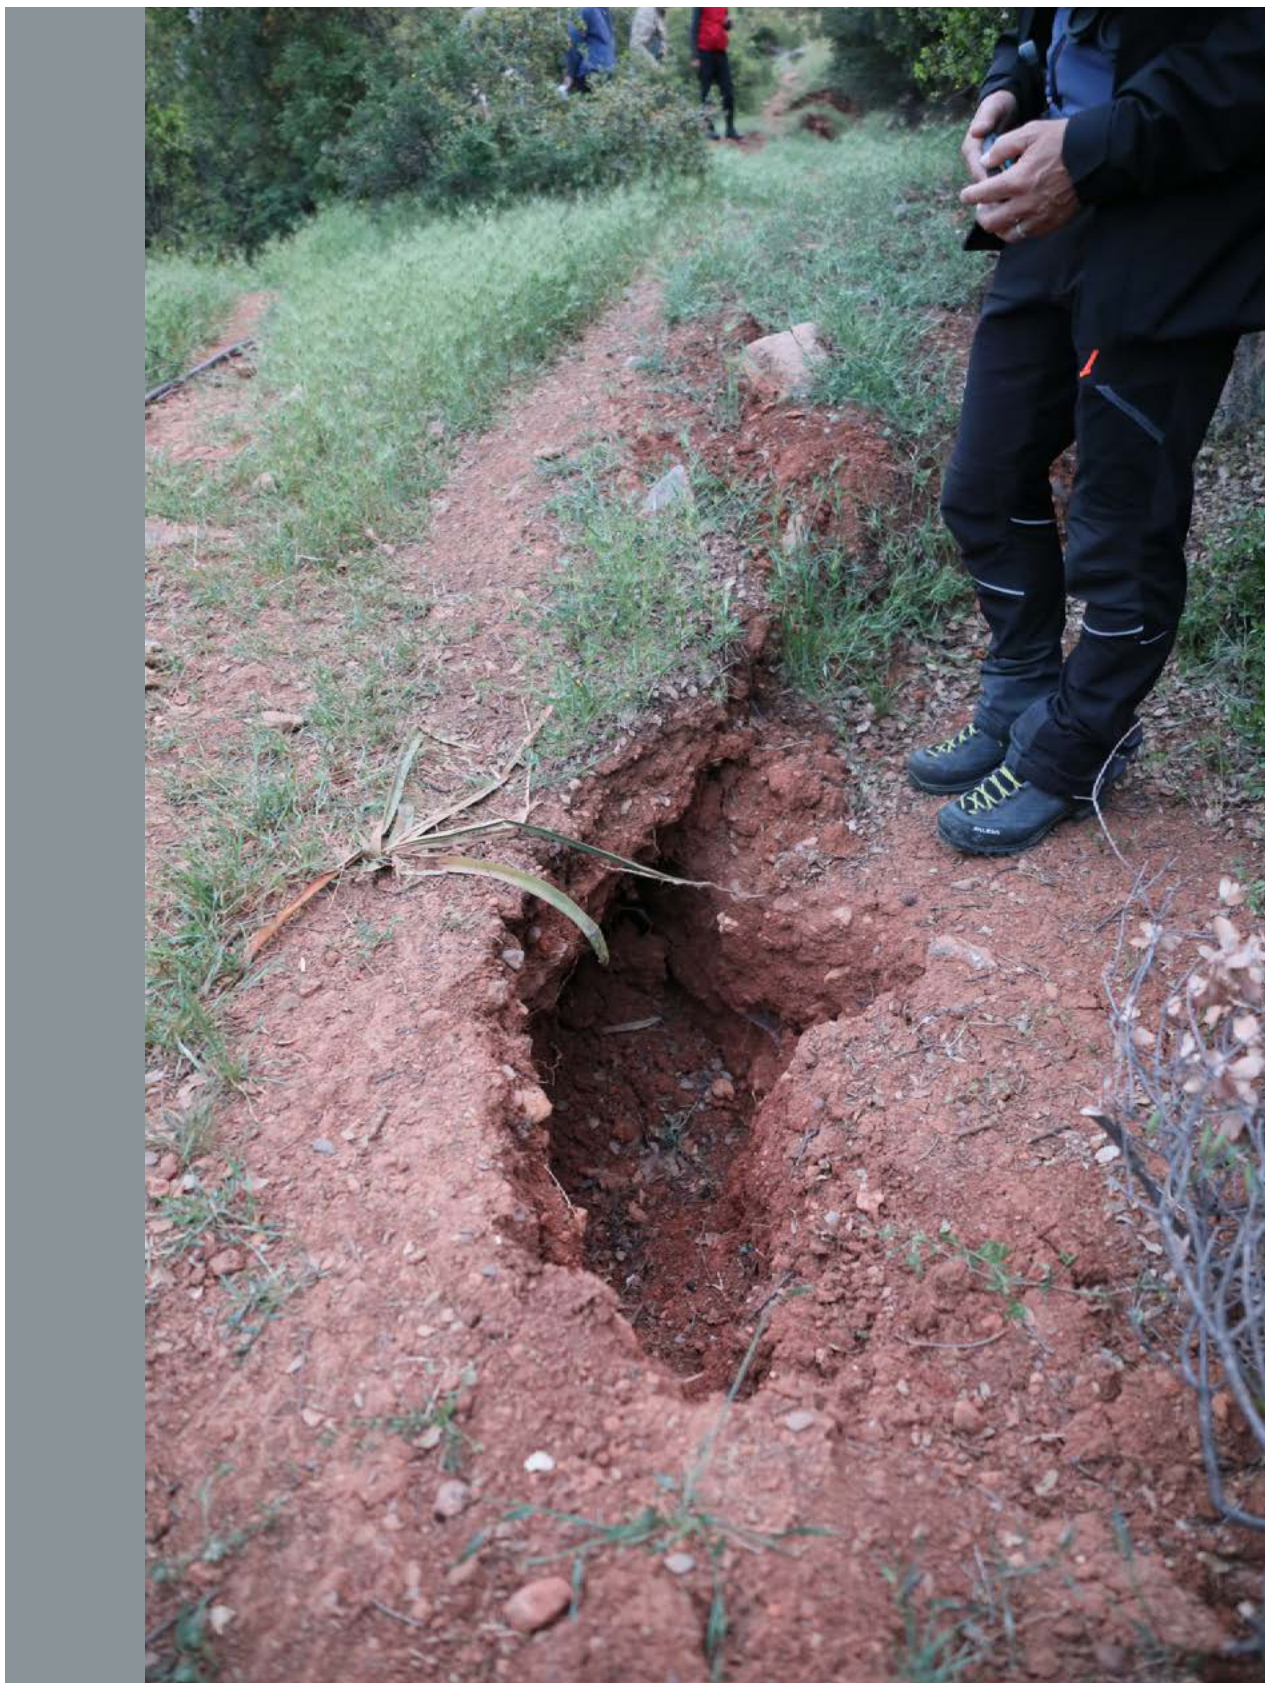
**Photo 3** (37.139790°N, 36.679613°E) – Metric-scale transpressive (push-ups) and transtensive (Riedel shears) structures alternate, forming a rupture mole-track. Transtensional features display openings of up to 40 cm, while push-up structures reach heights of up to 30 cm.

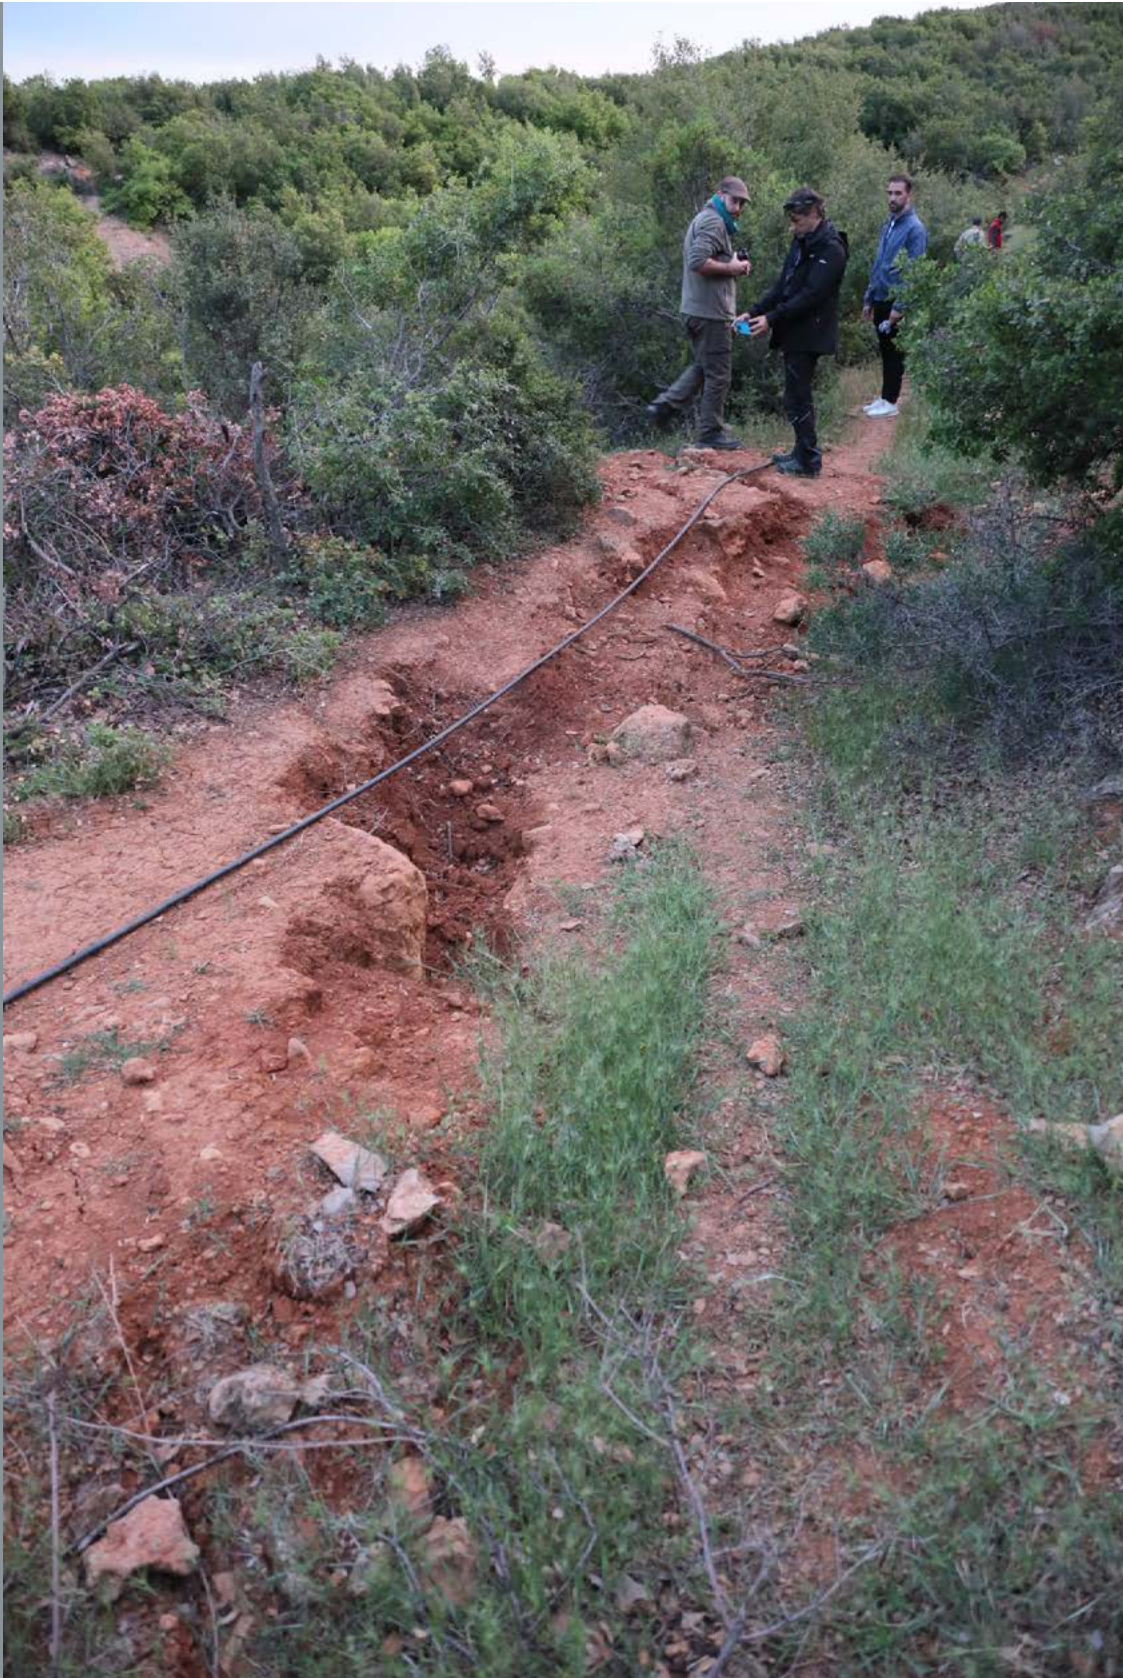
**Photo 4** (37.139790°N, 36.679613°E) – Coseismic surface rupture highlighted by a mole-track with a pressure ridge, approximately 8 m in length, showing up to 70 cm of vertical component of the deformation.

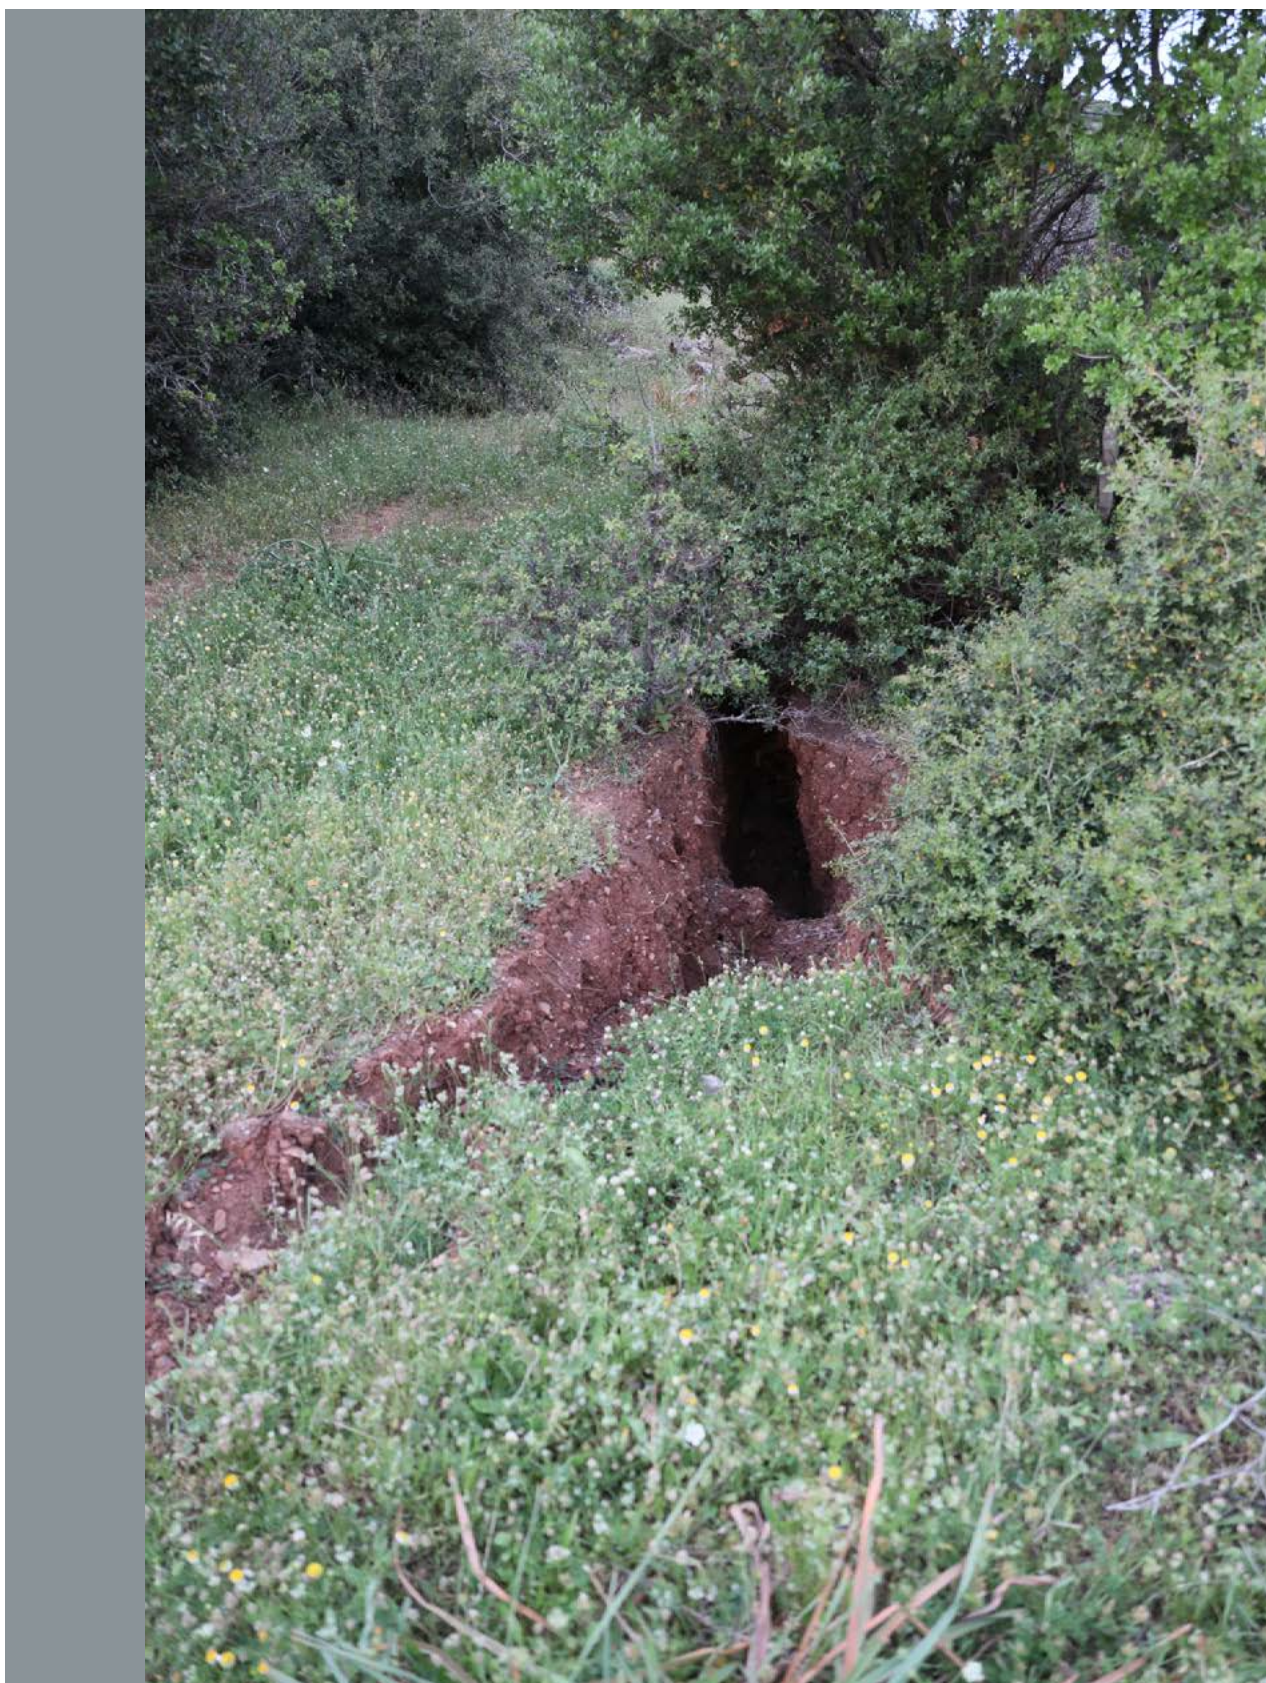
**Photo 5** (37.140573°N, 36.680943°E) – The coseismic surface rupture, expressed as a mole-track, is characterised by transtensional structures, producing grabens up to 70 cm wide and about 10 m long.

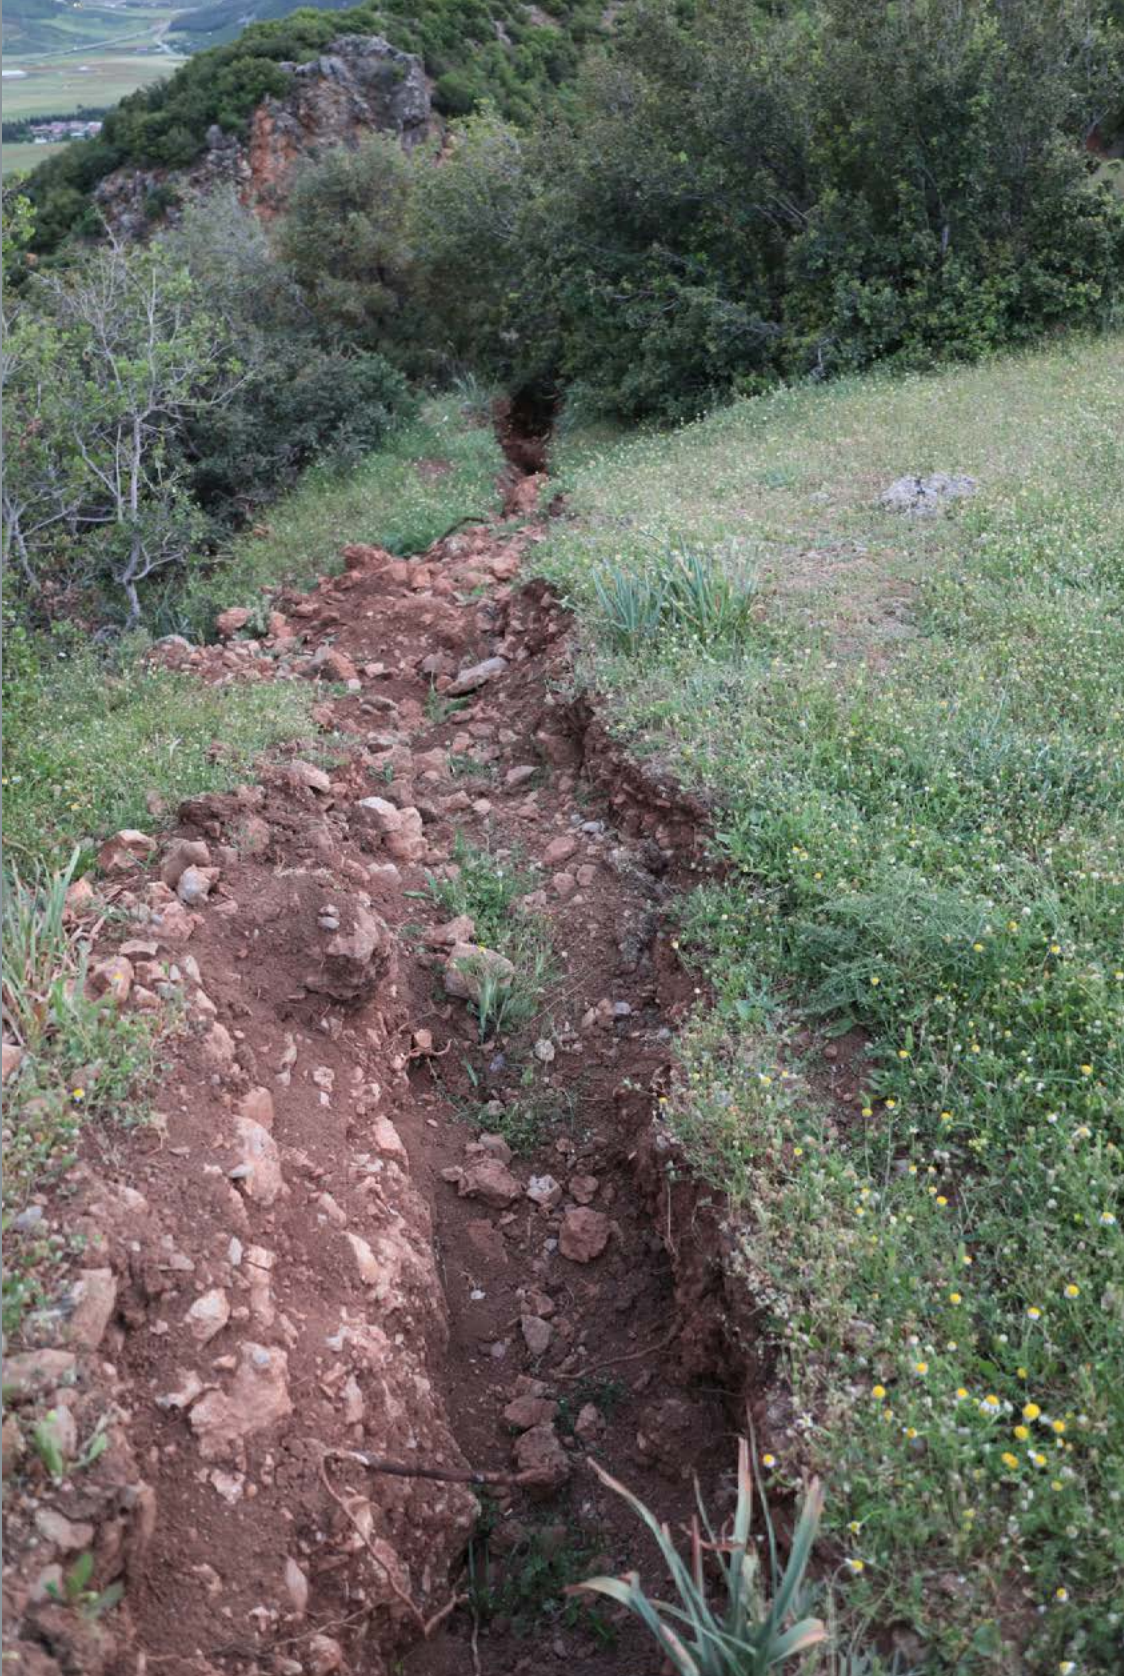
**Photo 6** (37.140567°N, 36.681057°E) – The mole-track pattern is characterised by transtensional fractures with up to 60 cm of opening component, resulting in a trench up to 2 meters deep, frequently infilled by gravitational collapse of the two walls.

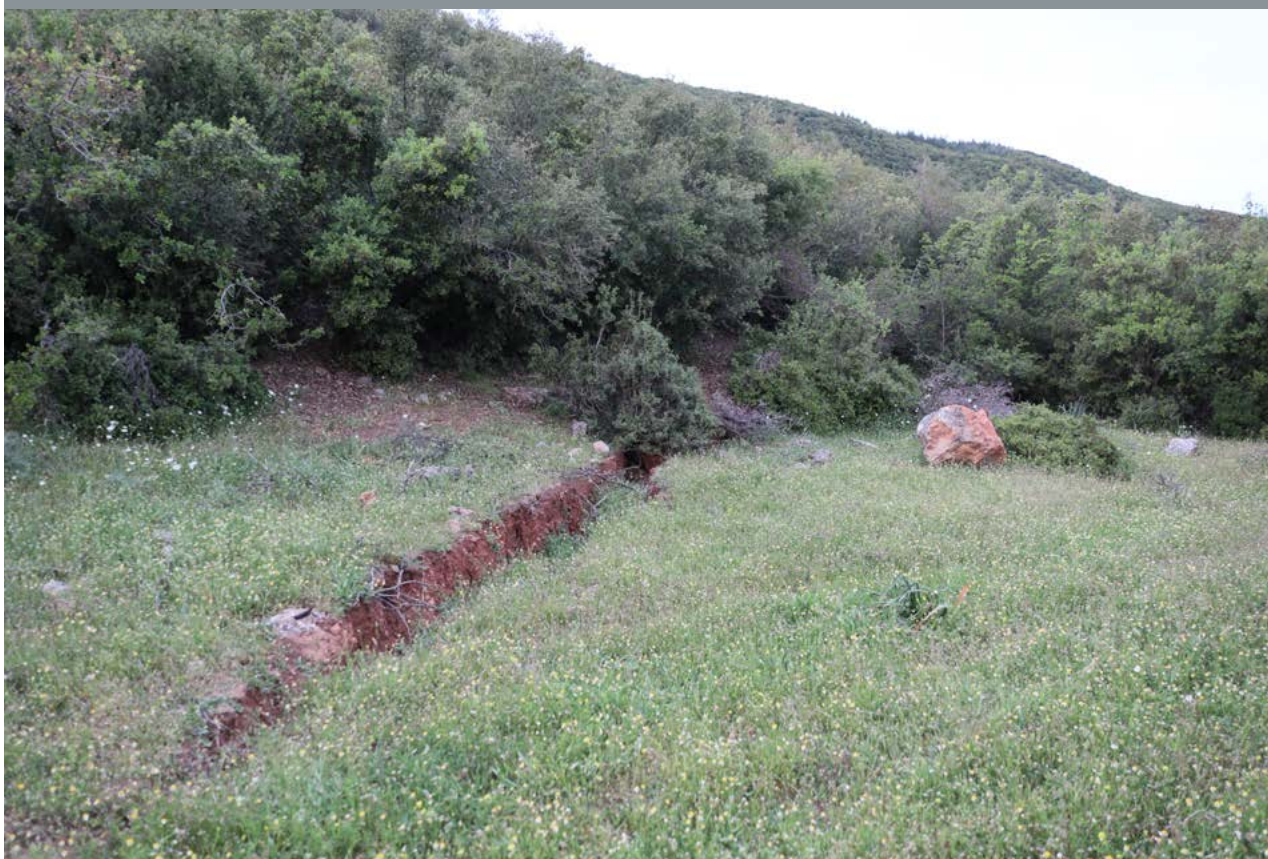
**Photo 7** (37.140567°N, 36.681057°E) – In this site, the coseismic surface rupture is composed by major Riedel elements, expressing a dominant transtensional component with a maximum vertical offset of 50 cm, and a limited opening component.

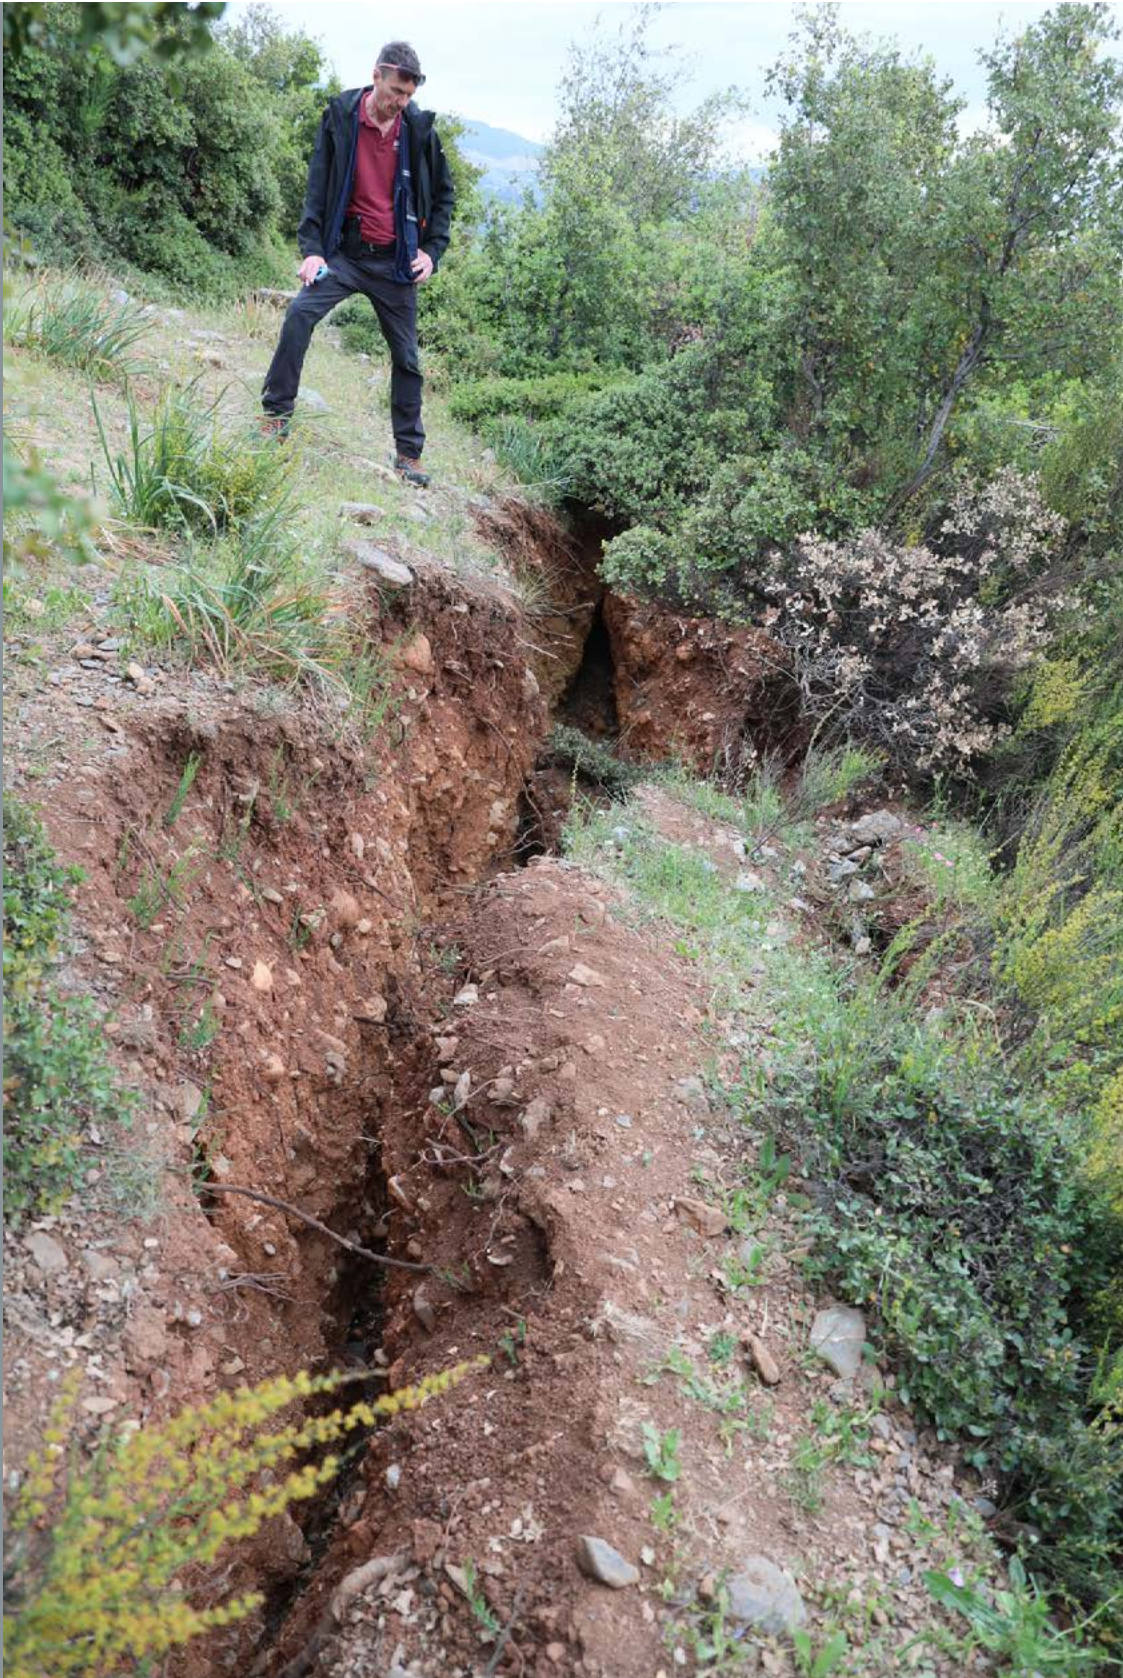
**Photo 8** (37.160682°N, 36.704166°E) – The mole-track pattern is here characterised by decametric en-echelon extensional elements, producing a vertical offset of up to 110 cm and a trench up to 130 cm wide and 2 meters deep.

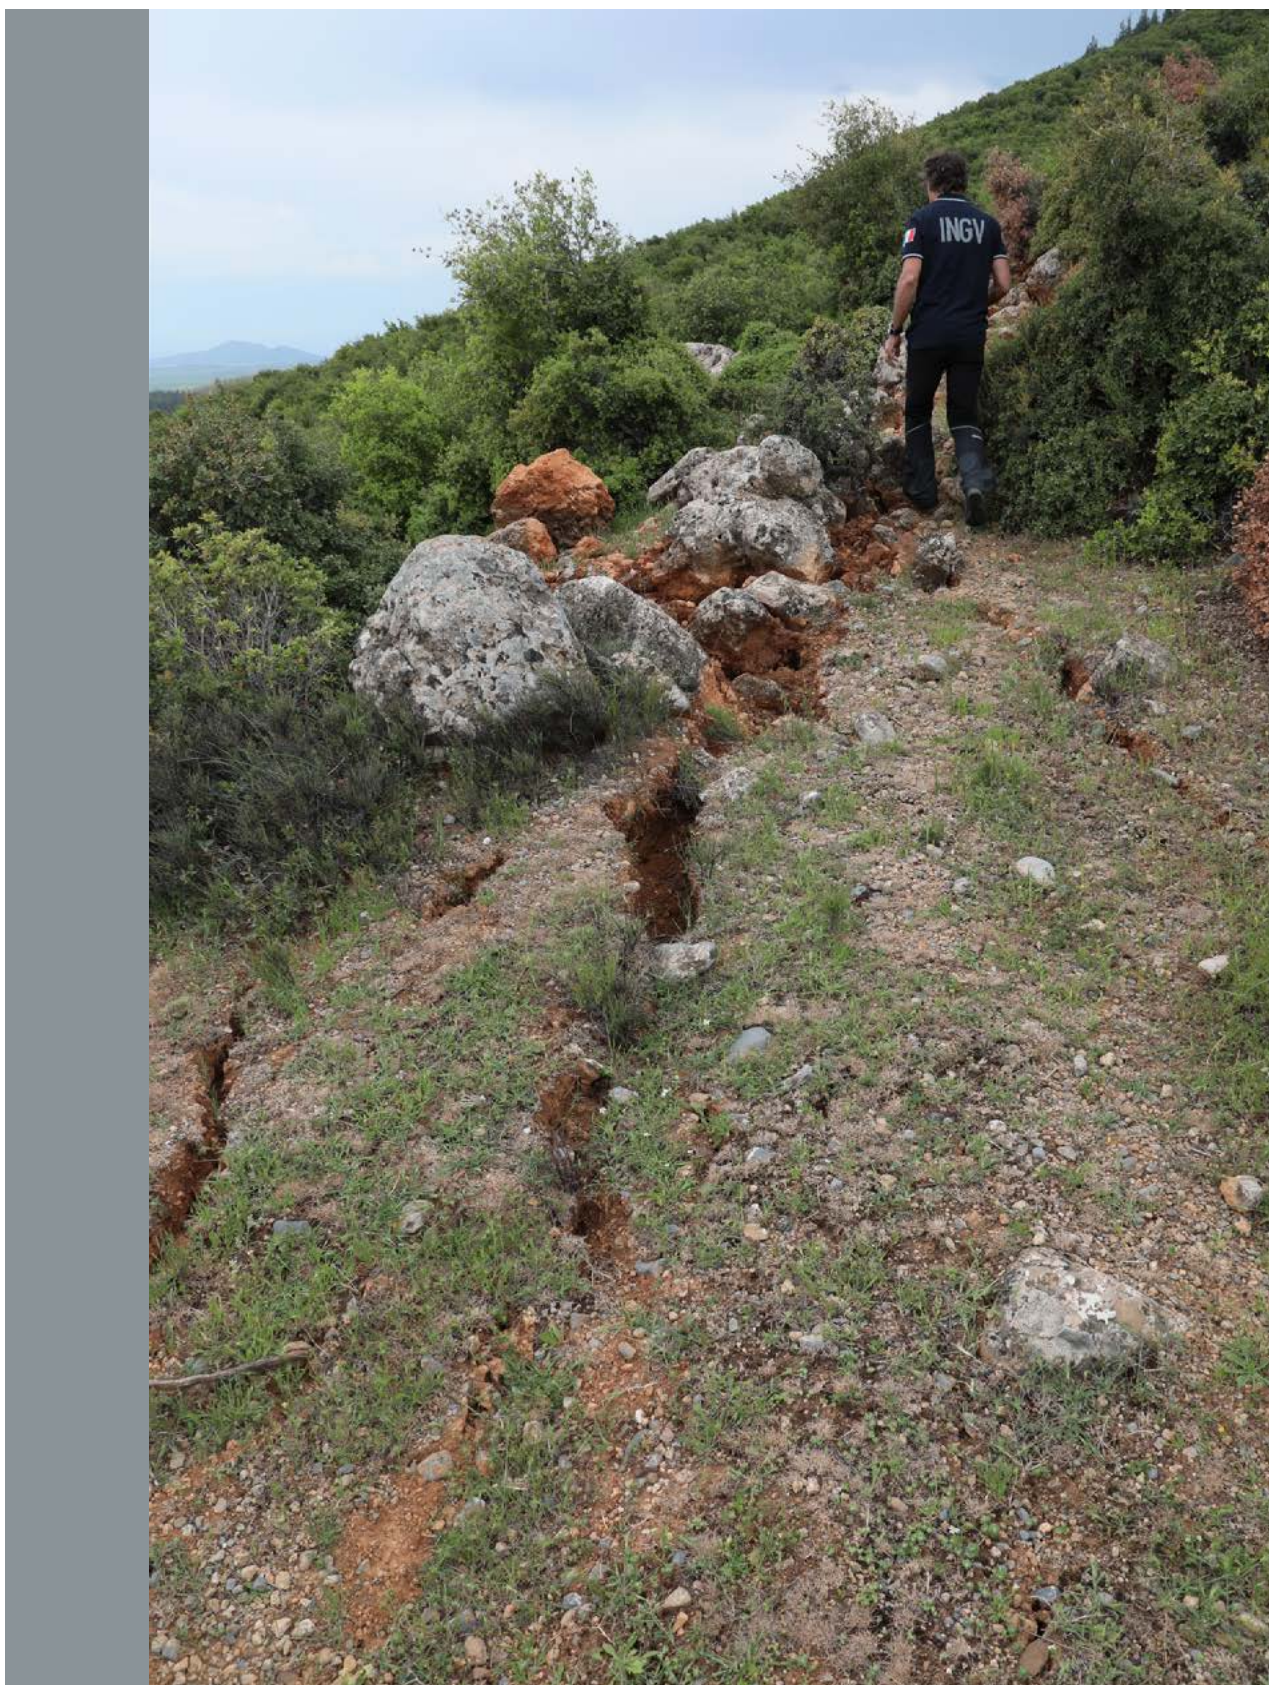
**Photo 9** (37.160984°N, 36.704419°E) – The coseismic surface rupture is expressed by decametric-scale en-echelon elements. Here, a set of tensional openings, up to 50 cm each, affects a ca. 5 m-wide push-up responding to the ground flexure. The cumulative opening of the mole-track is ca. 130 cm.

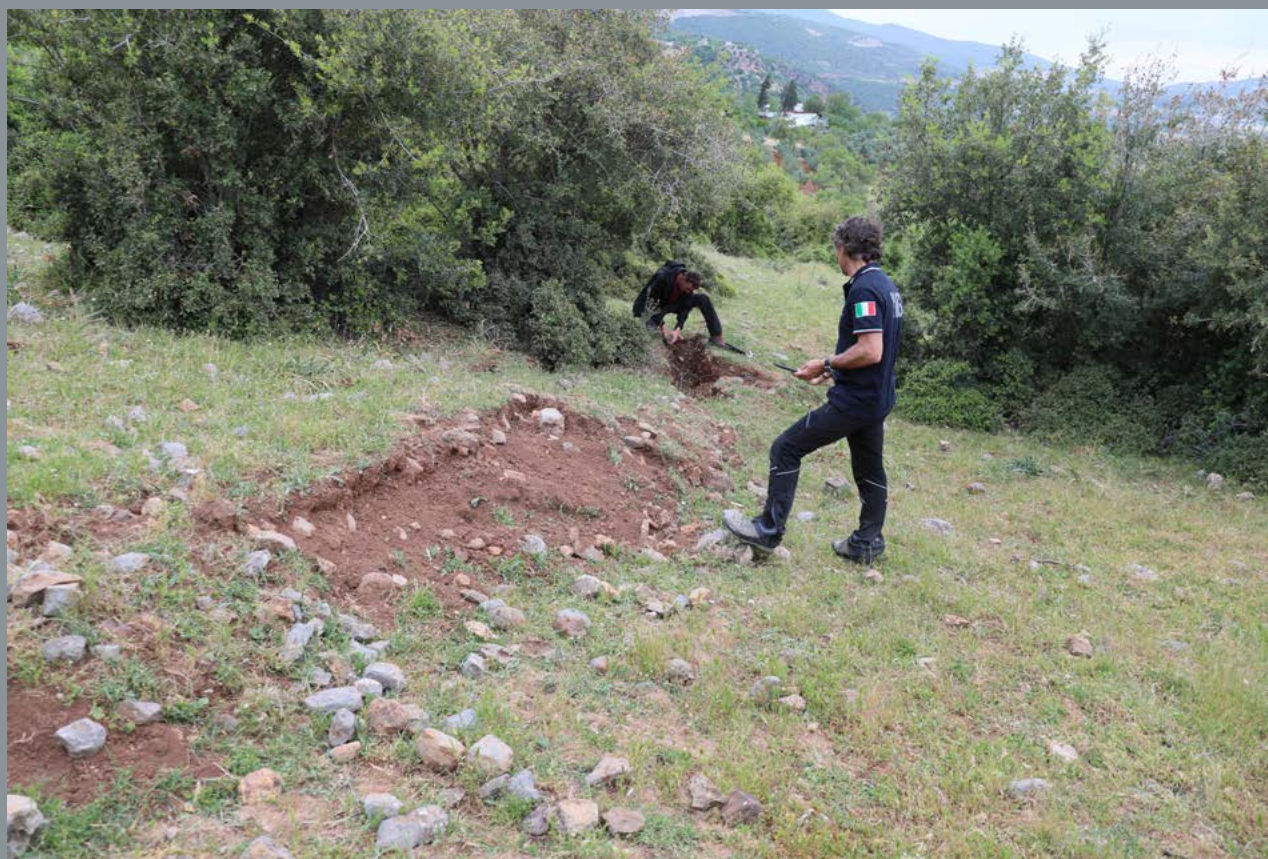
**Photo 10** (37.161528°N, 36.704793°E) – At this site, the earthquake rupture features an en-echelon right-stepping push-up, 50 cm in height, showing a net width of 5 m.

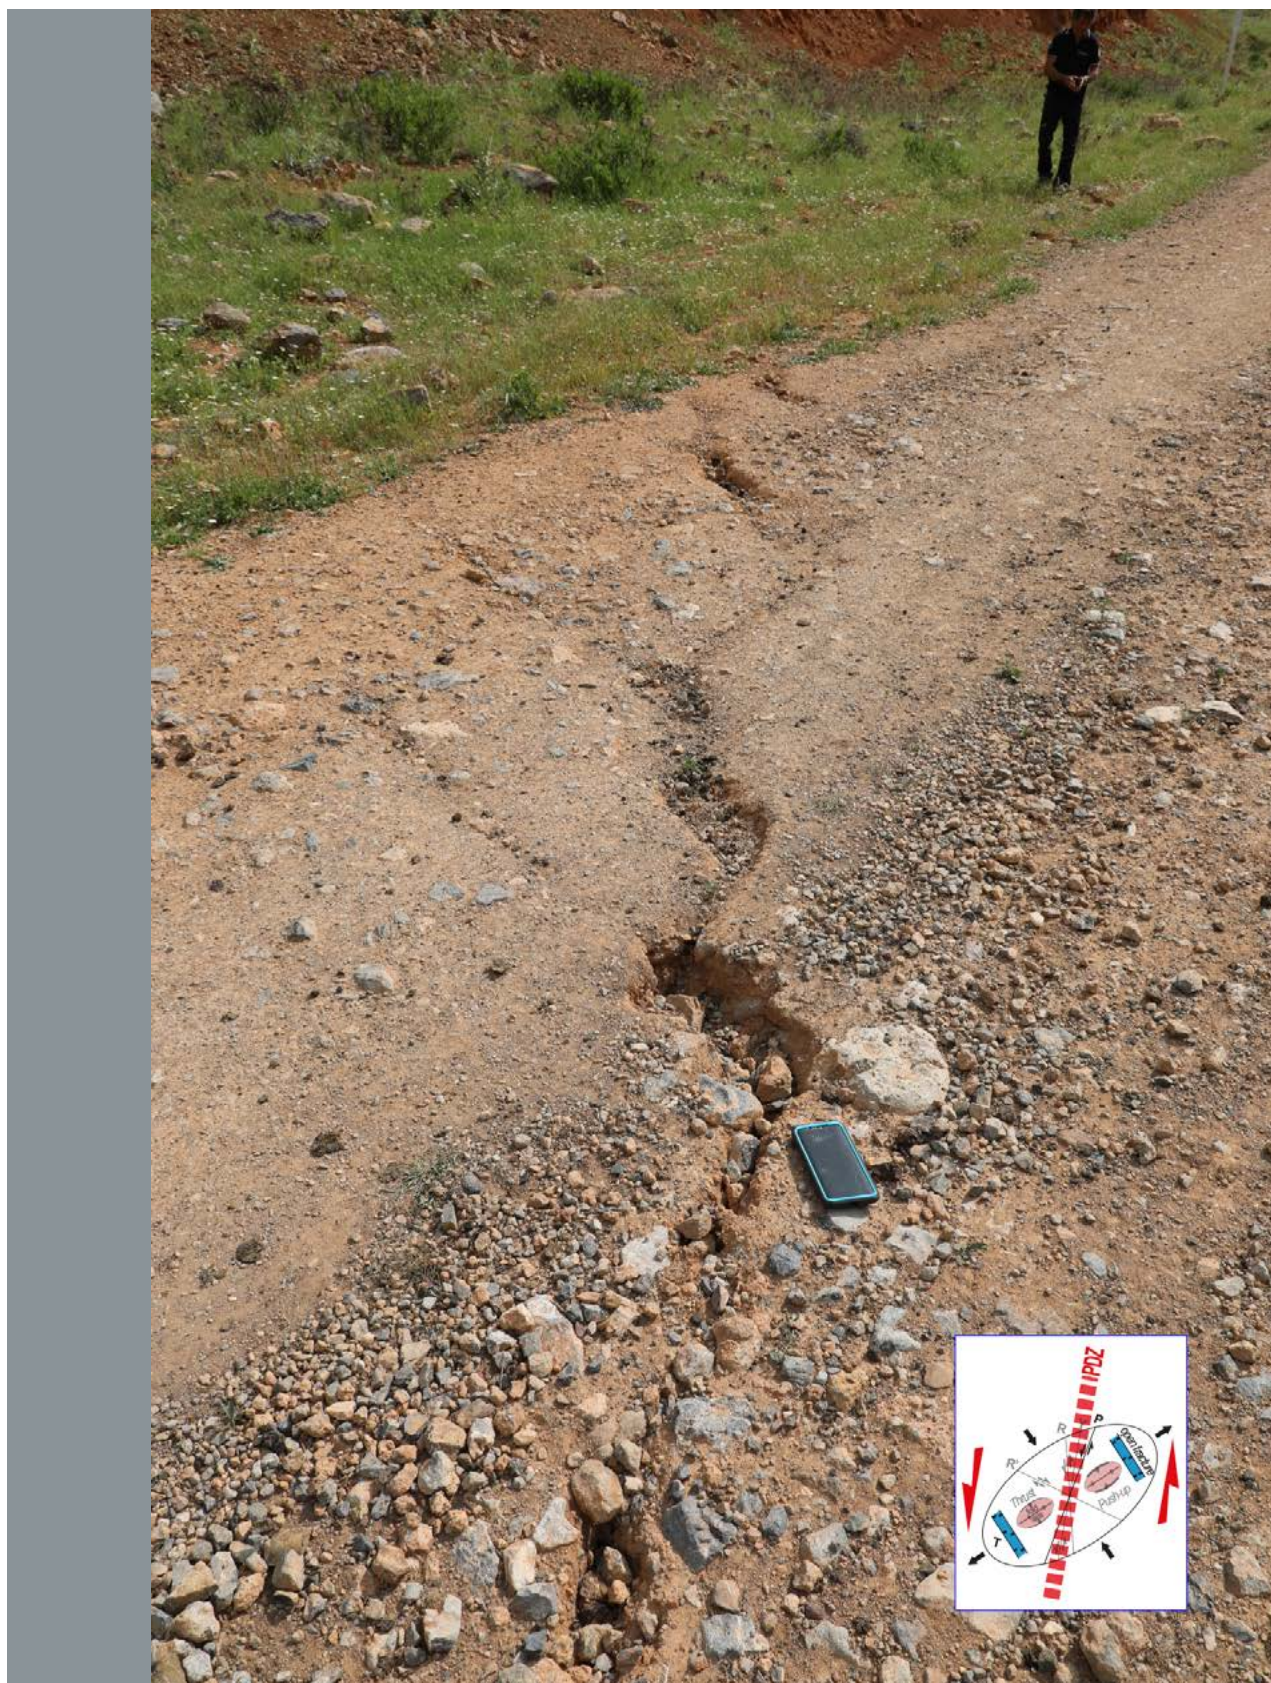
**Photo 11** (37.161863°N, 36.702838°E) – Coseismic rupture with dominant right-lateral en-echelon tension cracks (2–3 m long; opening 10 cm) linked by left-stepping strike-slip elements. This pattern characterizes transtensional zones, such as releasing step-overs. The inset shows theoretical rupture typology from infinitesimal plane strain (symbols in Figure 2); non-observed typologies are opacified.

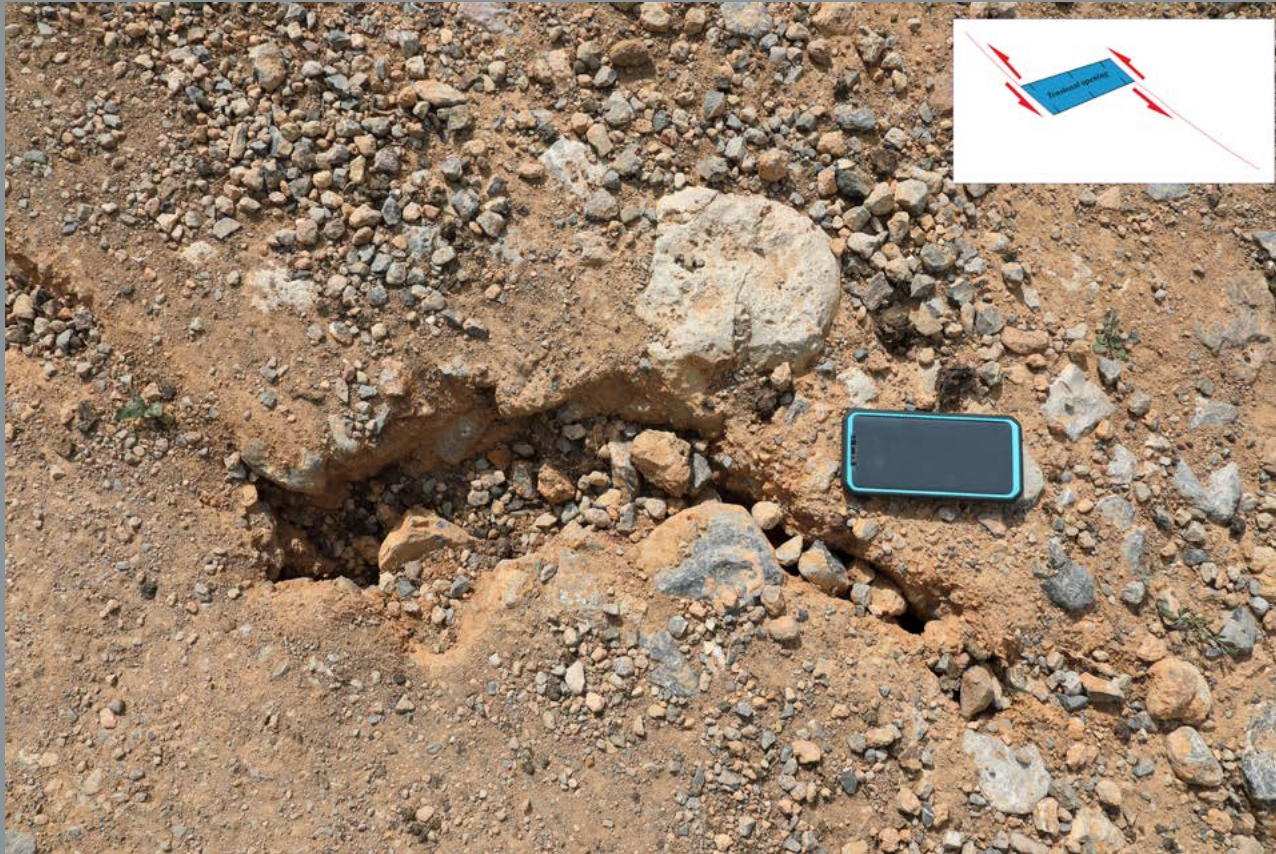
**Photo 12** (37.161863°N, 36.702838°E) – Detail of the previous structural pattern (photo 11). The left-lateral strike-slip kinematics of the left-stepping en-echelon arrangement of the strike-slip elements determine a tensional opening between the two elements (few-cm wide, with no vertical component). In the box a sketch map of the typology of rupture.
