# MISCELLANEA INGV

A photo and video collection on the  
surface faulting: the Mw 7.8  
Kahramanmaraş (Turkey) earthquake  
of February 6, 2023

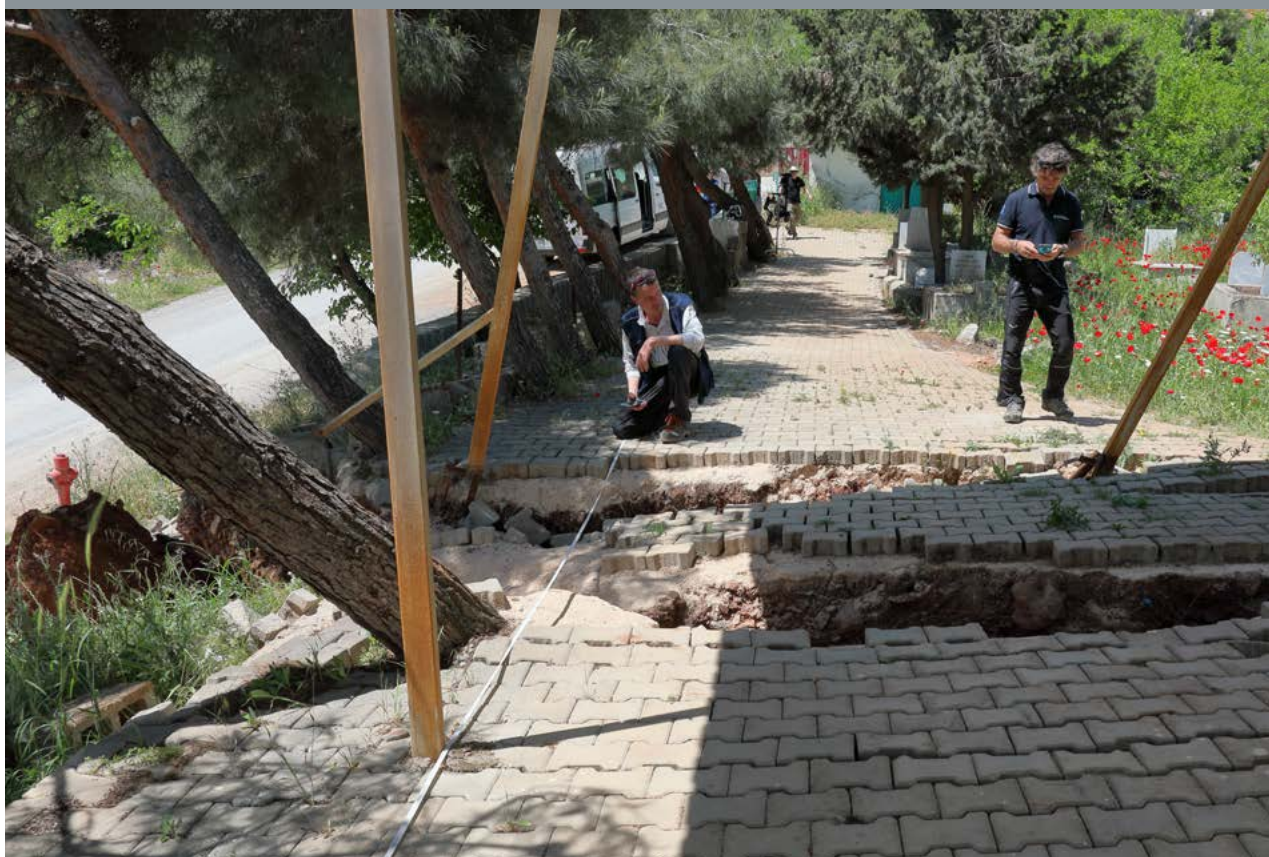
**Photo 13** (37.164370°N, 36.706508°E) – Transtensional earthquake rupture crossing Gökçedere (Nurdağı/Gaziantep). In the cemetery, decametric en-echelon segments dislocate the pavement. Total displacement shows a ~130 cm left-lateral offset (using tree line reference) and a 40 cm vertical offset (east-facing viewpoint).

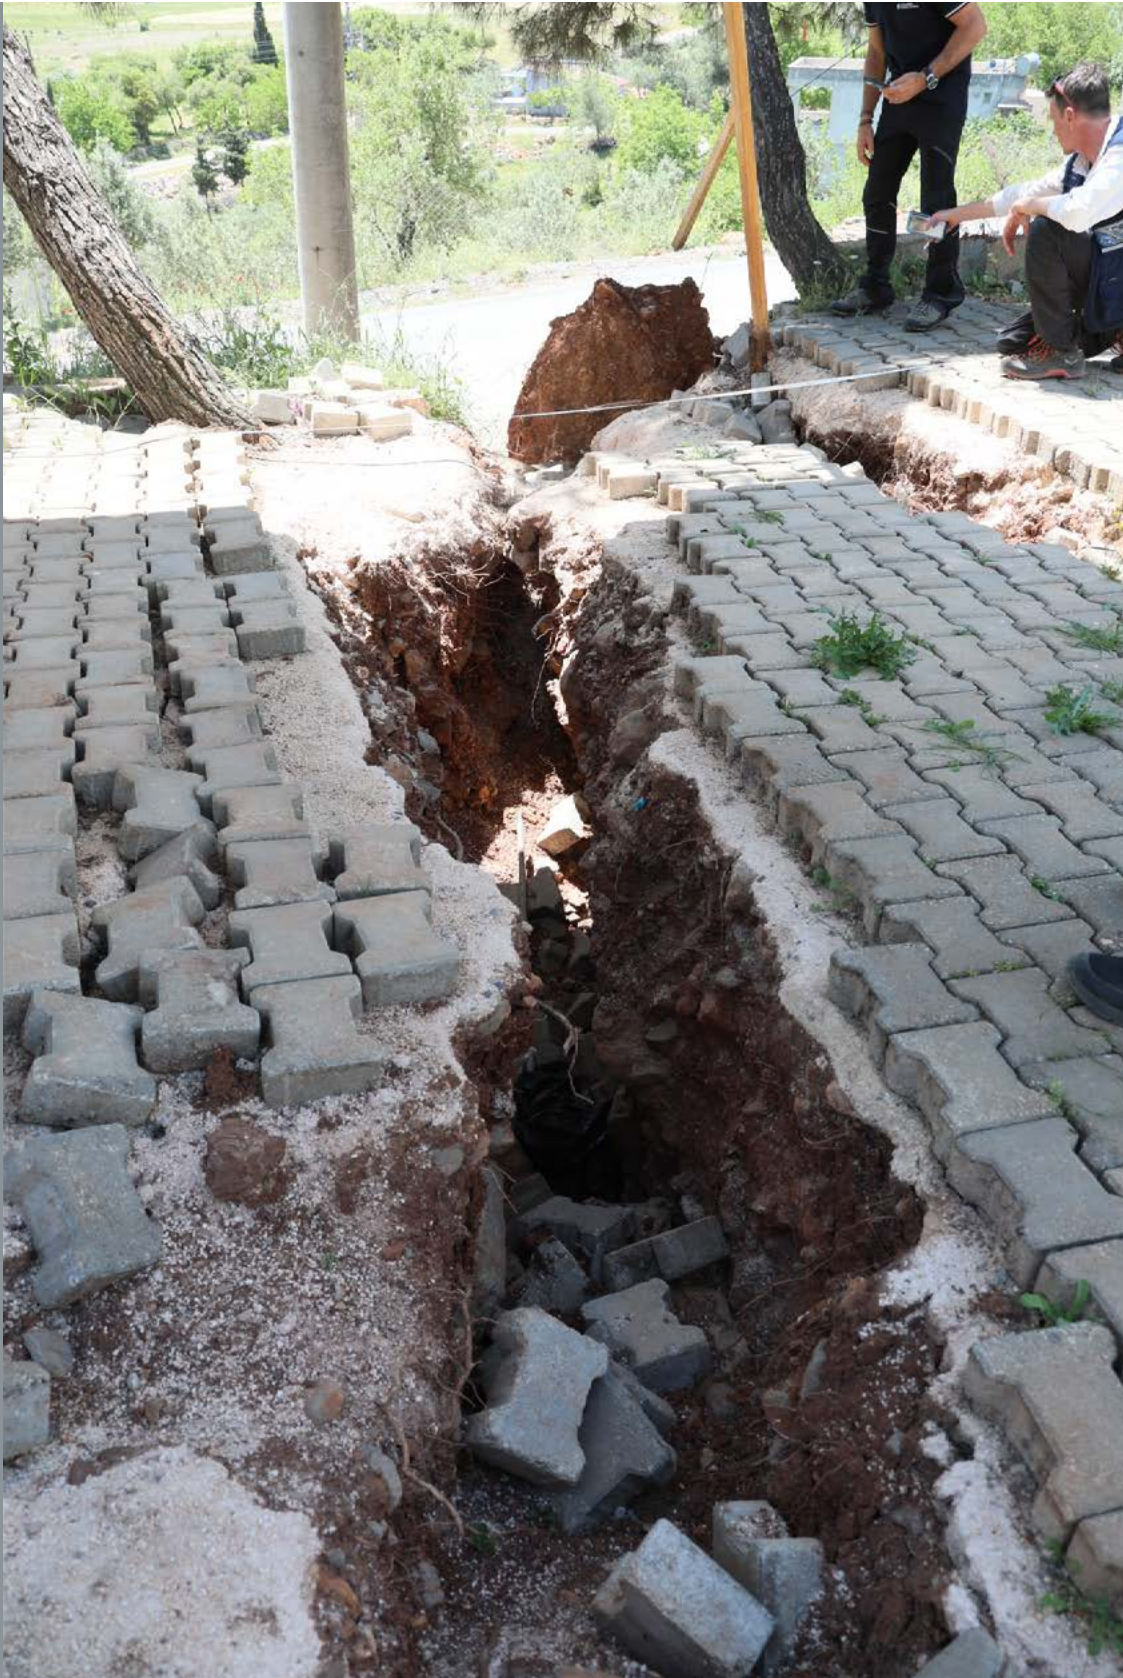
**Photo 14** (37.164370°N, 36.706508°E) – Detail of the previous photo 13 (viewed from the north). The coseismic surface rupture is characterised by two en-echelon, decameter-scale transtensional branches with a large opening component and a meter-scale interposed gravity graben.

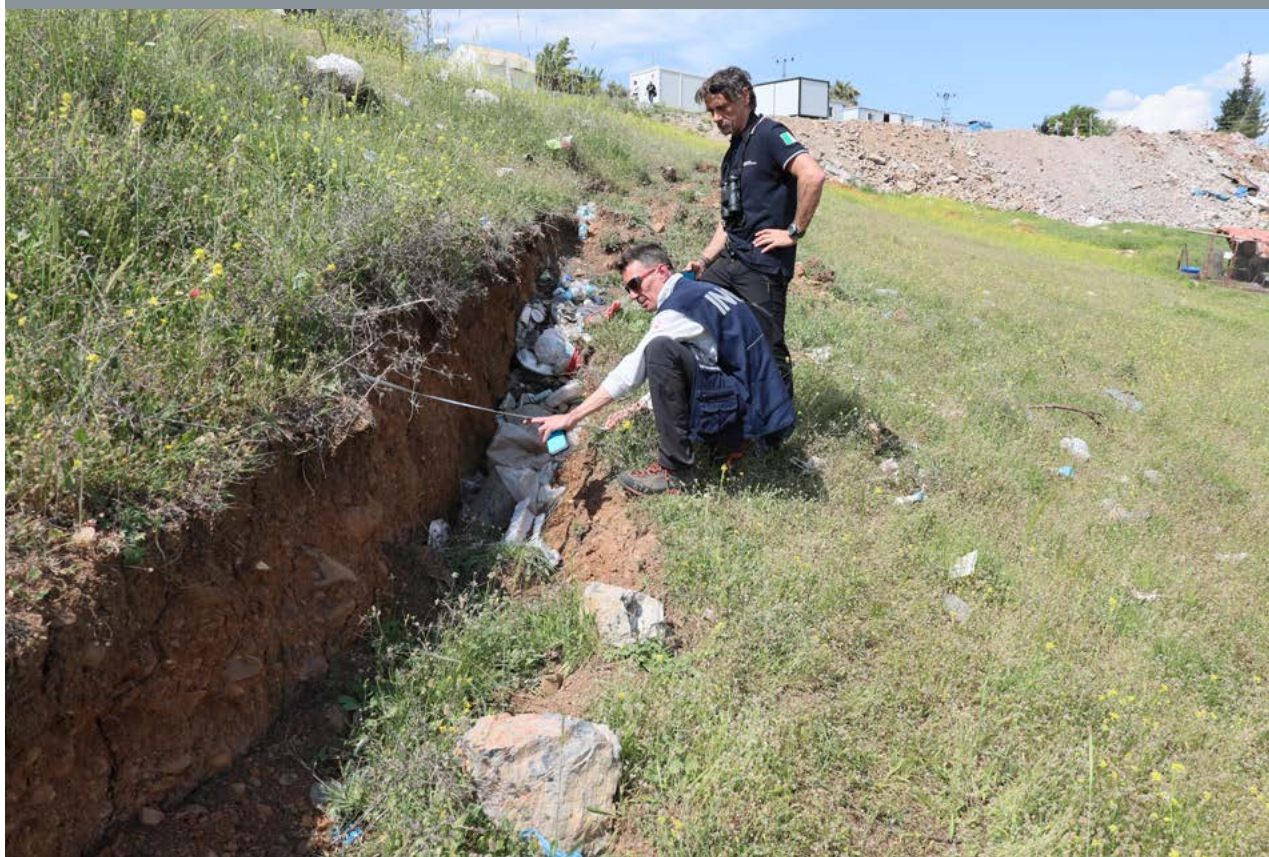
**Photo 17** (37.194690°N, 36.726102°E) – Detail of the previous photo 16: here, the rupture features a prevailing transtensional movement with an opening of up to 110 cm.

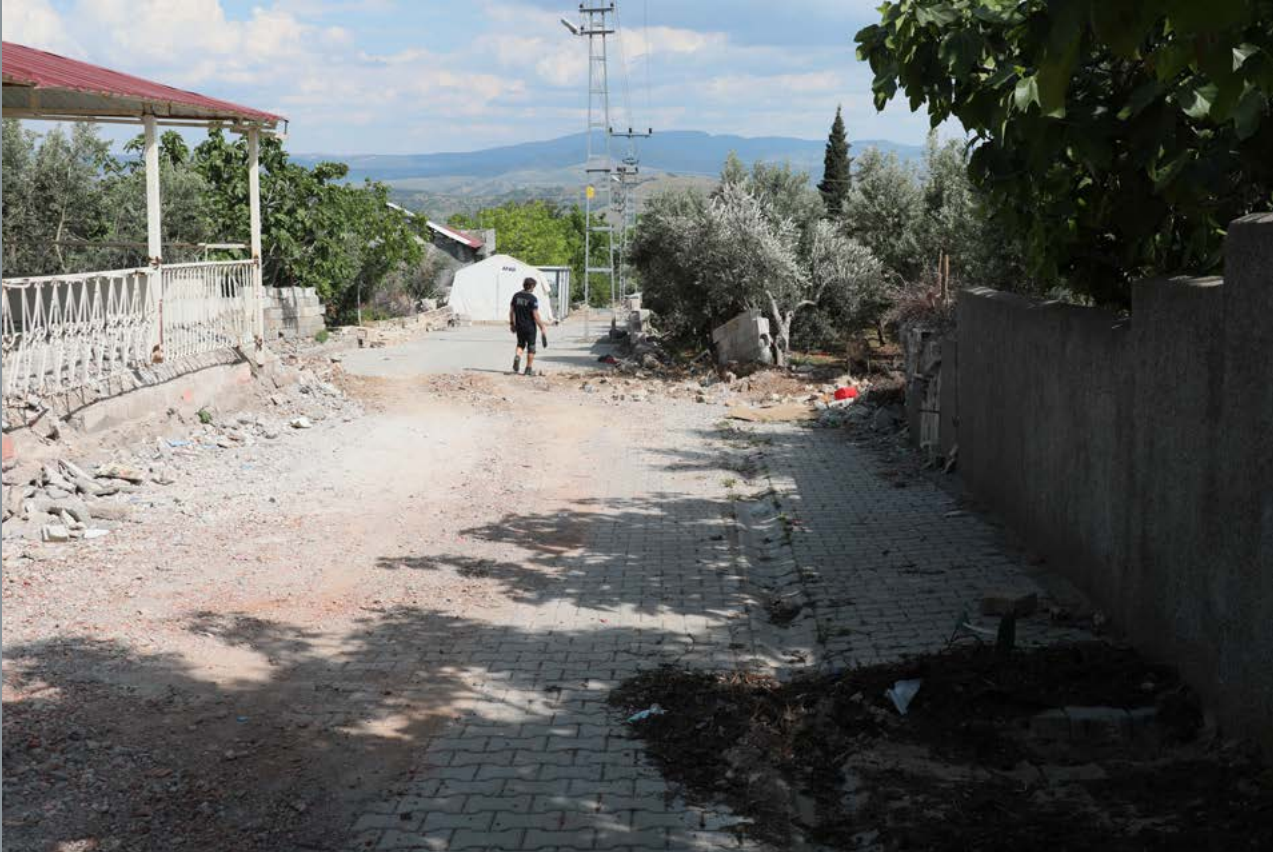
**Photo 18** (37.196710°N, 36.727732°E) – Surface coseismic rupture characterized by a left-lateral offset of 300 cm of a paved road in the village of Başpınar.

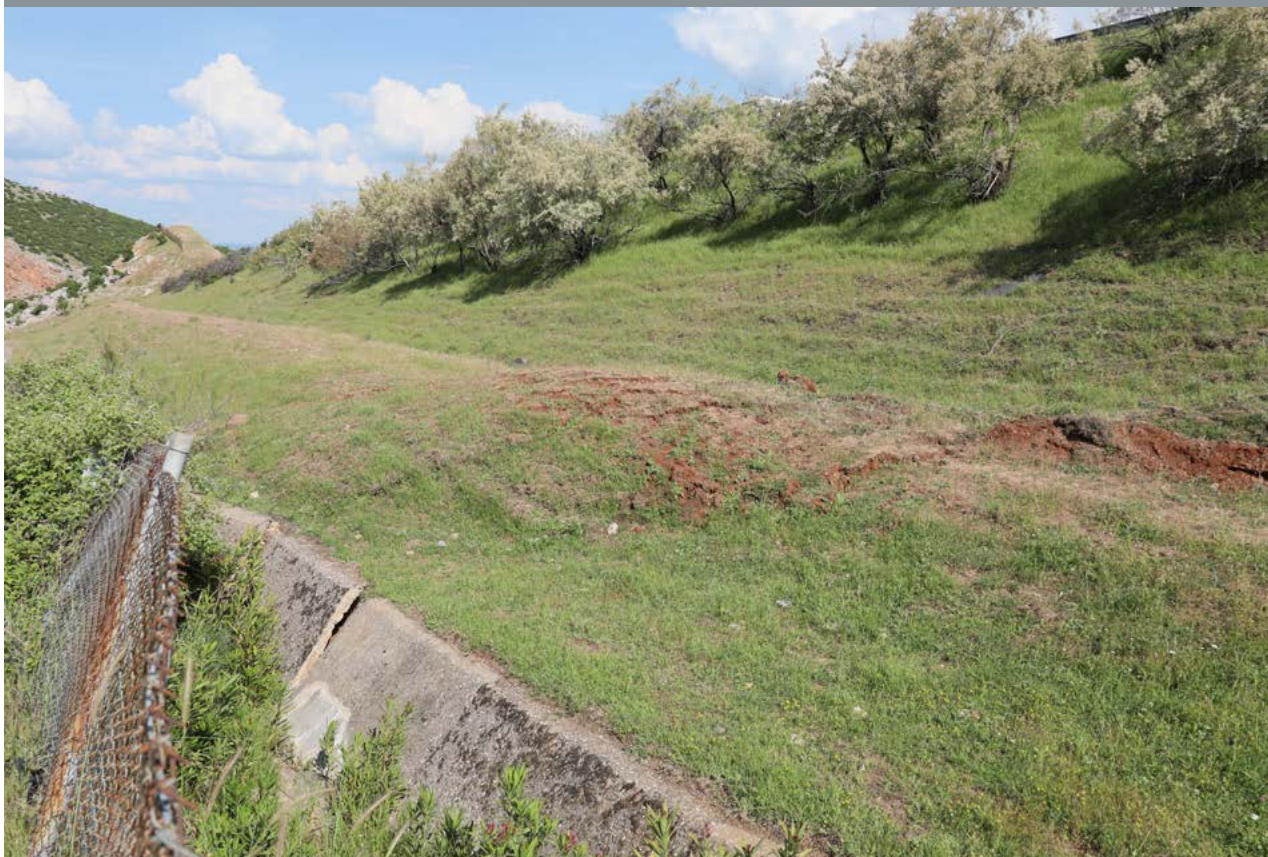
**Photo 19** (37.201277°N, 36.732665°E) – Here, the coseismic rupture shows a metric-scale push-up ridge with smaller flexural cracks affecting the fold hinge.

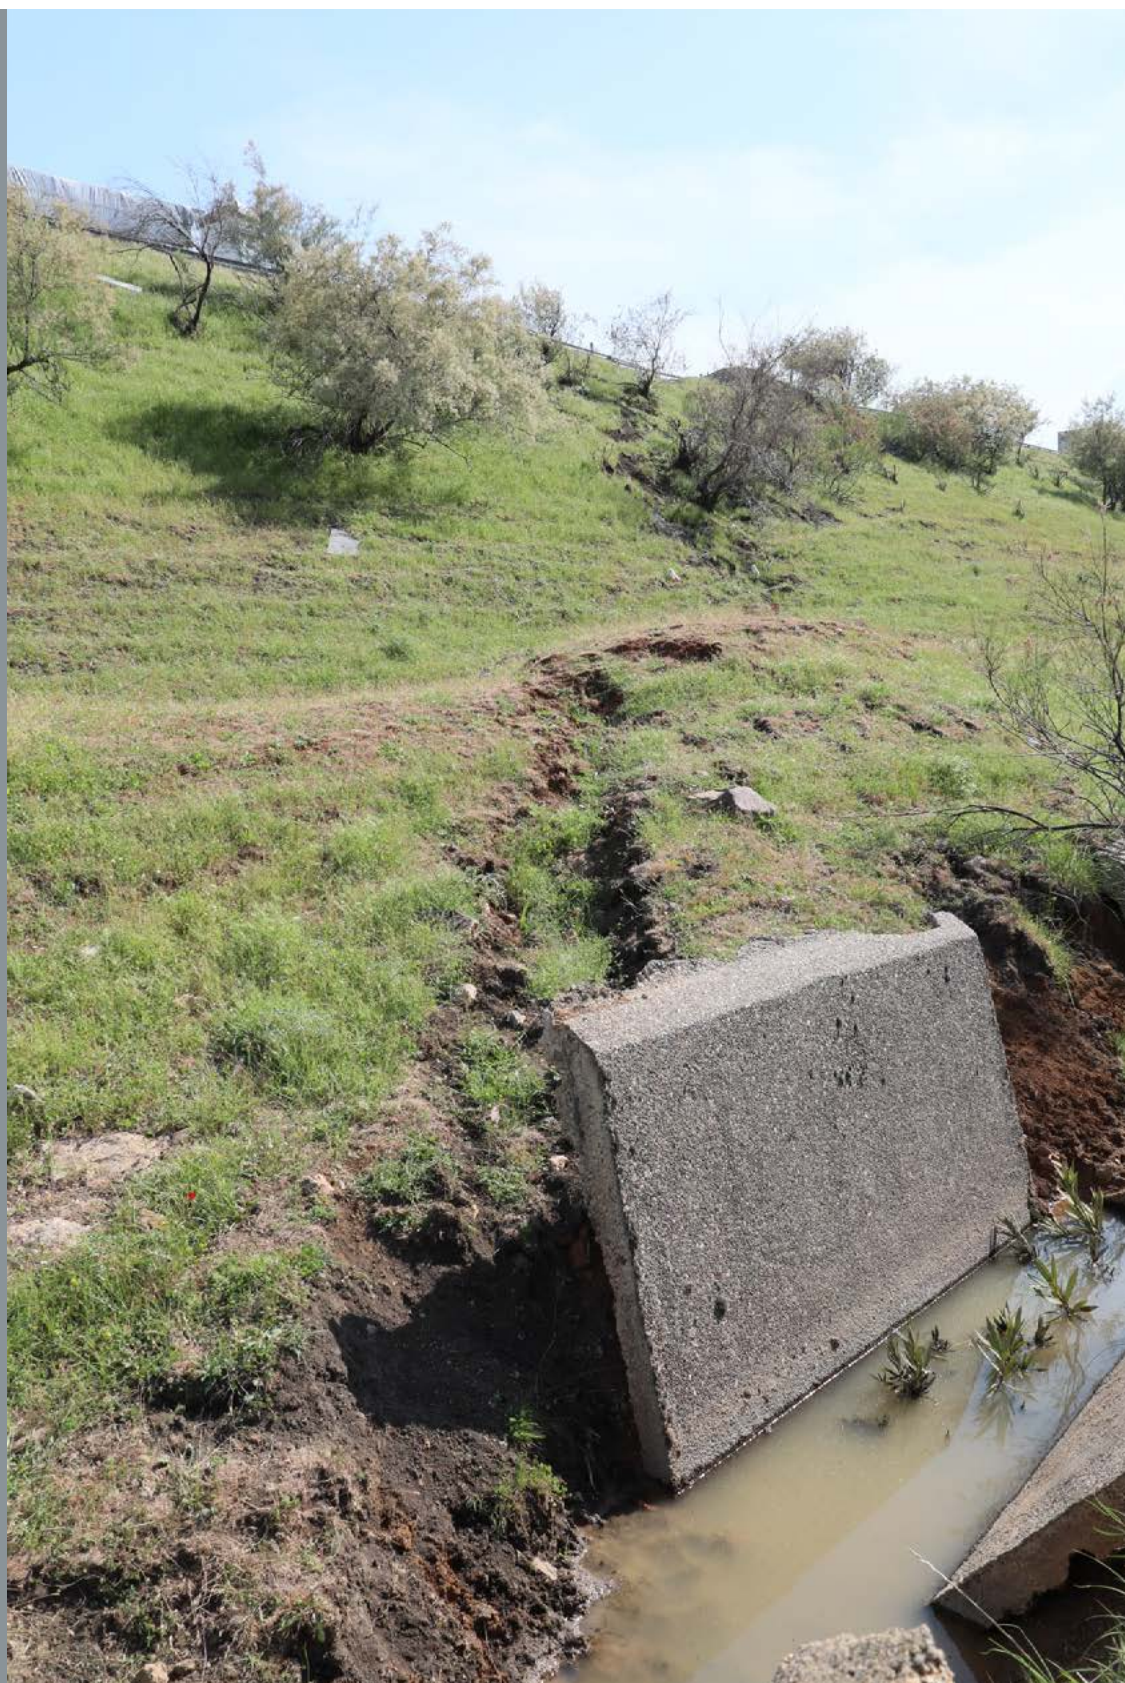
**Photo 20** (37.201277°N 36.732665°) – Detail of the previous photo 19: the push-up generated between the en-echelon right-stepping transtensional Riedel shears.

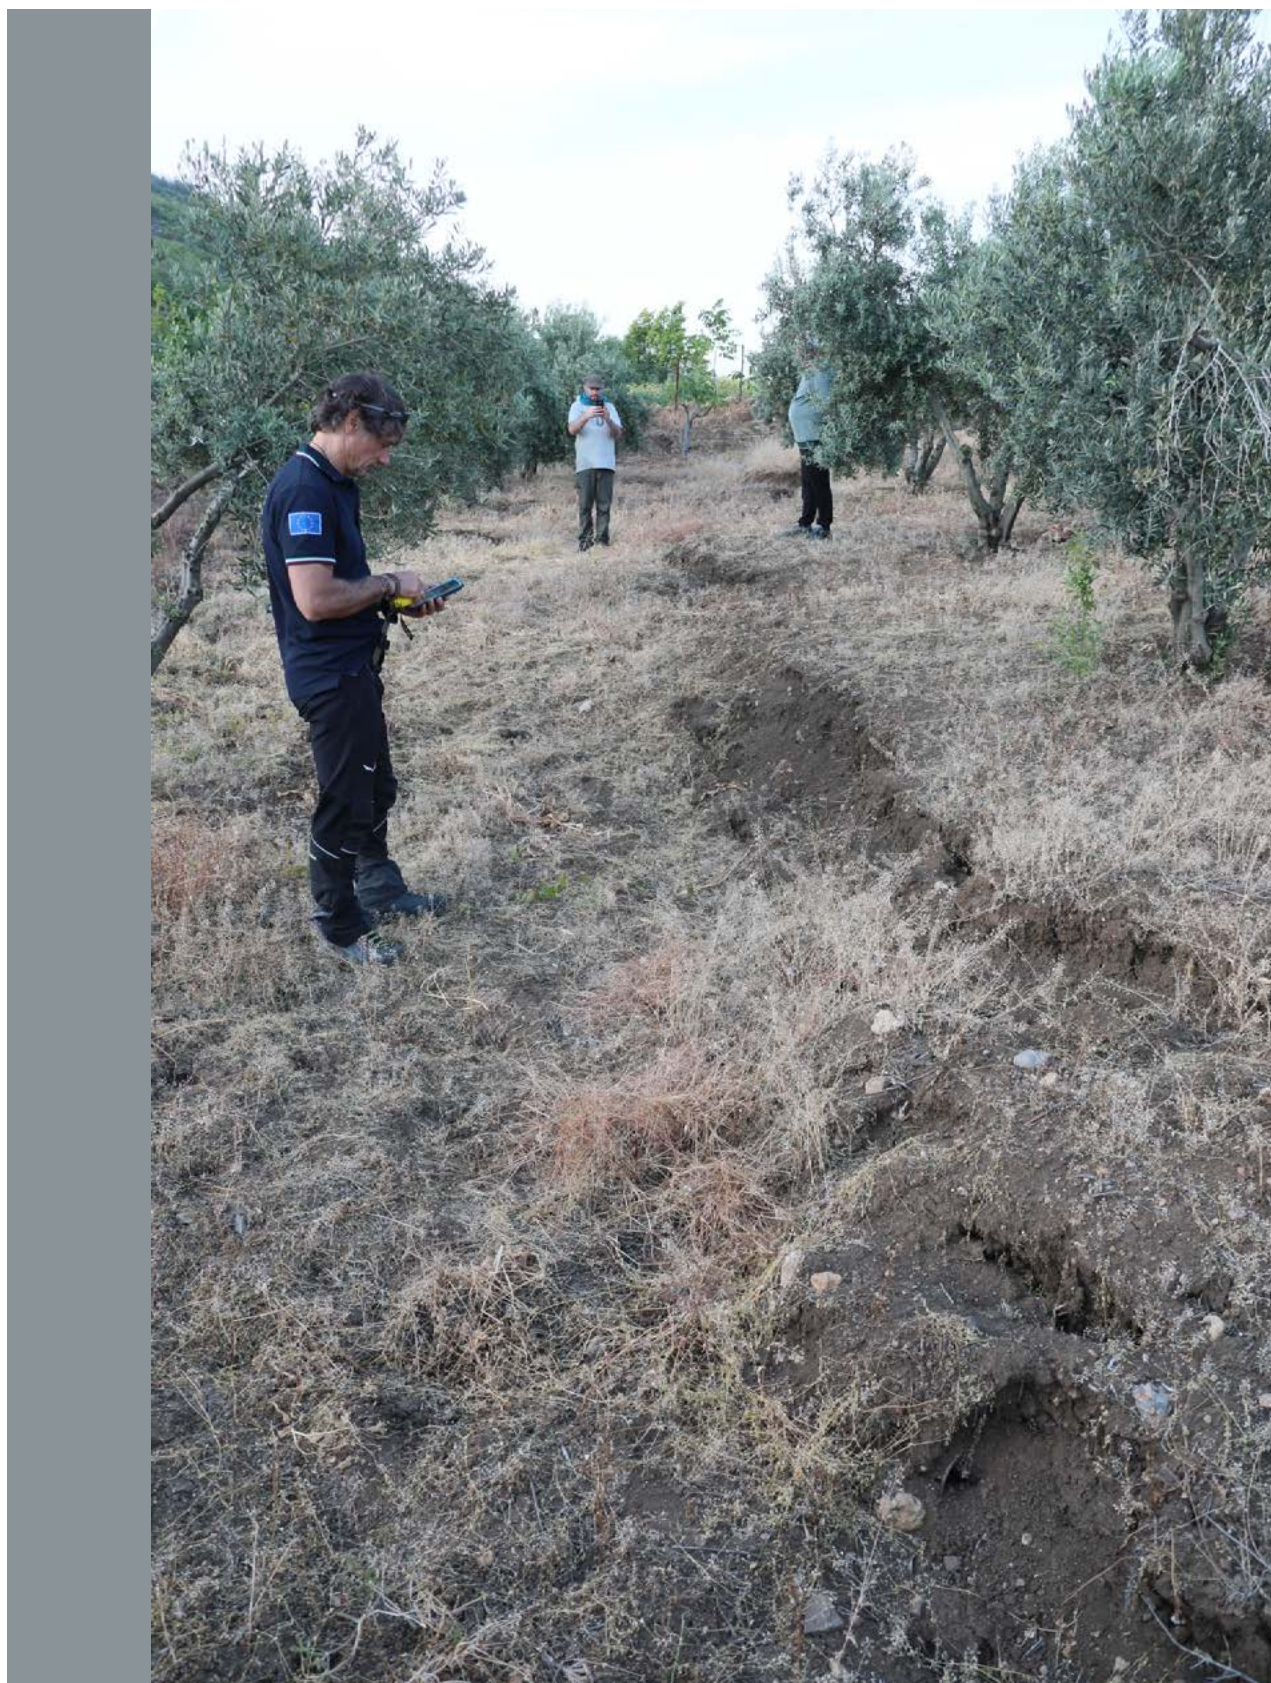
**Photo 29** (37.219515°N 36.748460°E) – Detail of the coseismic rupture associated with a transtensive kinematics resulting in dominant right-stepping Riedels, with vertical offset component of up to 60 cm, linked by lateral ramps.

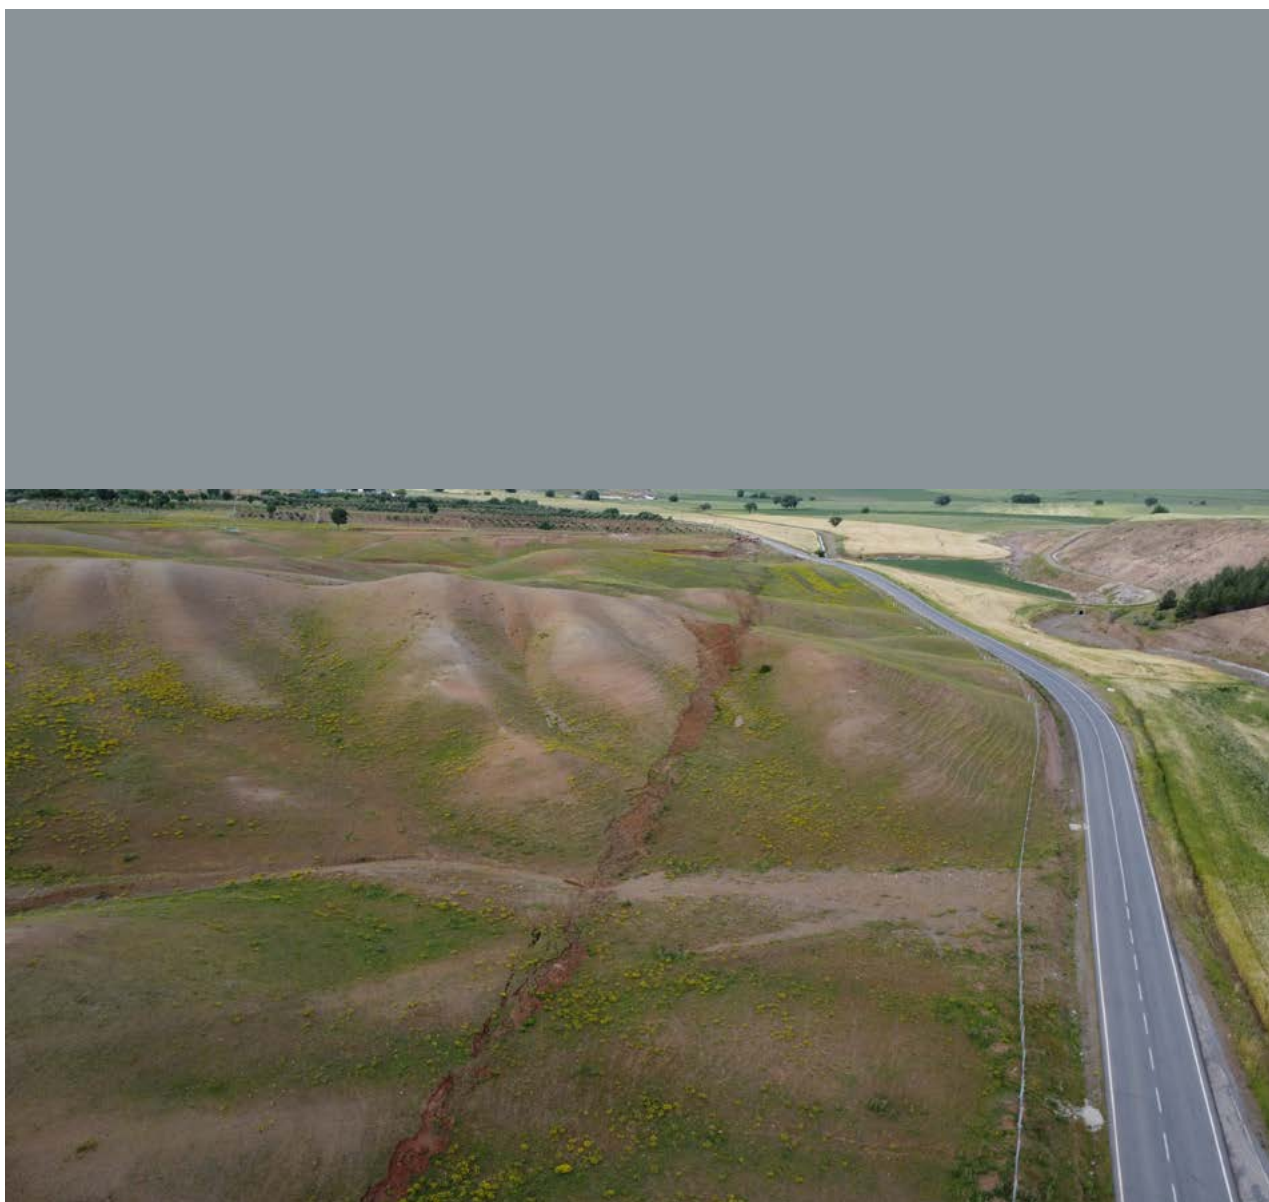
**Photo 30** (37.452119°N, 36.982894°E) – Drone view (from southwest) of the fault trace near the village of Tevekkelli. The linear coseismic rupture displaces ridge crests, hill flanks, and gullies, creating shutter ridges and deflected drainage. Maximum left-lateral displacement measures ~340 cm.

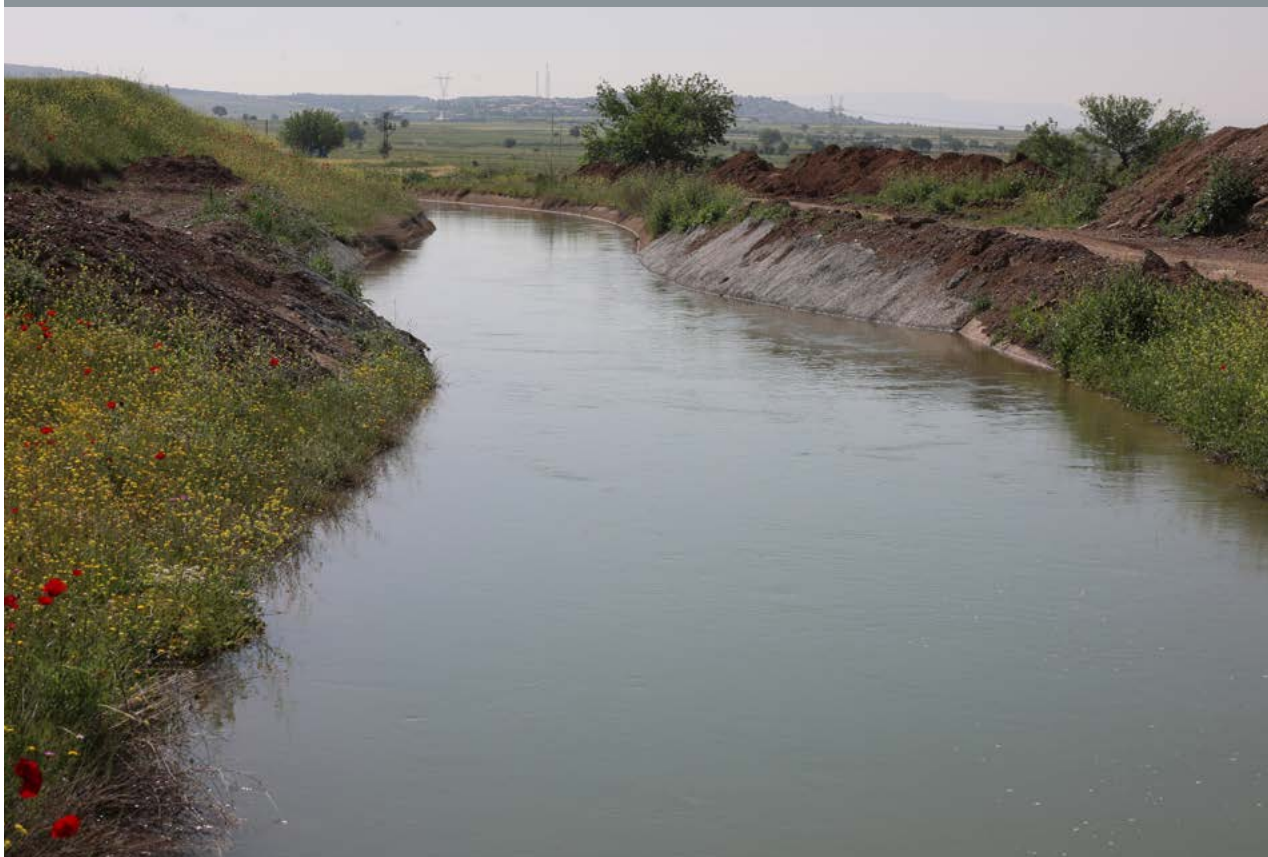
**Photo 34** (37.485160°N, 37.053903°E) – Coseismic left-lateral deflection of ~400 cm affecting an artificial waterway near the Çiğli village.

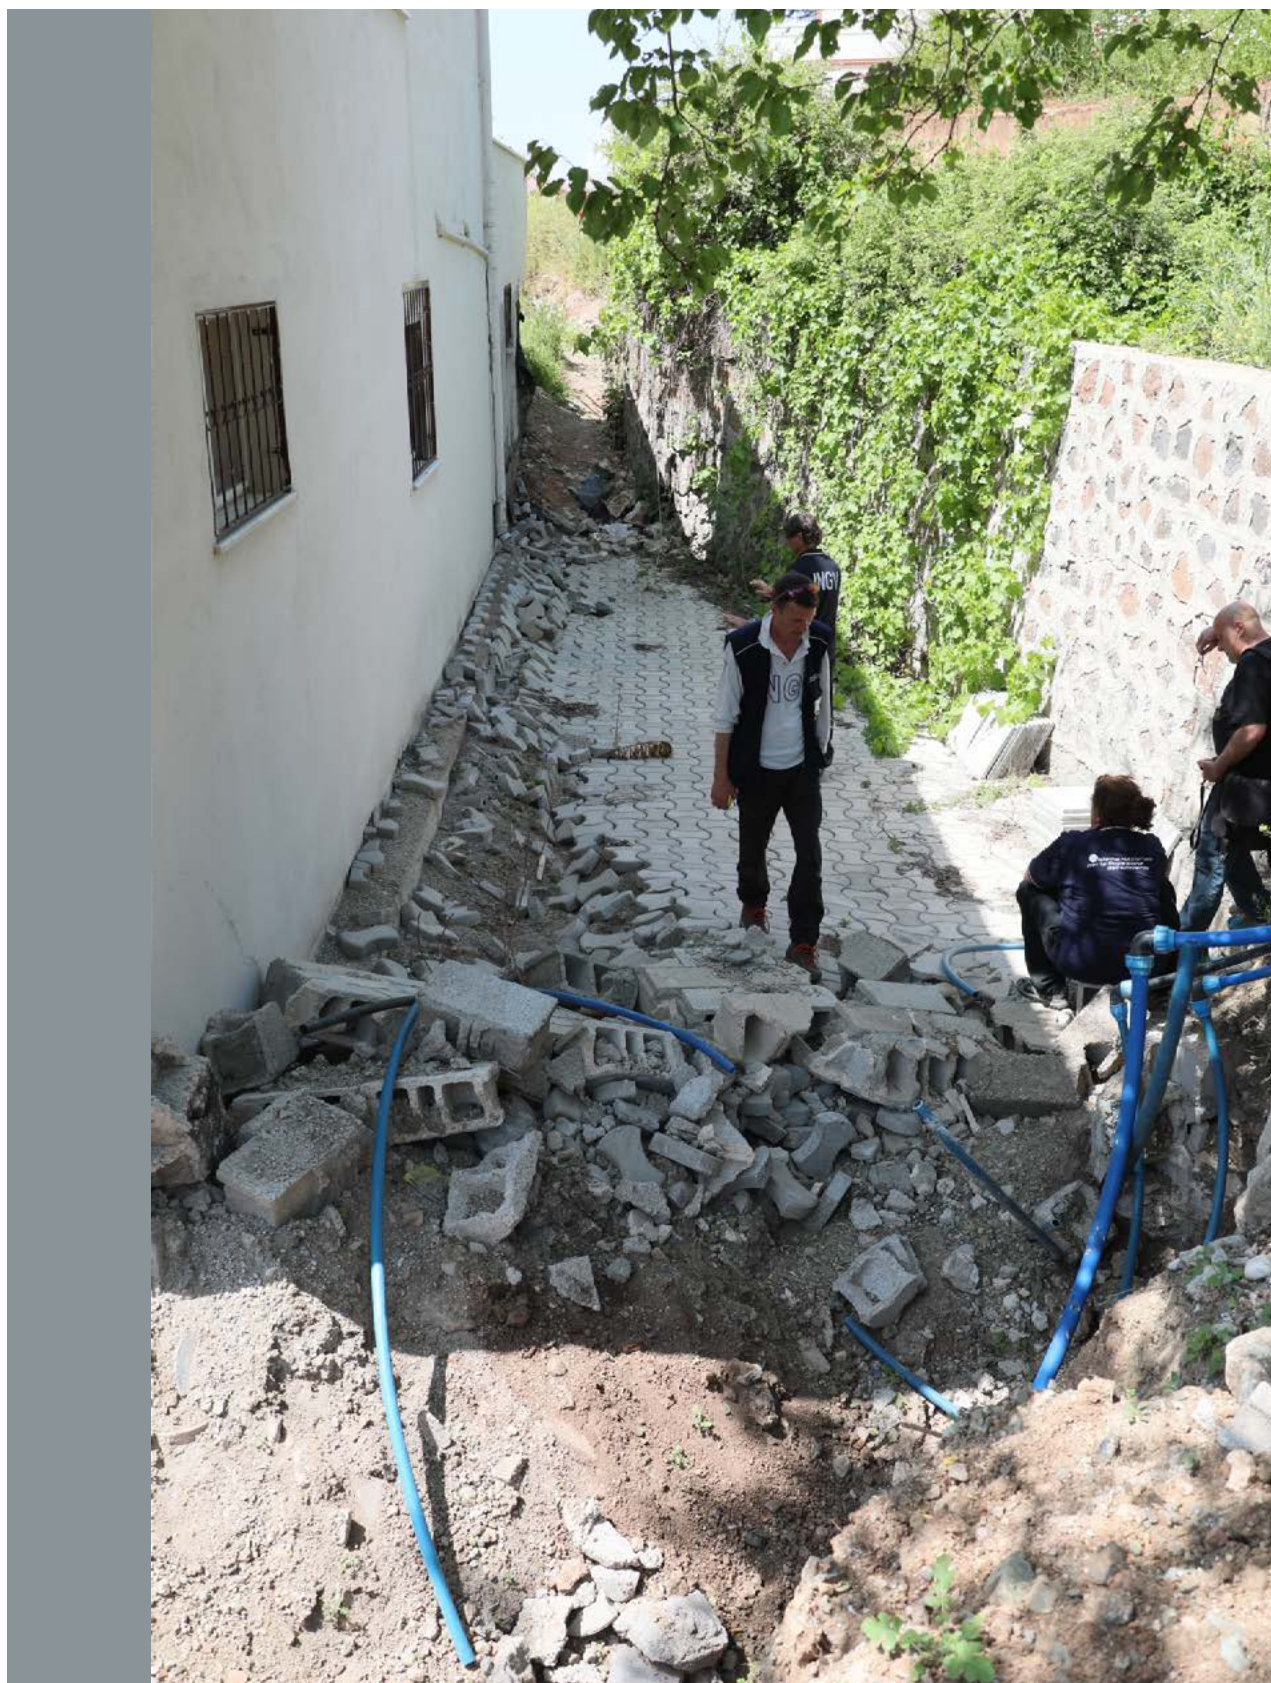
**Photo 36** (37.490882°N, 37.067873°E) – At this site (view from the northeast) the coseismic rupture trace runs parallel to the house wall uplifting the house with respect to the paved outdoor, no clear significant damage can be reported.

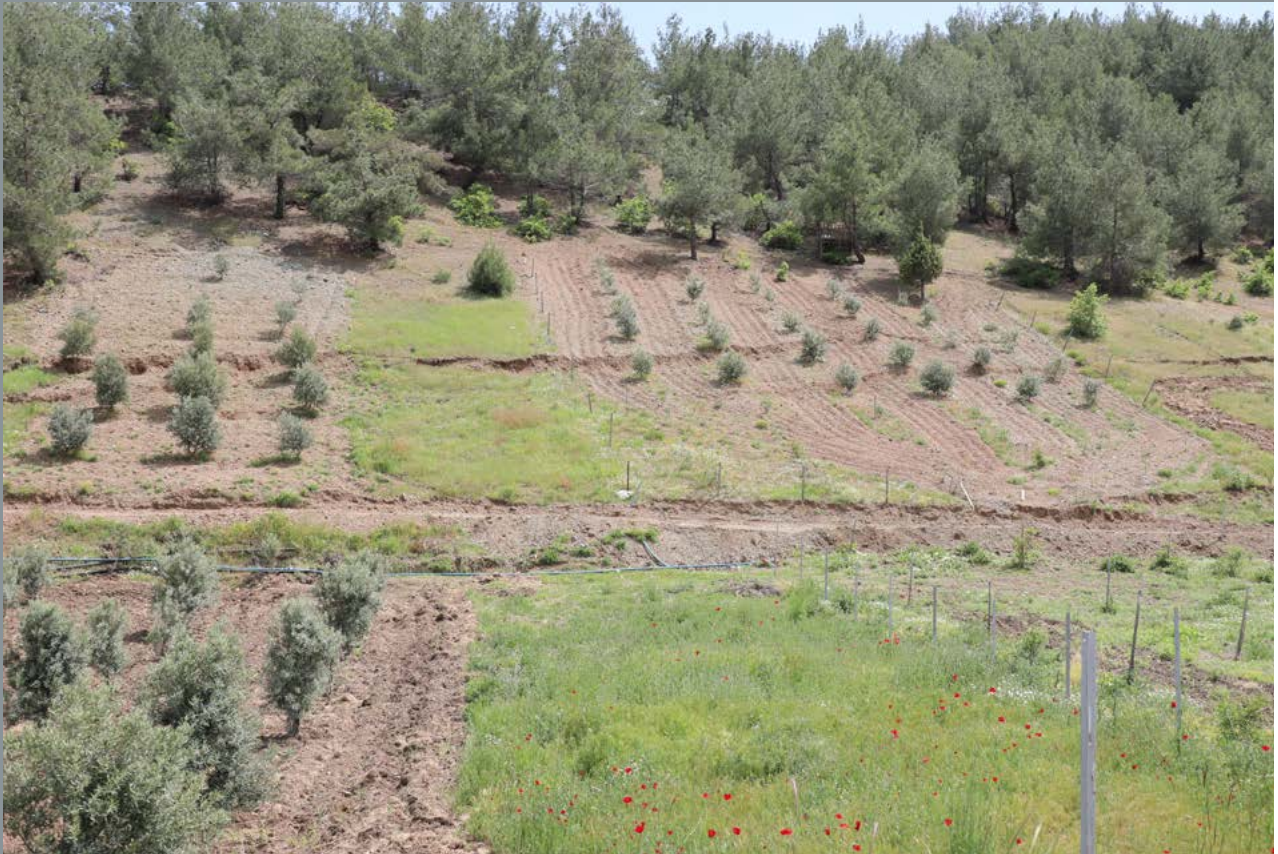
**Photo 37** (37.509495°N, 37.121345 °E) – Panoramic view (from north) of the coseismic rupture southwest of the village of Kartal. Here, the coseismic surface rupture branches in multiple parallel strands, with partitioning of the left-lateral displacement (see also photographs 38, 39, 40).

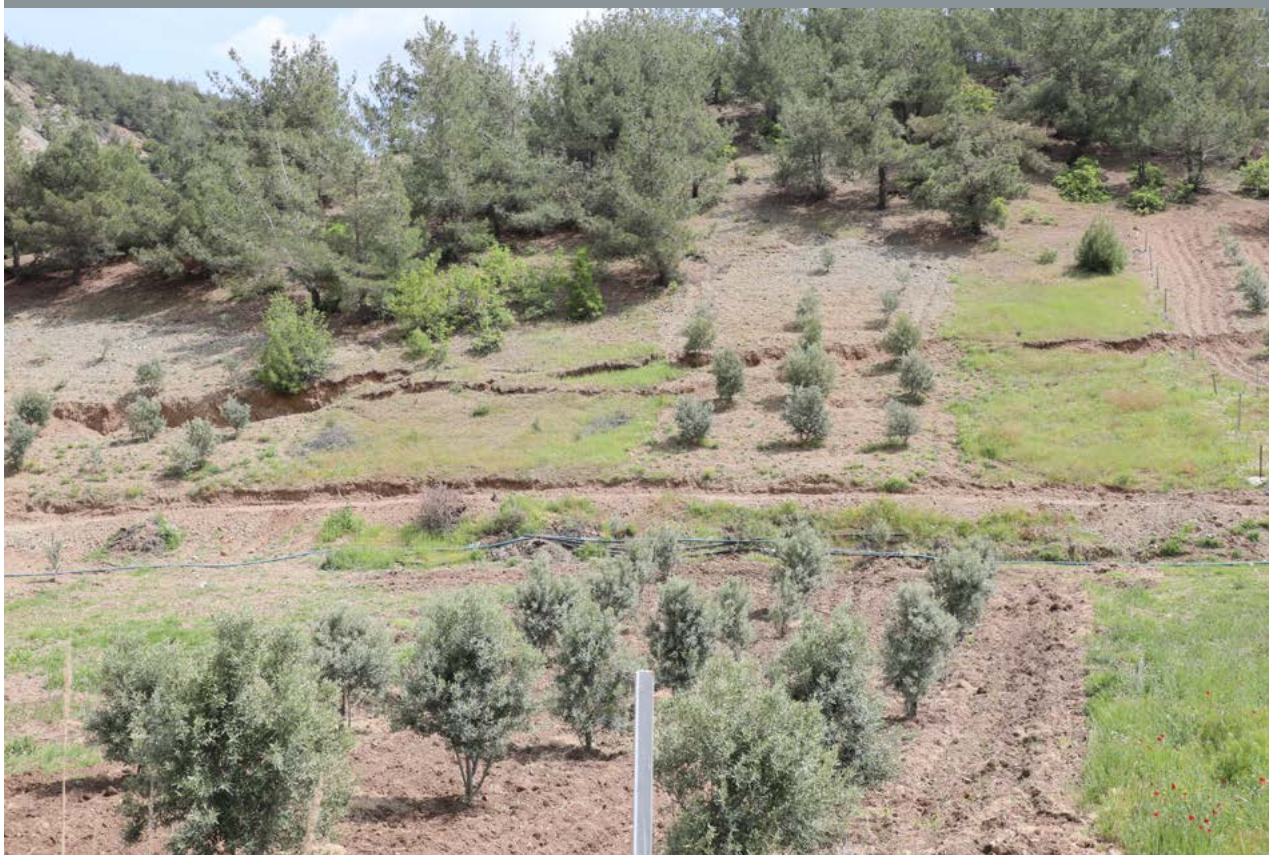
**Photo 38** (37.509495°N, 37.121345 °E) – Previous photo close up: note the left-lateral displacement of the tree alignments along the hill slope and the coseismic rupture with evident vertical offset component (see also photographs 37, 39, 41).

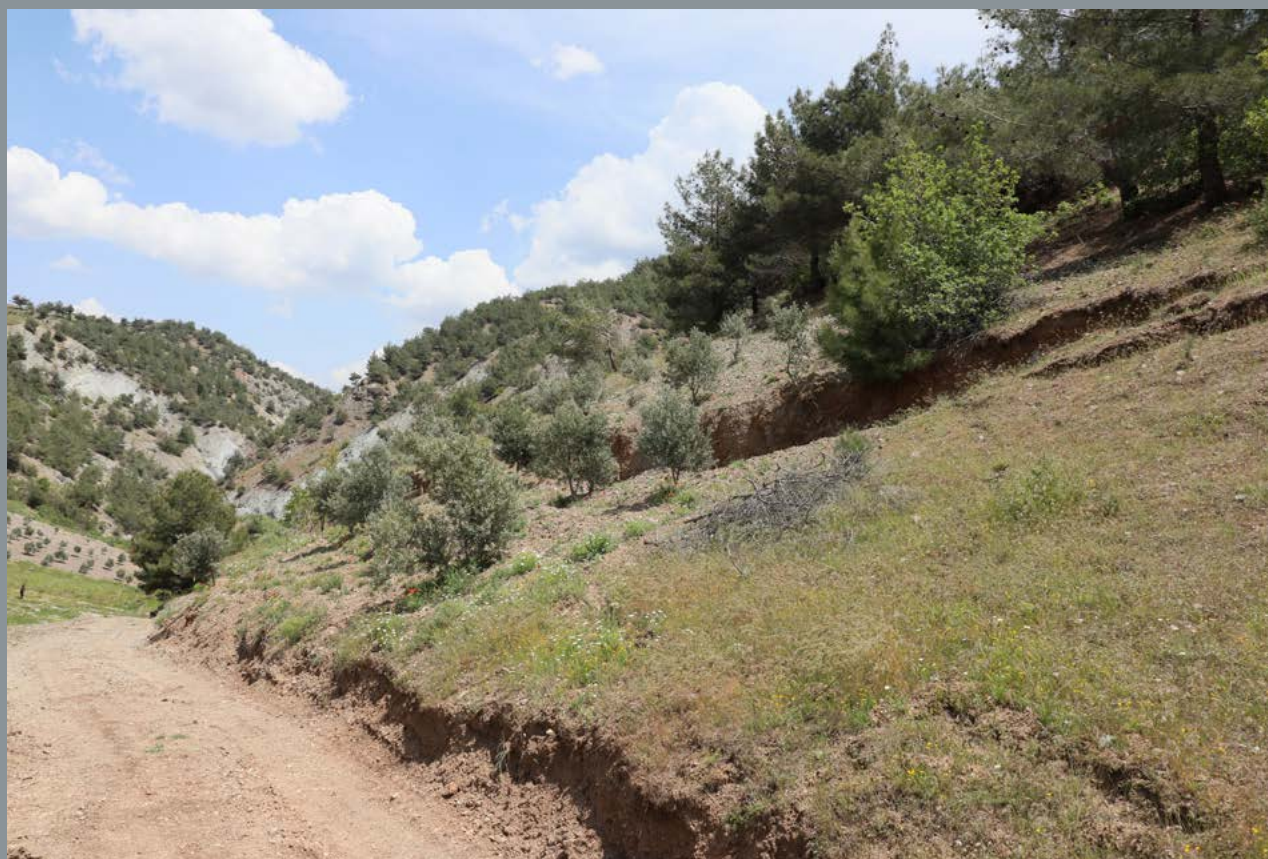
**Photo 39** (37.509500°N, 37.123718°E) – Detail of the previous photo: here the coseismic rupture features a left-lateral offset of 350 m with up to 250 cm of vertical offset. Note also the en-echelon arrangement of the individual elements.

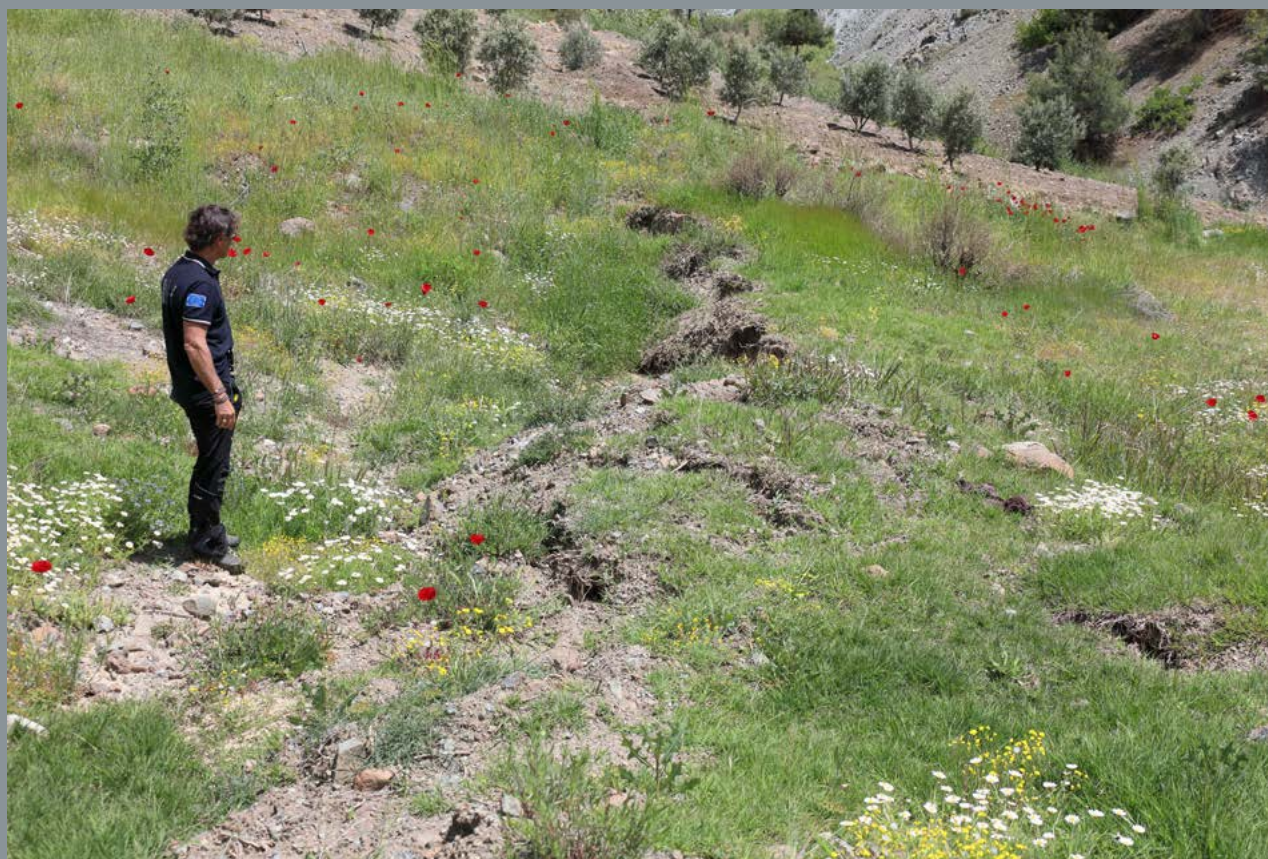
**Photo 41** (37.509380°N, 37.123407°E) – Mole-track expression of the rupture due to the dominant presence of push-ups, resulting from the transpressional kinematics of the hosting strand.

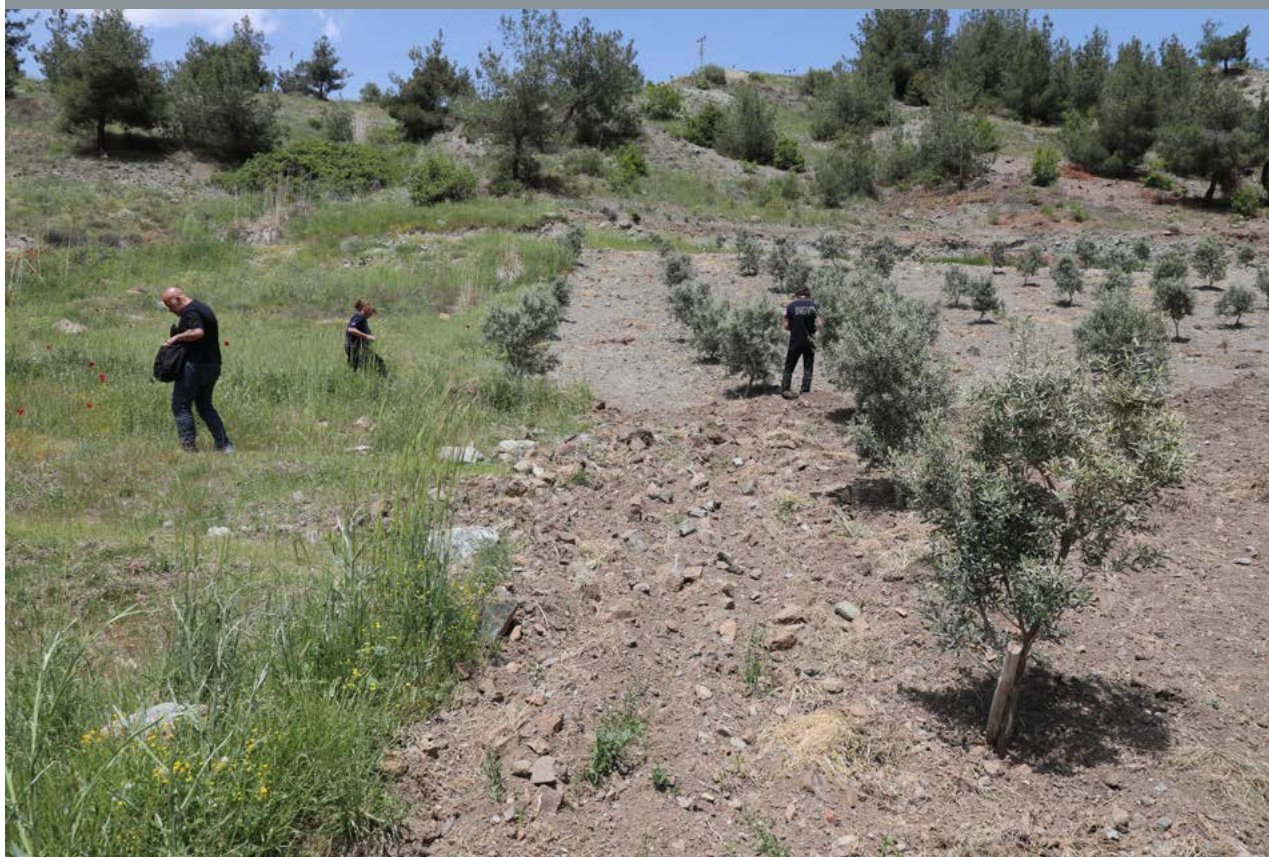
Photo 42 (37.509417°N, 37.509417°E) – Left-lateral offset of ~430 cm measured by means of the tree line dislocation.

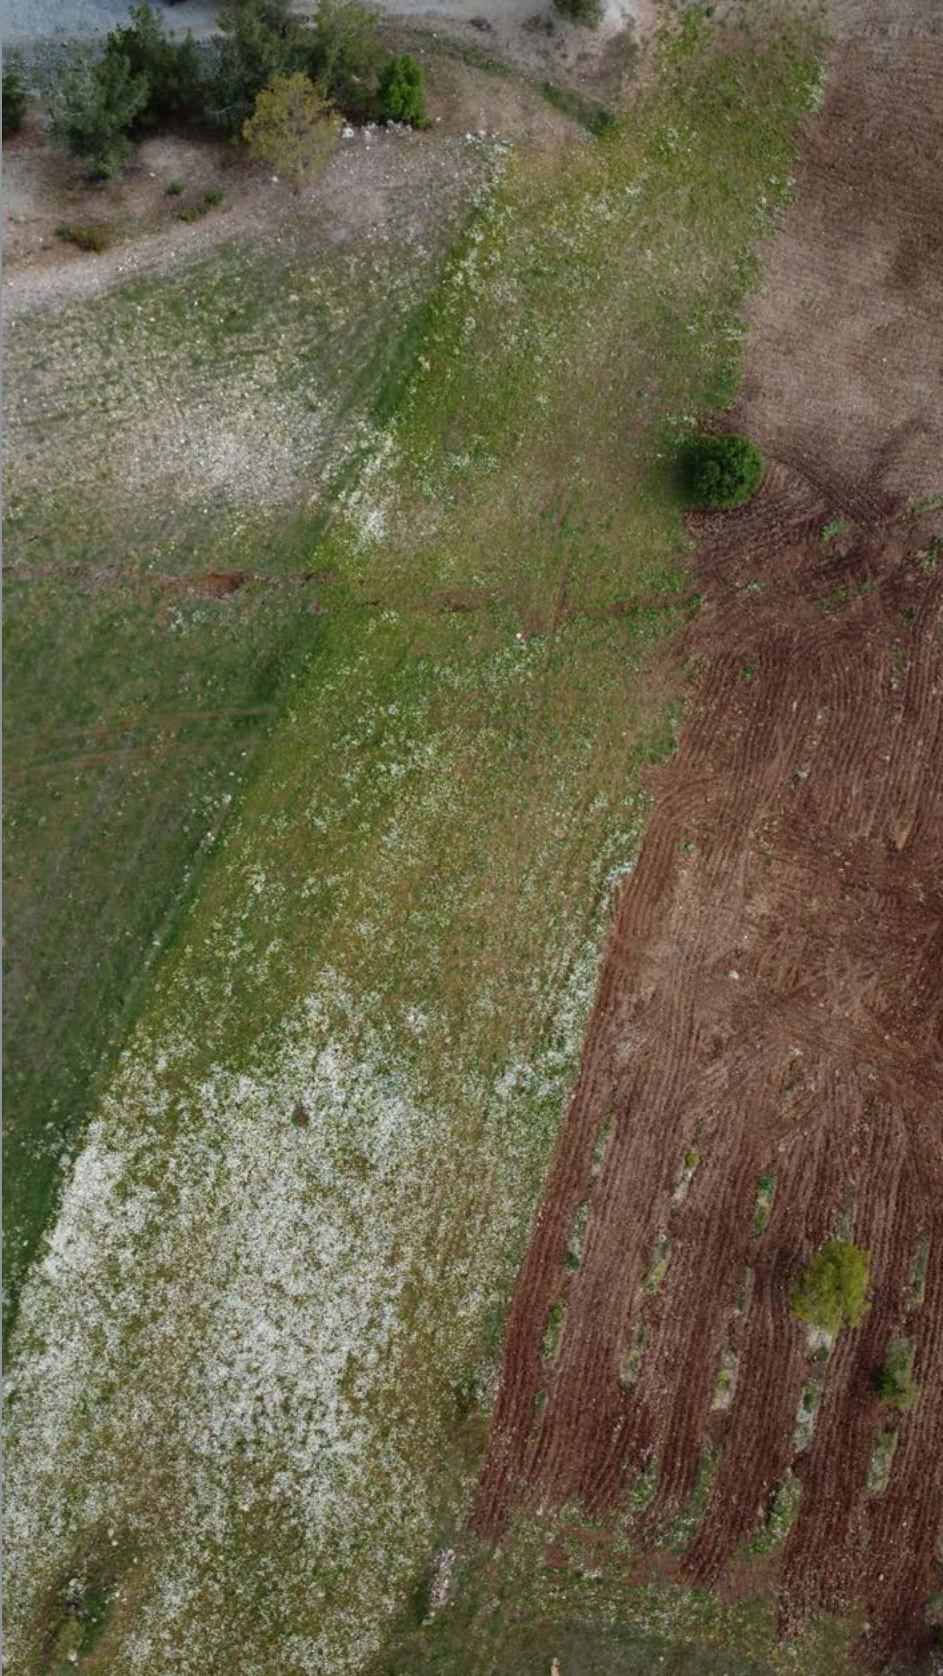
**Photo 45** (37.512746°N, 37.144398°E) – Detail of the previous photo. The horizontally dislocated (~330 cm) limit of the green and brown cultivated fields highlights the left-lateral component of movement.
