# MISCELLANEA INGV

A photo and video collection on the  
surface faulting: the Mw 7.8  
Kahramanmaraş (Turkey) earthquake  
of February 6, 2023

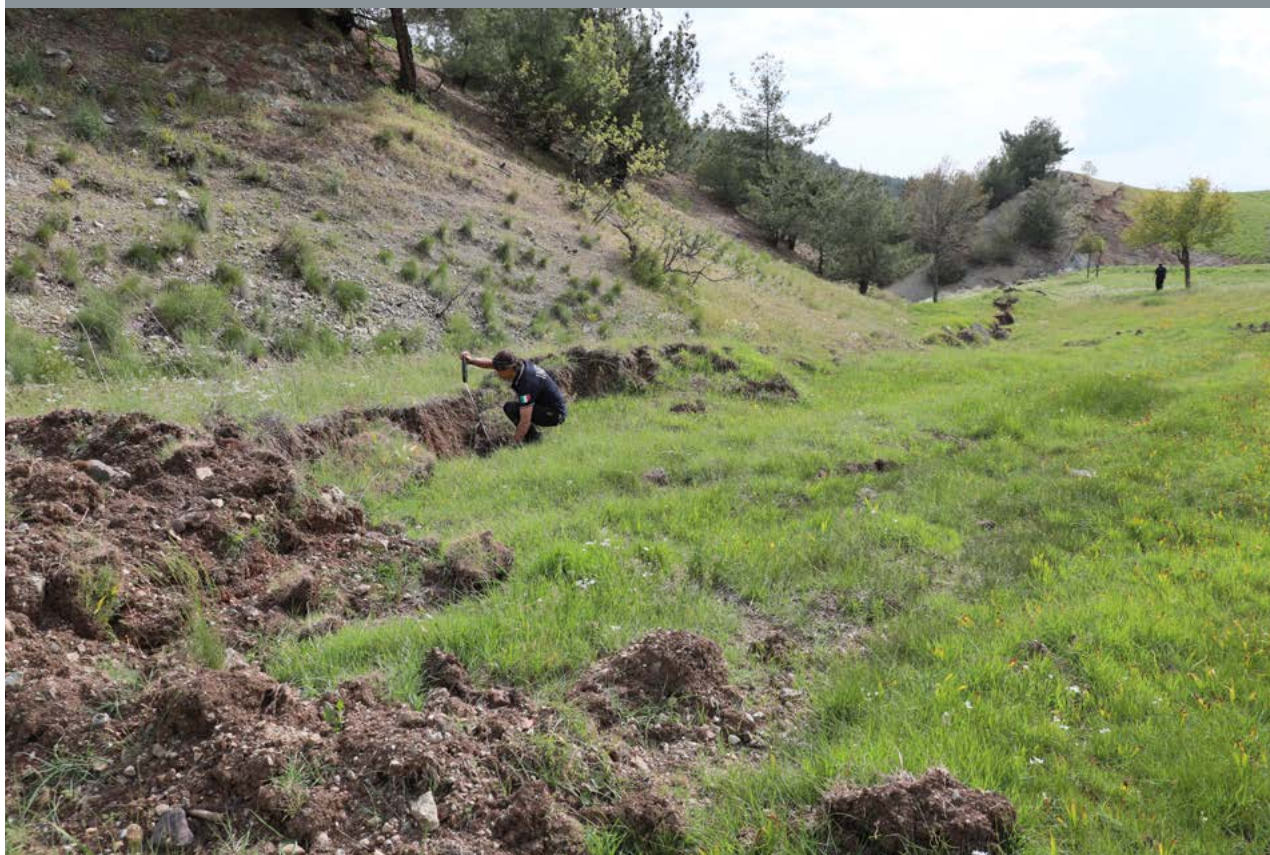
**Photo 48** (37.513147°N, 37.146798°E) – View of the coseismic rupture running at the base of the pressure ridge. The arrangement is consistent with quasi-pure left-lateral kinematics. Note the dip-slip component at the pull-apart basins, locally caused by small extensional bends.

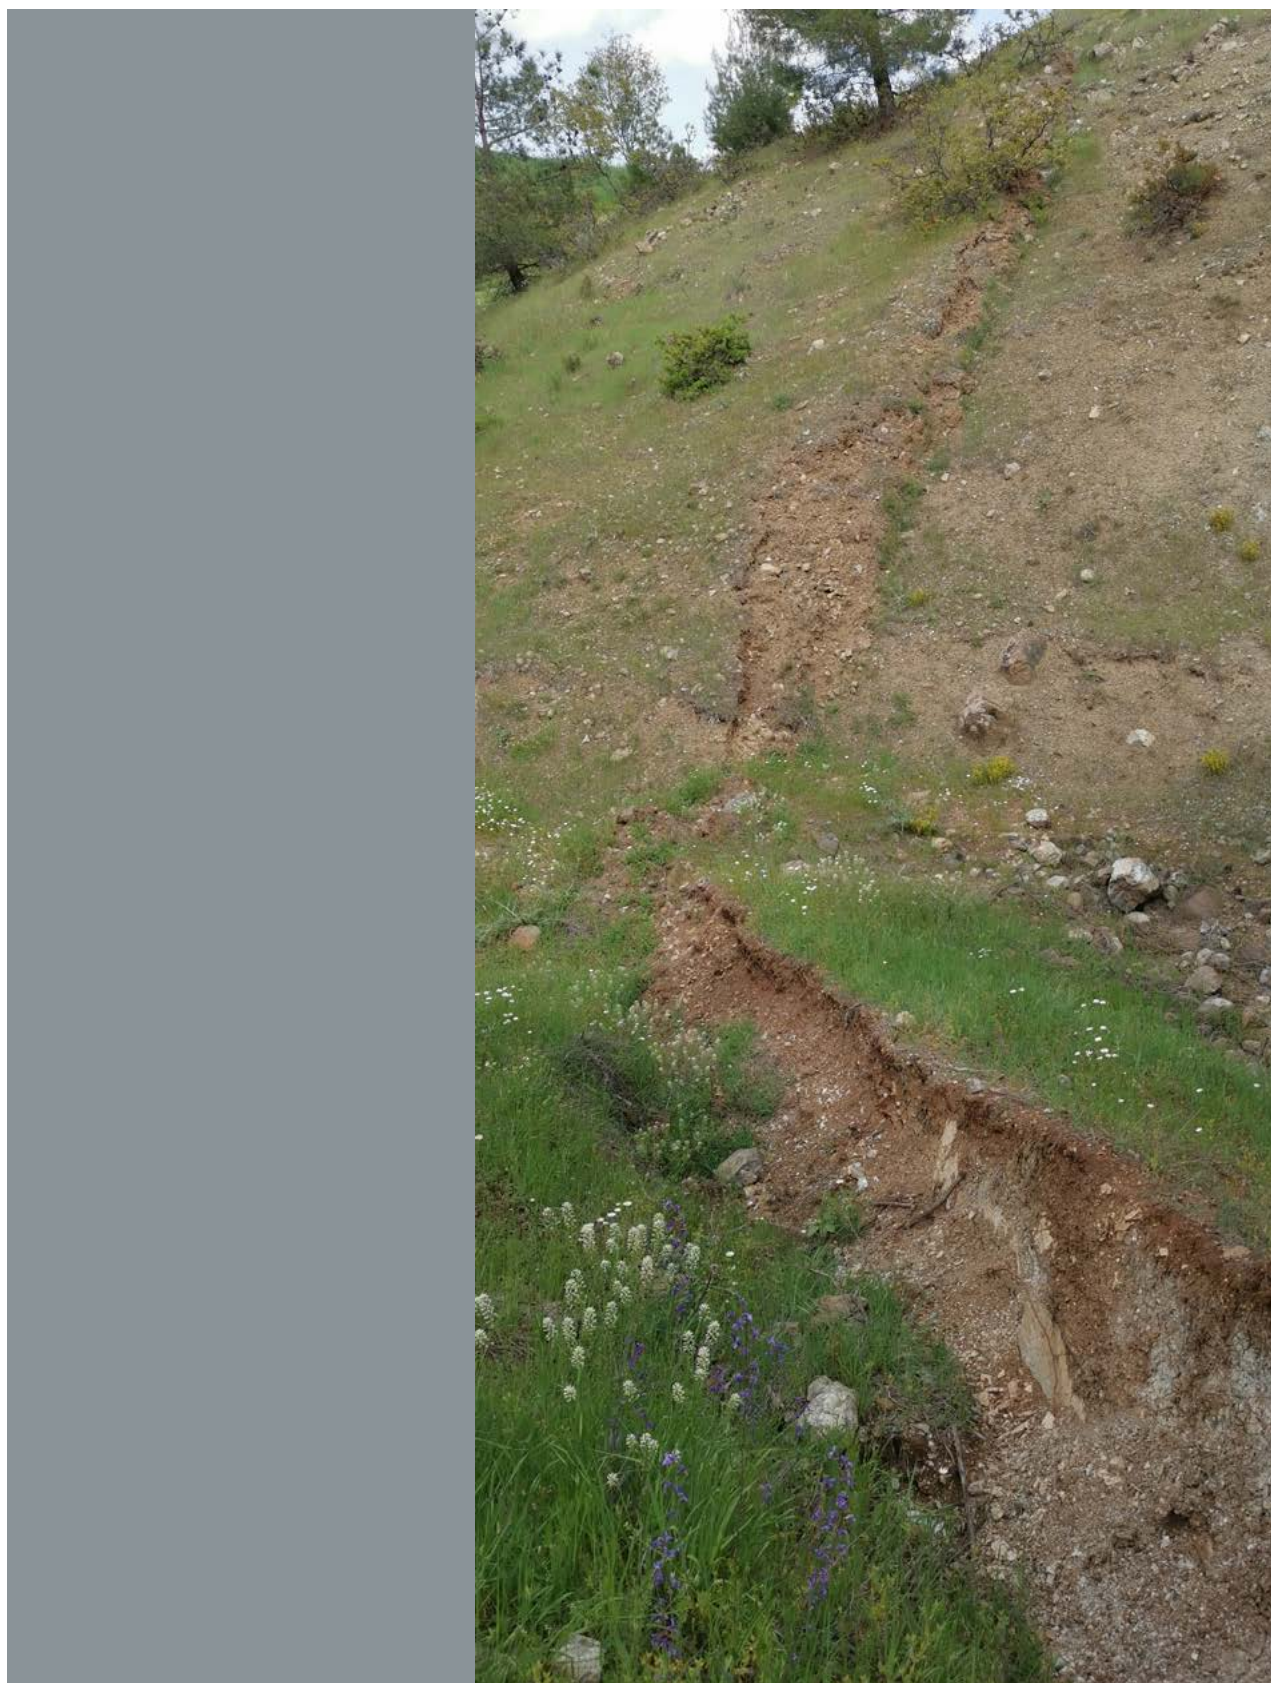
**Photo 50** (37.513710°N, 37.148678°E) – Detail of the previous photo (view from west).  
Note the flip of the coseismic free face due to the left-lateral slip component along differently oriented valley flanks.

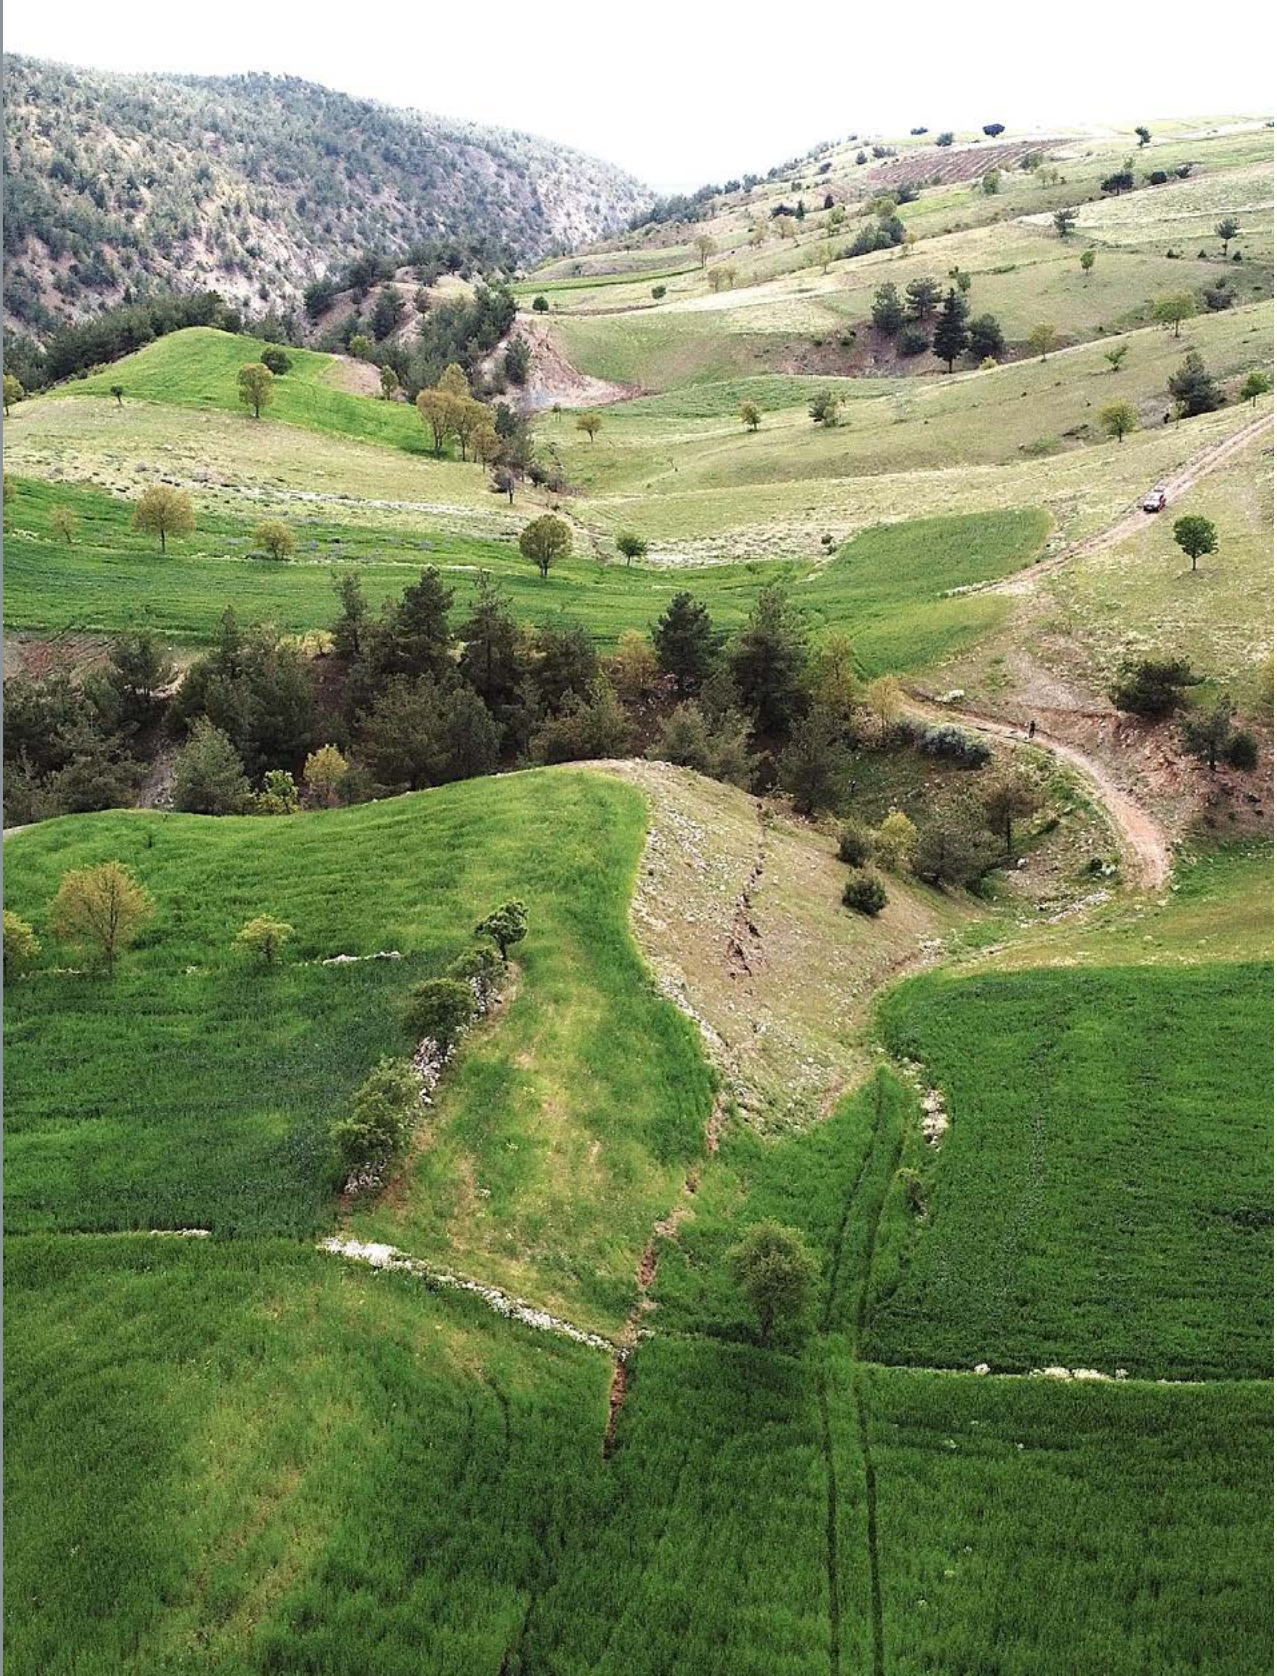
**Photo 55** (37.513502°N, 37.149821°E) – Panoramic view (from east) of the left-stepping pressure ridges flanked by the coseismic ruptures. Note that the coseismic offset of more than 300 cm of the whitish stone wall.

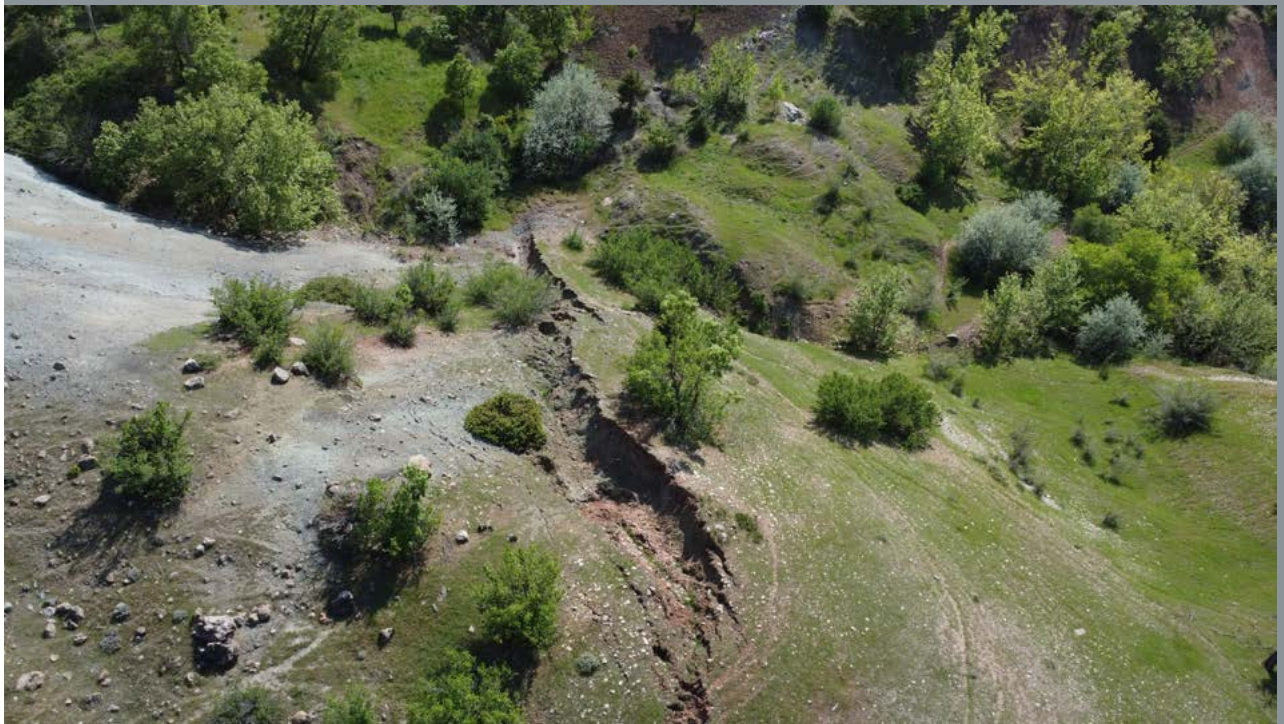
**Photo 56** (37.616031°N, 37.383909°E) – Drone view (from northeast) of the surface rupture characterized by decameter-scale pull-apart basins due to right-stepping Riedels.

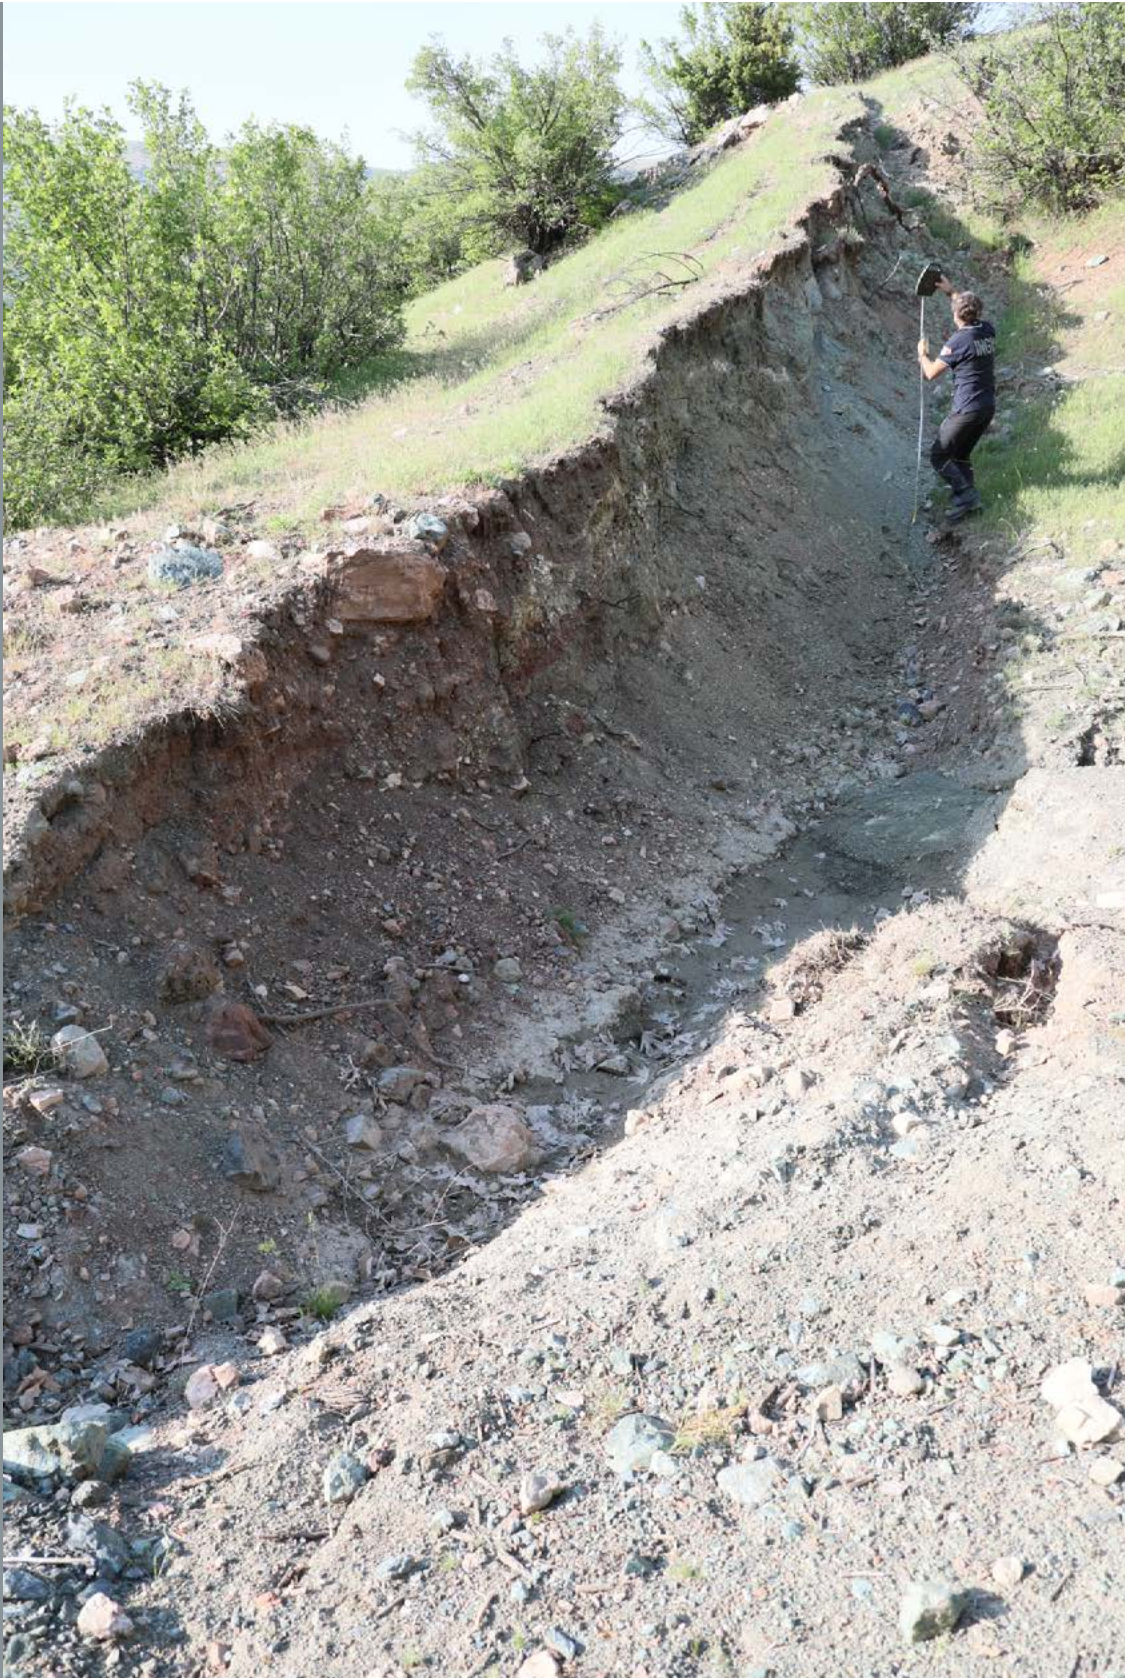
**Photo 57** (37.615527°N, 37.383265°E) – The apparent vertical offset component of up to 210 cm is given by the lateral dislocation of the oblique slope.

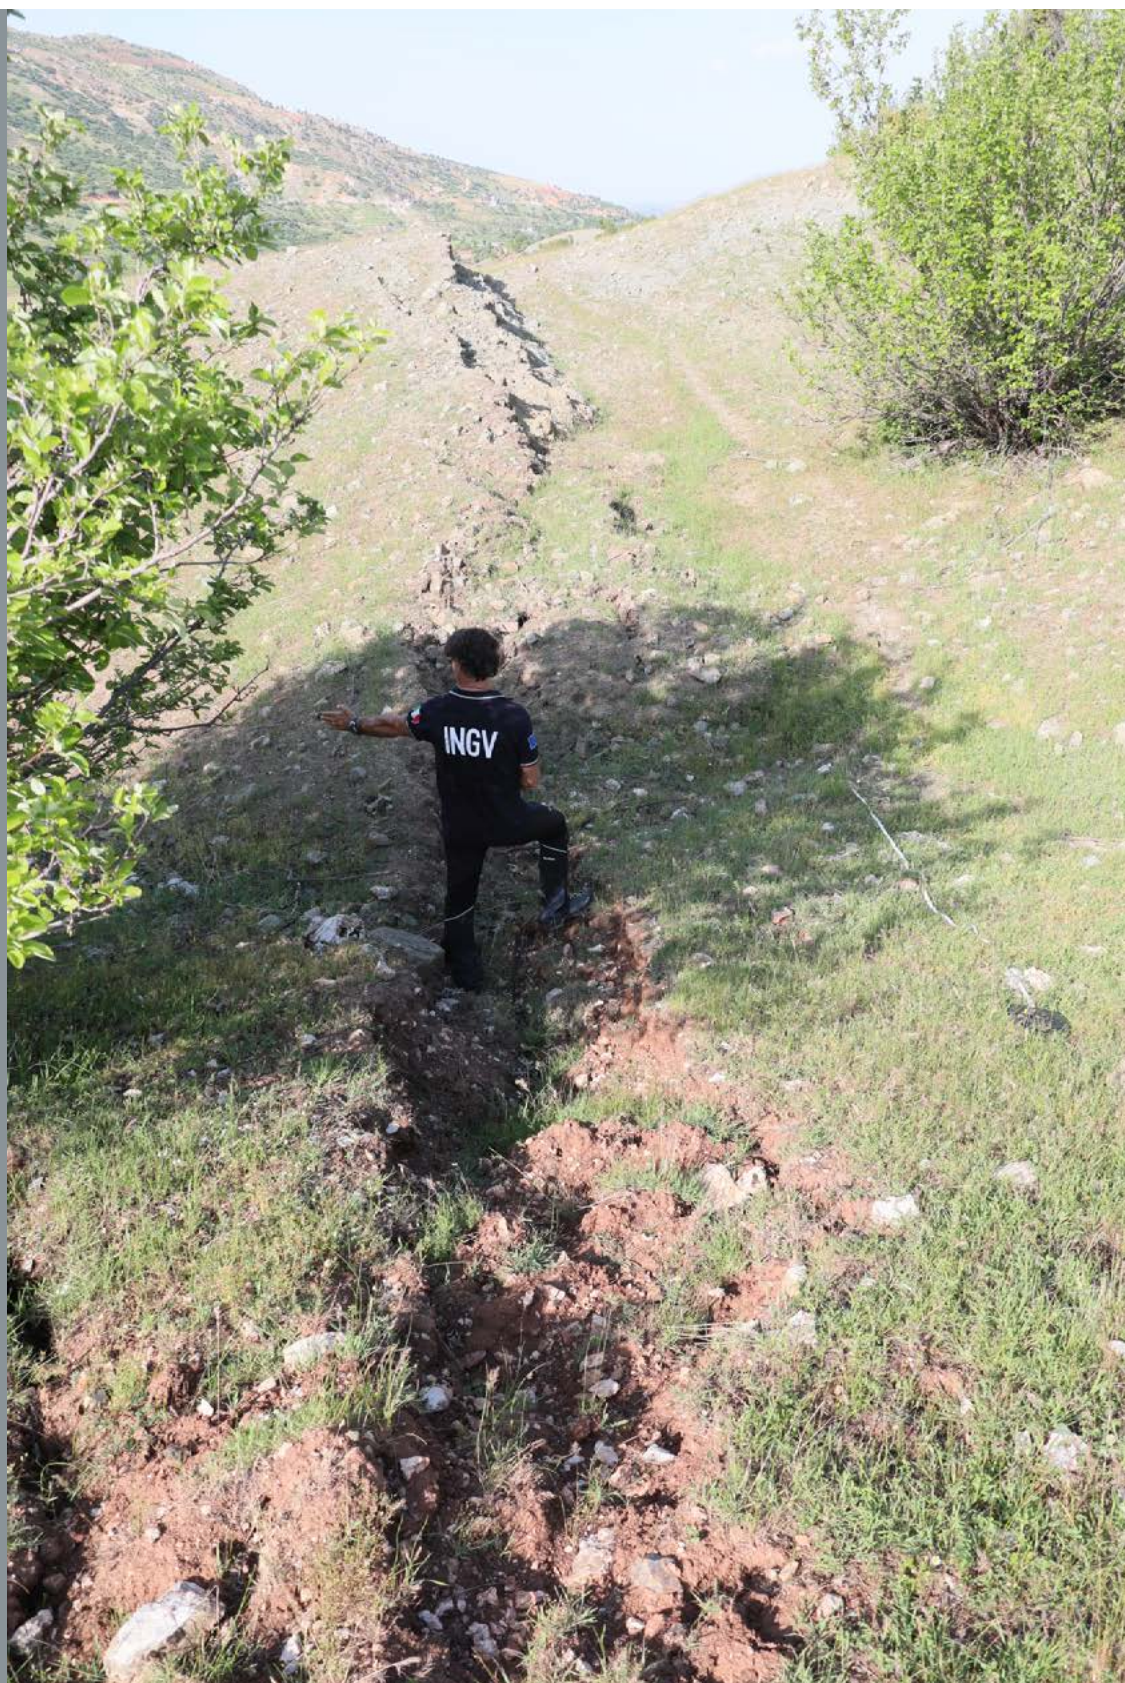
**Photo 61** (37.615917°N, 37.383838°E) – Detail of the mole-track. Alternating decametric transpressional (counterslope dip slip at the back) and transtensional structures (front).

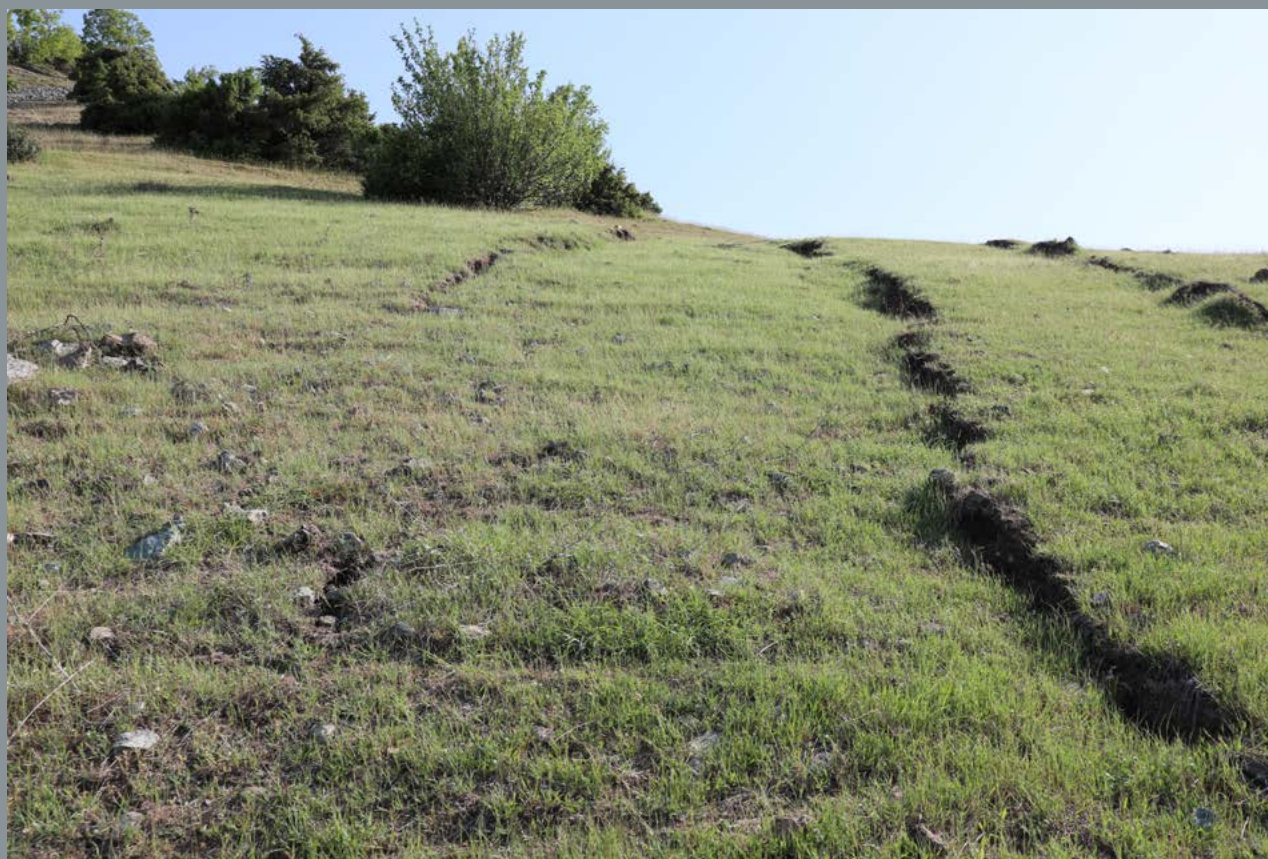
**Photo 63** (37.616457°N, 37.384436°E) – Particular of the parallel strands (view from northeast) shown in the previous photo. Please note the small-scale arrangement of right-stepping Riedels and left-stepping compressional turf rolls.

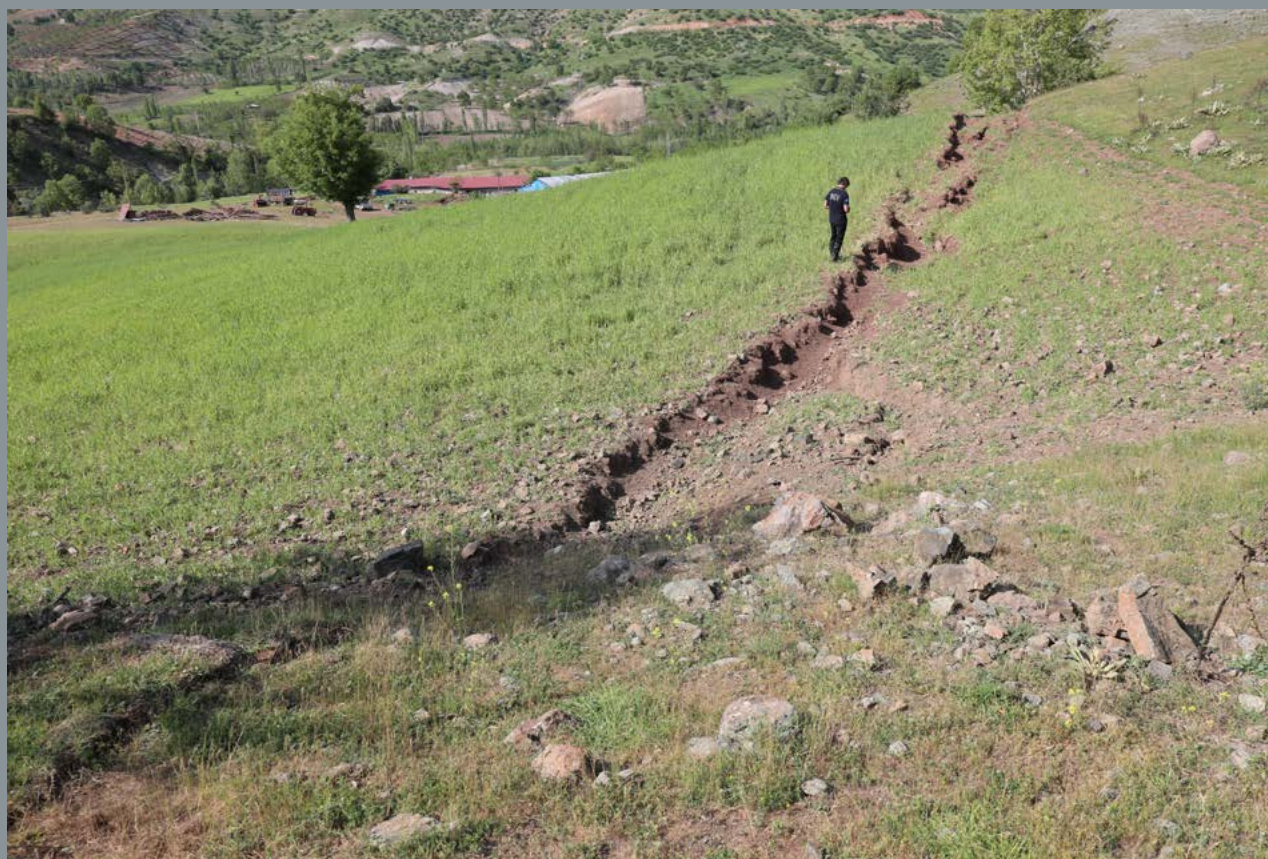
**Photo 69** (37.617865°N, 37.386536°E) – Locally, the coseismic rupture (view from southwest) is characterised by a simple and narrow clear-cut paralleling the average trend of the displacement zone (Y-shear).

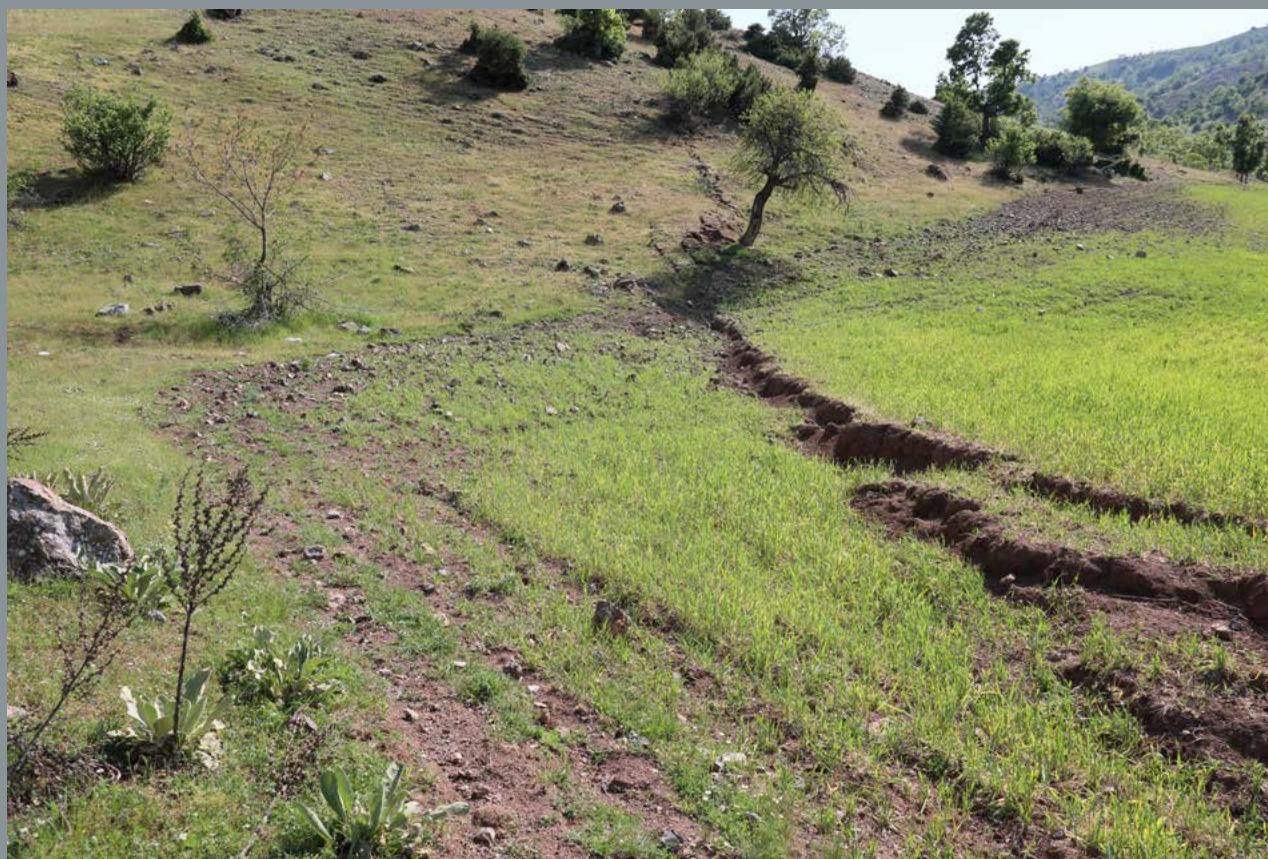
**Photo 71** (37.618105°N, 37.386790°E) – Particular of the individual right-stepping en-echelon elements (lower right corner) and view (from southwest) of a right bend of the rupture trace.

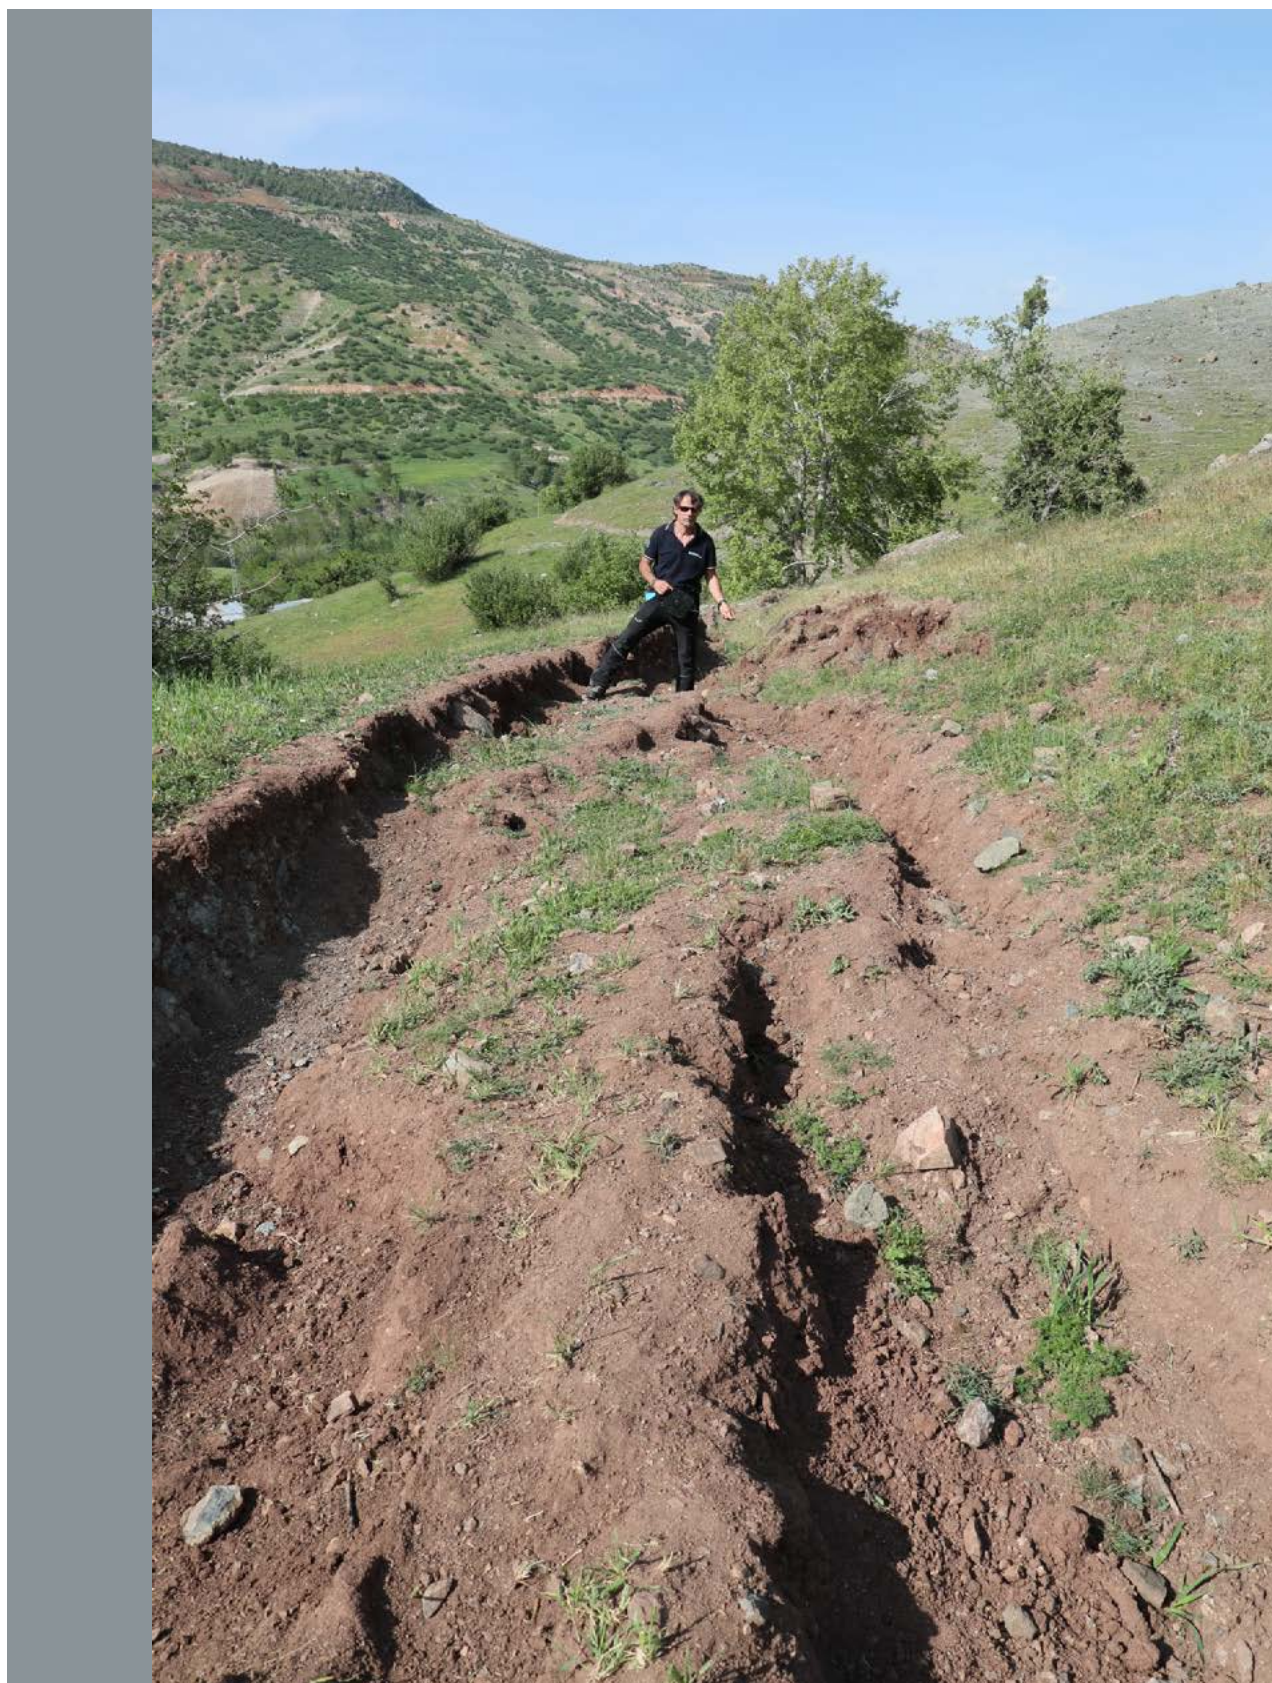
**Photo 72** (37.618116°N, 37.386815°E) – Detail of a large gravity-graben (due to loose deposits collapse at the opening transtensional Riedels): ~17 m long, up to 2.3 m wide, with a mean apparent vertical offset of 40 cm.

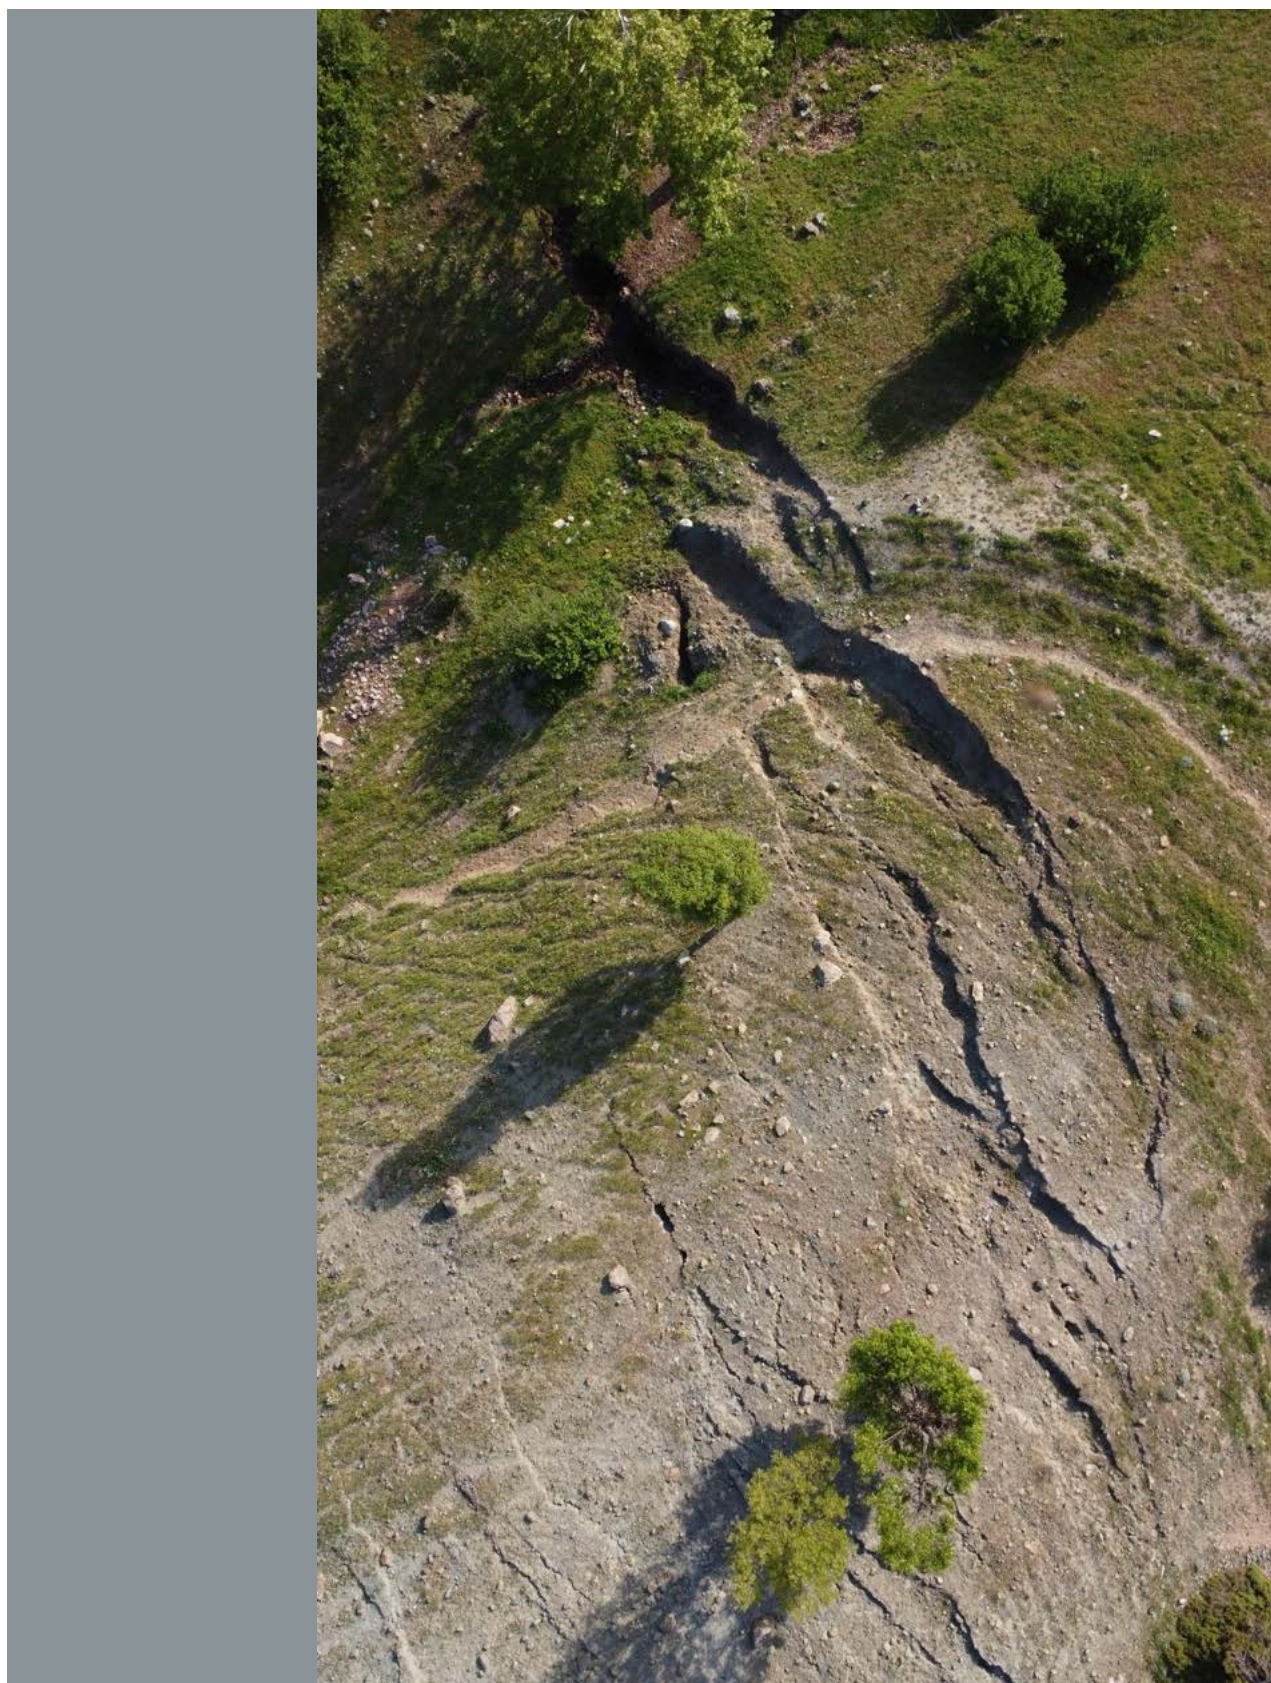
**Photo 74** (37.618716°N, 37.387383°E) – Detail of the previous photo: the tree in the left upper corner is shown in the next photo.

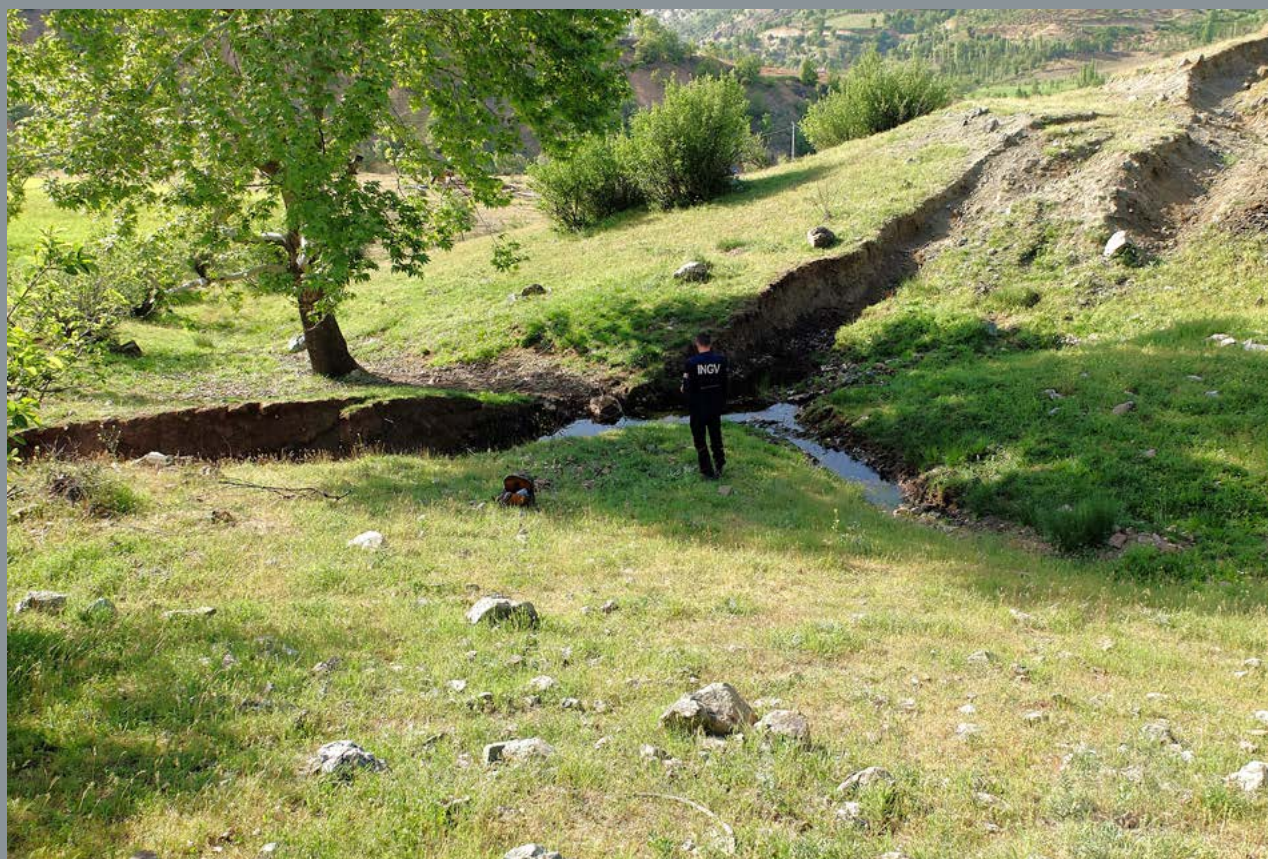
**Photo 75** (37.618392°N, 37.387276°E) – View (from south) of the site shown in photos 73 and 74. The coseismic rupture offset and dammed the stream thalweg, where the 120 cm apparent vertical offset produced a pond.

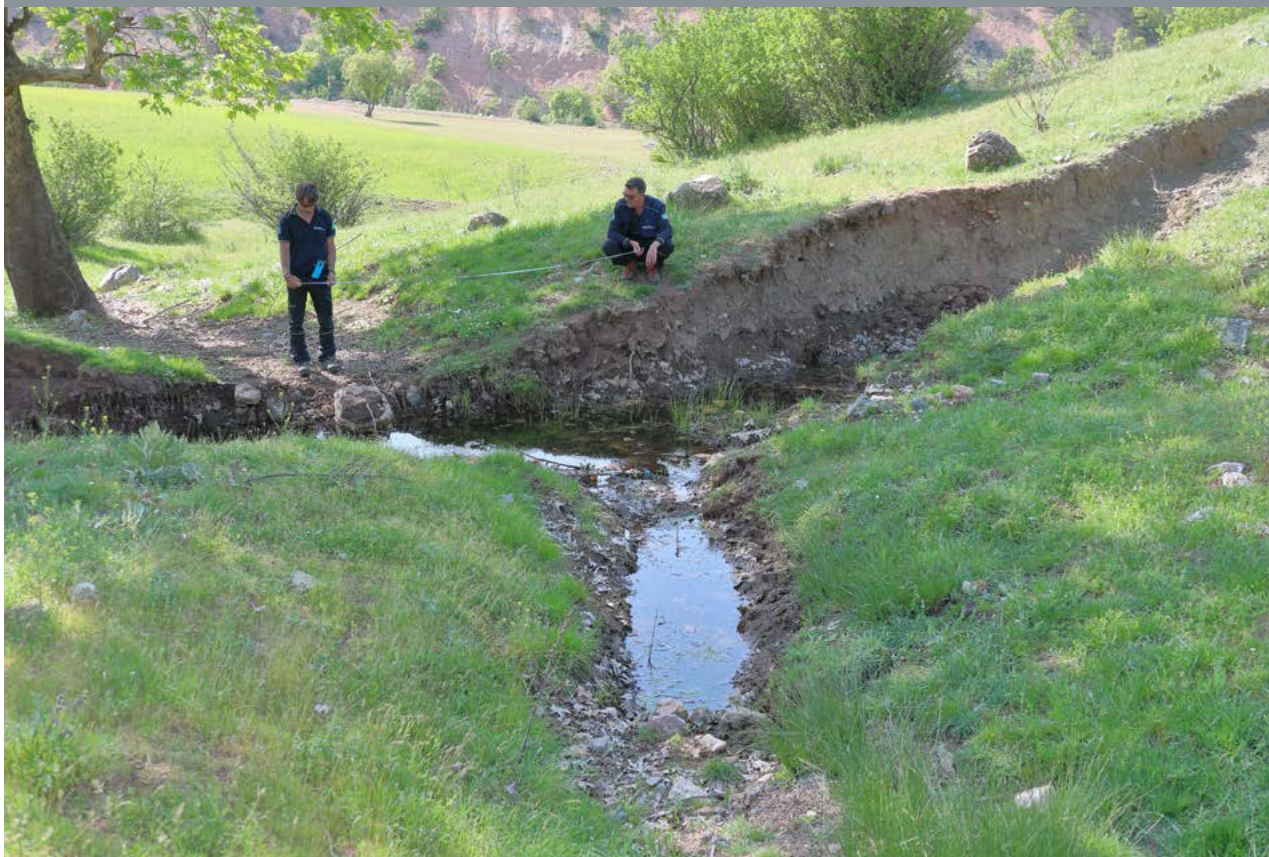
**Photo 76** (37.618451°N, 37.387307°E) – Close-up of the previous photo. The thalweg cut-off was used as a piercing point to measure a net left-lateral offset of 300 cm, with a true vertical component of 50 cm.

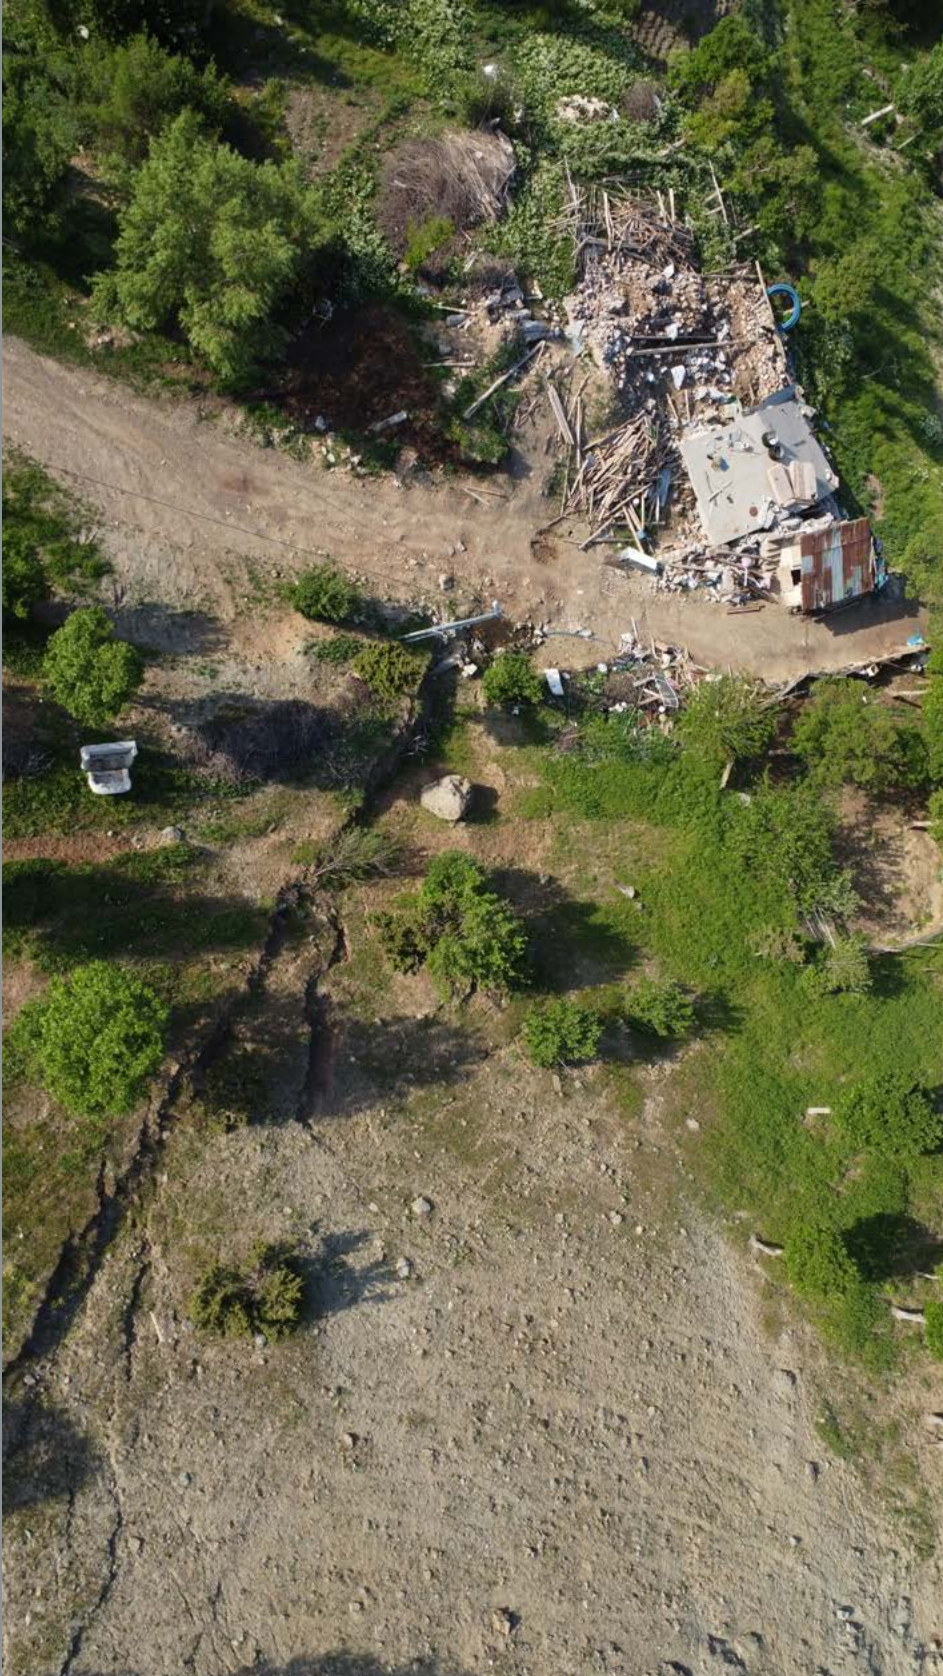
**Photo 77** (37.619174°N, 37.387709°E) – Azimuthal view of the coseismic rupture crossing a farm and causing its complete collapse.

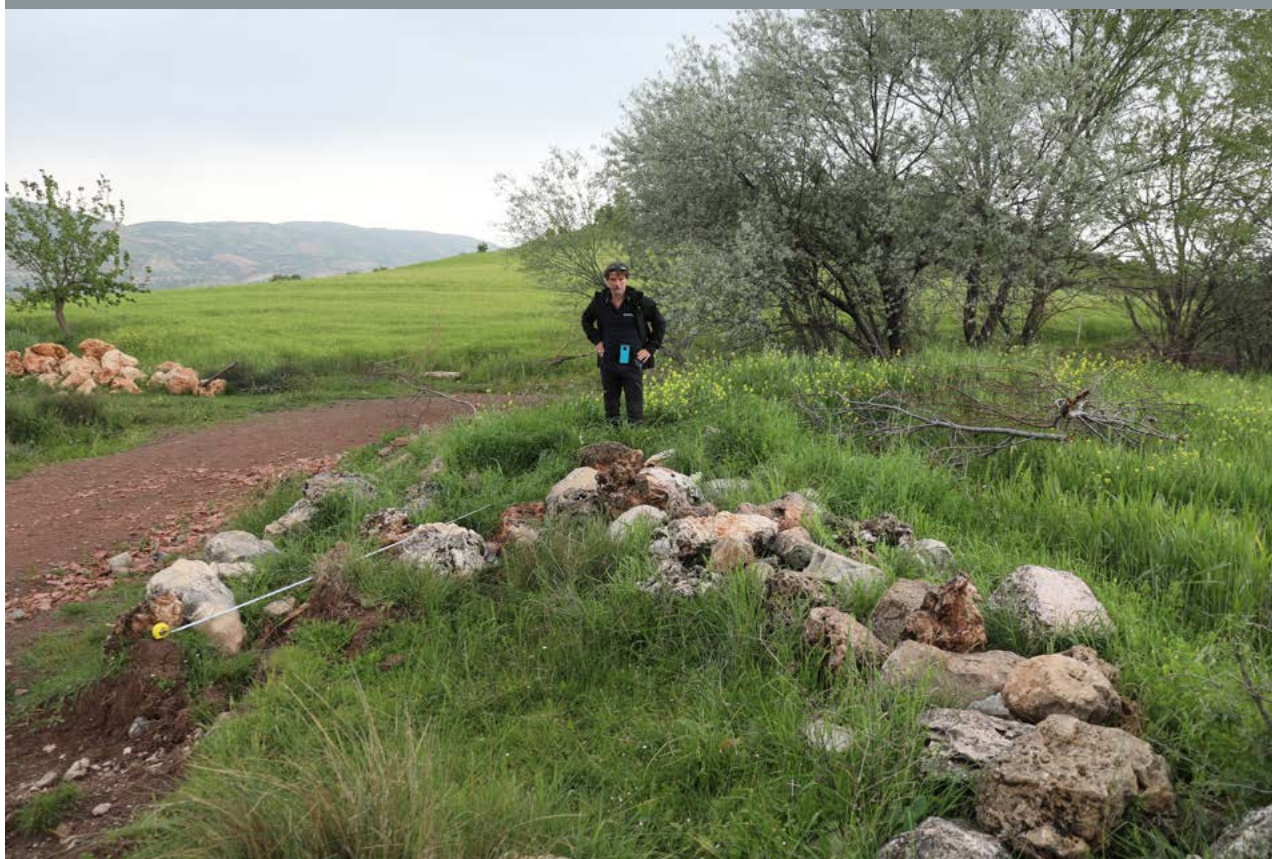
**Photo 85** (37.726239°N, 37.549748°E) – Drystone wall displaced by the coseismic surface rupture (view from south). The left-lateral net slip is 390 cm; note that the offset is accommodated smoothly, with a bend, since the incoherent nature of the man-made feature.
