# MISCELLANEA INGV

A photo and video collection on the  
surface faulting: the Mw 7.8  
Kahramanmaraş (Turkey) earthquake  
of February 6, 2023

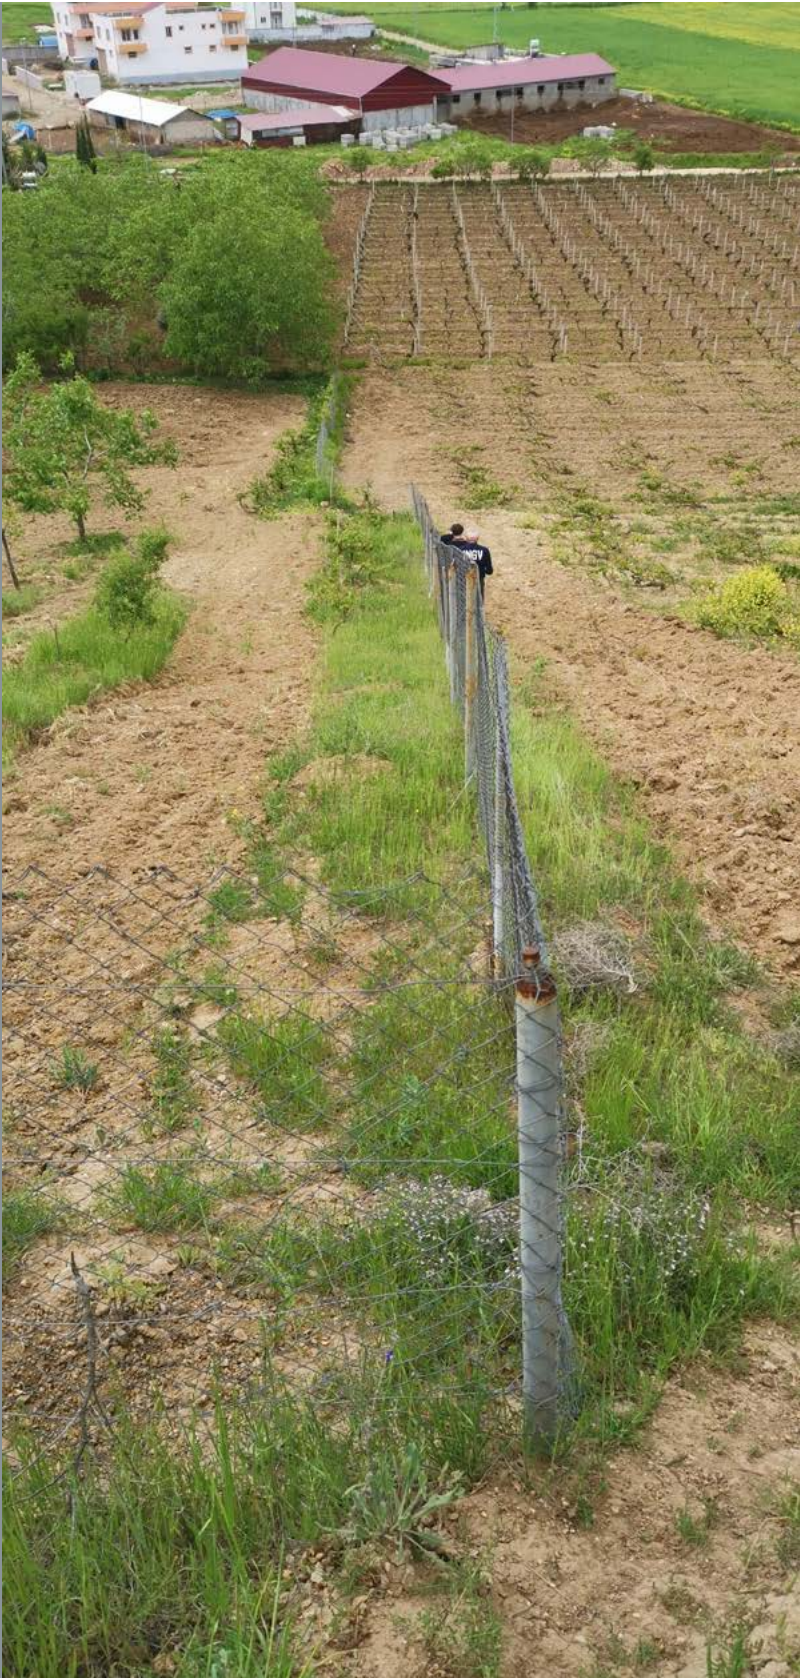
**Photo 86** (37.728819°N, 37.554887°E) – Fence dislocated by the left-lateral strike-slip fault (view from northwest).

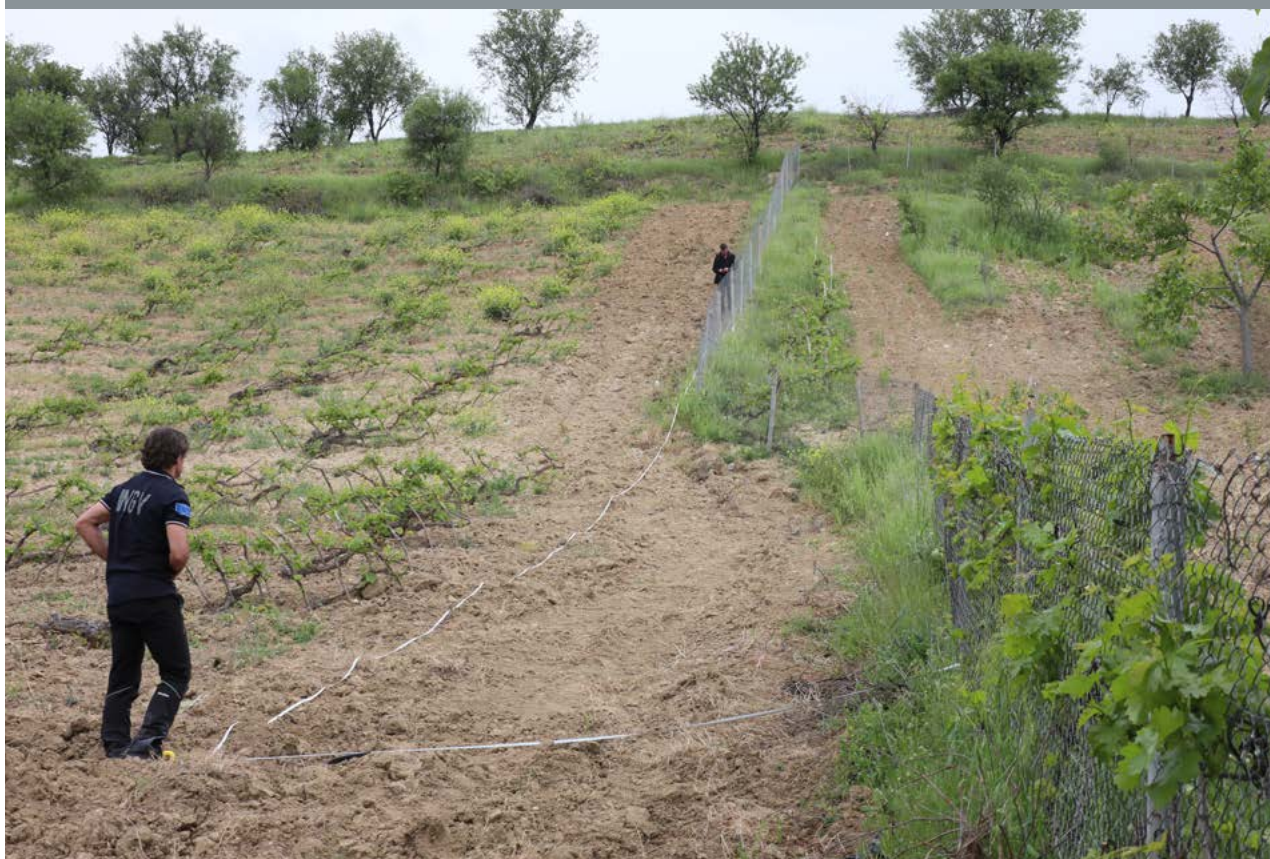
**Photo 87** (37.728526°N, 37.555025°E) – Same fence of the previous photo (view from southeast). Here, the coseismic net left-lateral horizontal slip at the surface is 360 cm, calculated by projecting the fence trend and taking into account the real general strike of the rupture (not orthogonal to the fence).

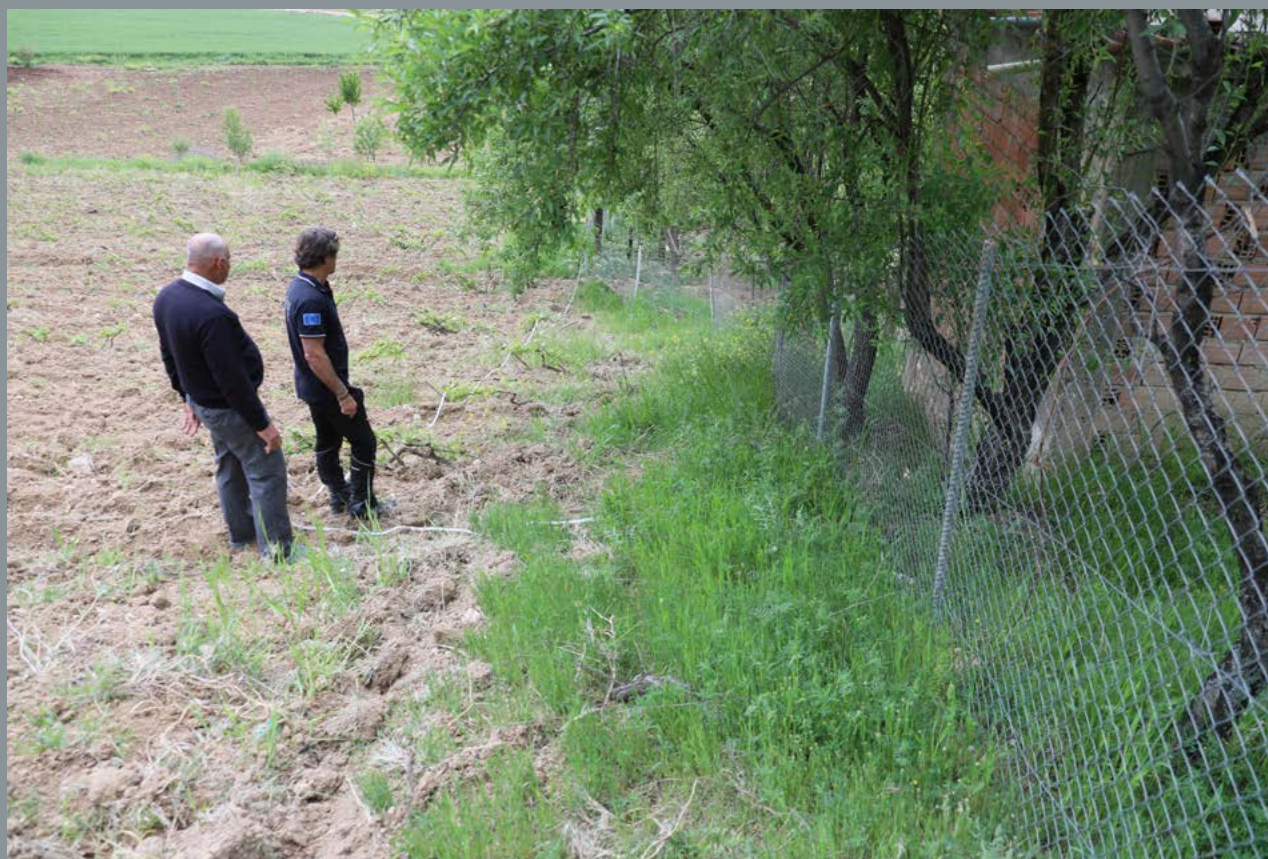
**Photo 88** (37.729071°N, 37.555299°E) – Another parallel fence dislocated by the coseismic surface fault rupture (view from northwest). The left-lateral horizontal slip is 340 cm.

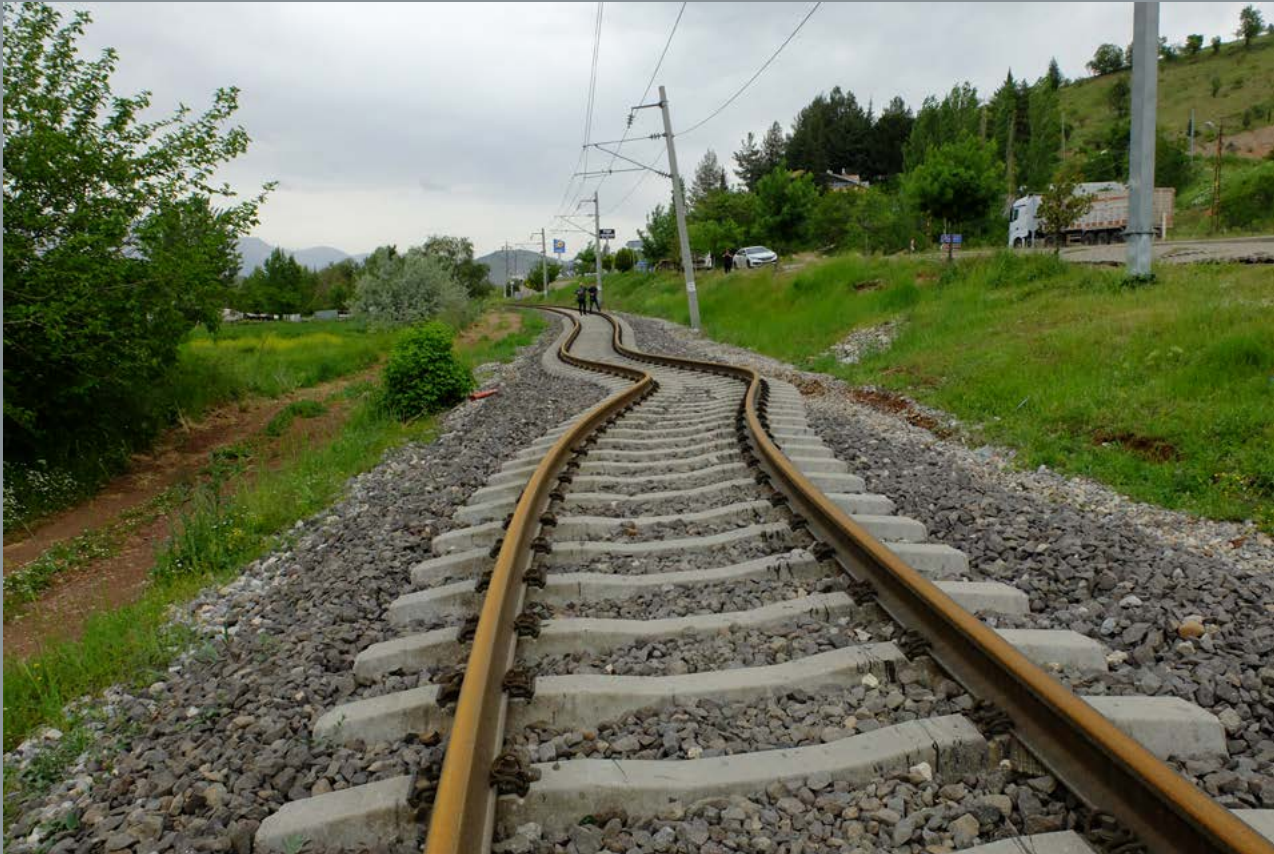
**Photo 93** (37.795853°N, 37.659954°E) – Railway deformation (NE view). Unlike the direct rupture intersection, this bending lacks lateral embankment or road displacement. Here, the tracks align with the compressional component between two stepping rupture sections; deformation results from plastic shortening transmitted through the rigid steel (see Pucci et al., 2025 for details).

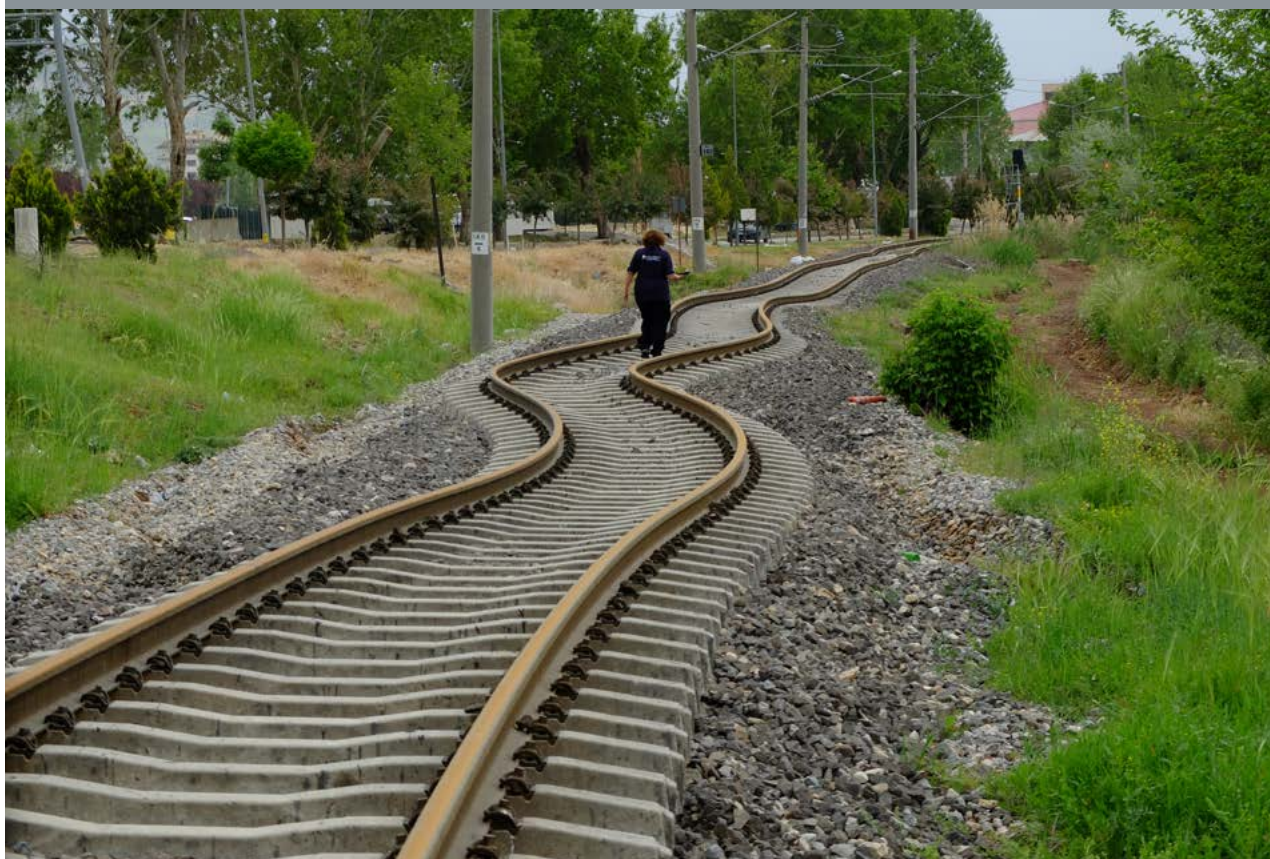
**Photo 94** (37.795885°N, 37.660012°E) – Railway deformation in Gölbaşı (view from southwest). In this case the bending was determined directly by the coseismic rupture crosscut (note the railway embankment dislocation).

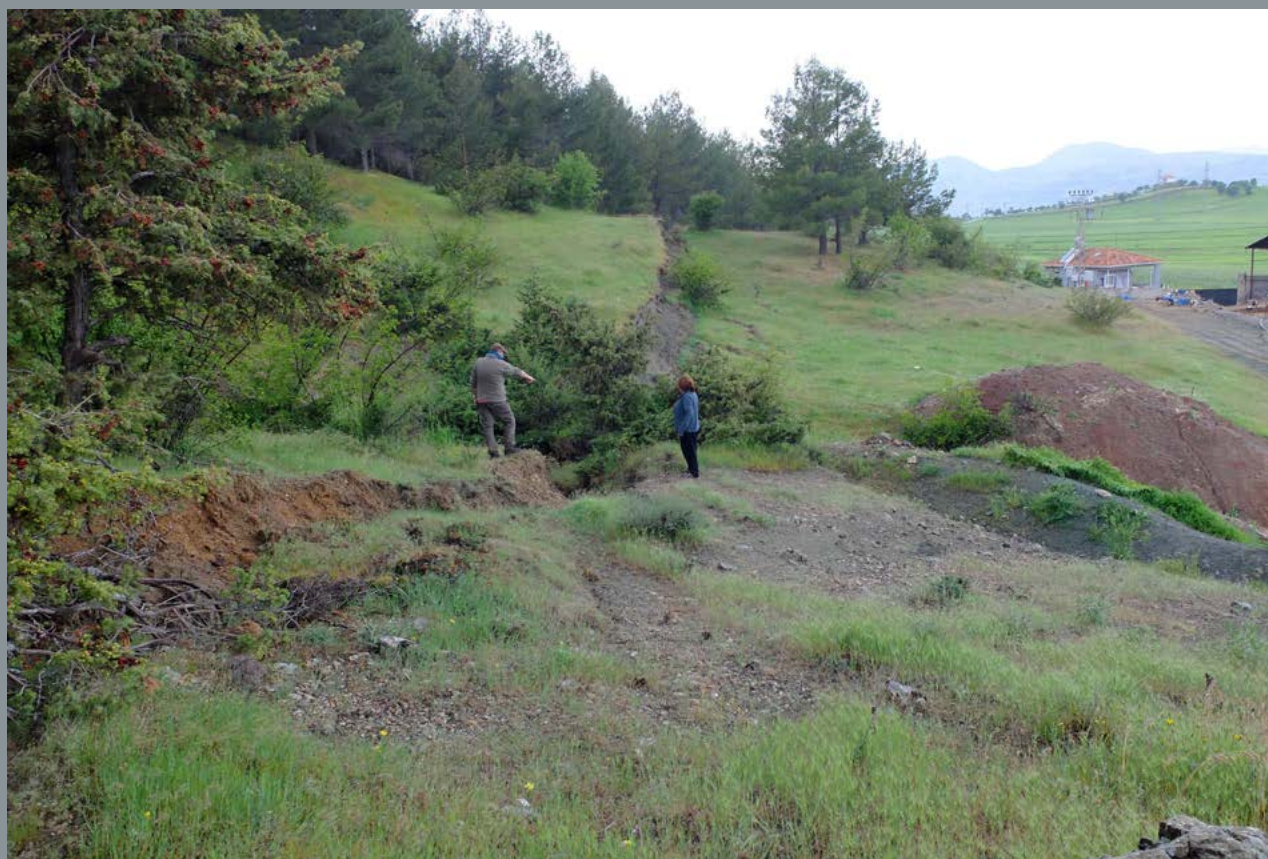
**Photo 95** (37.795370°N, 37.683104°E) – View (from east) of the coseismic rupture showing ~200 cm of left-lateral offset and up to 100 cm of vertical component.

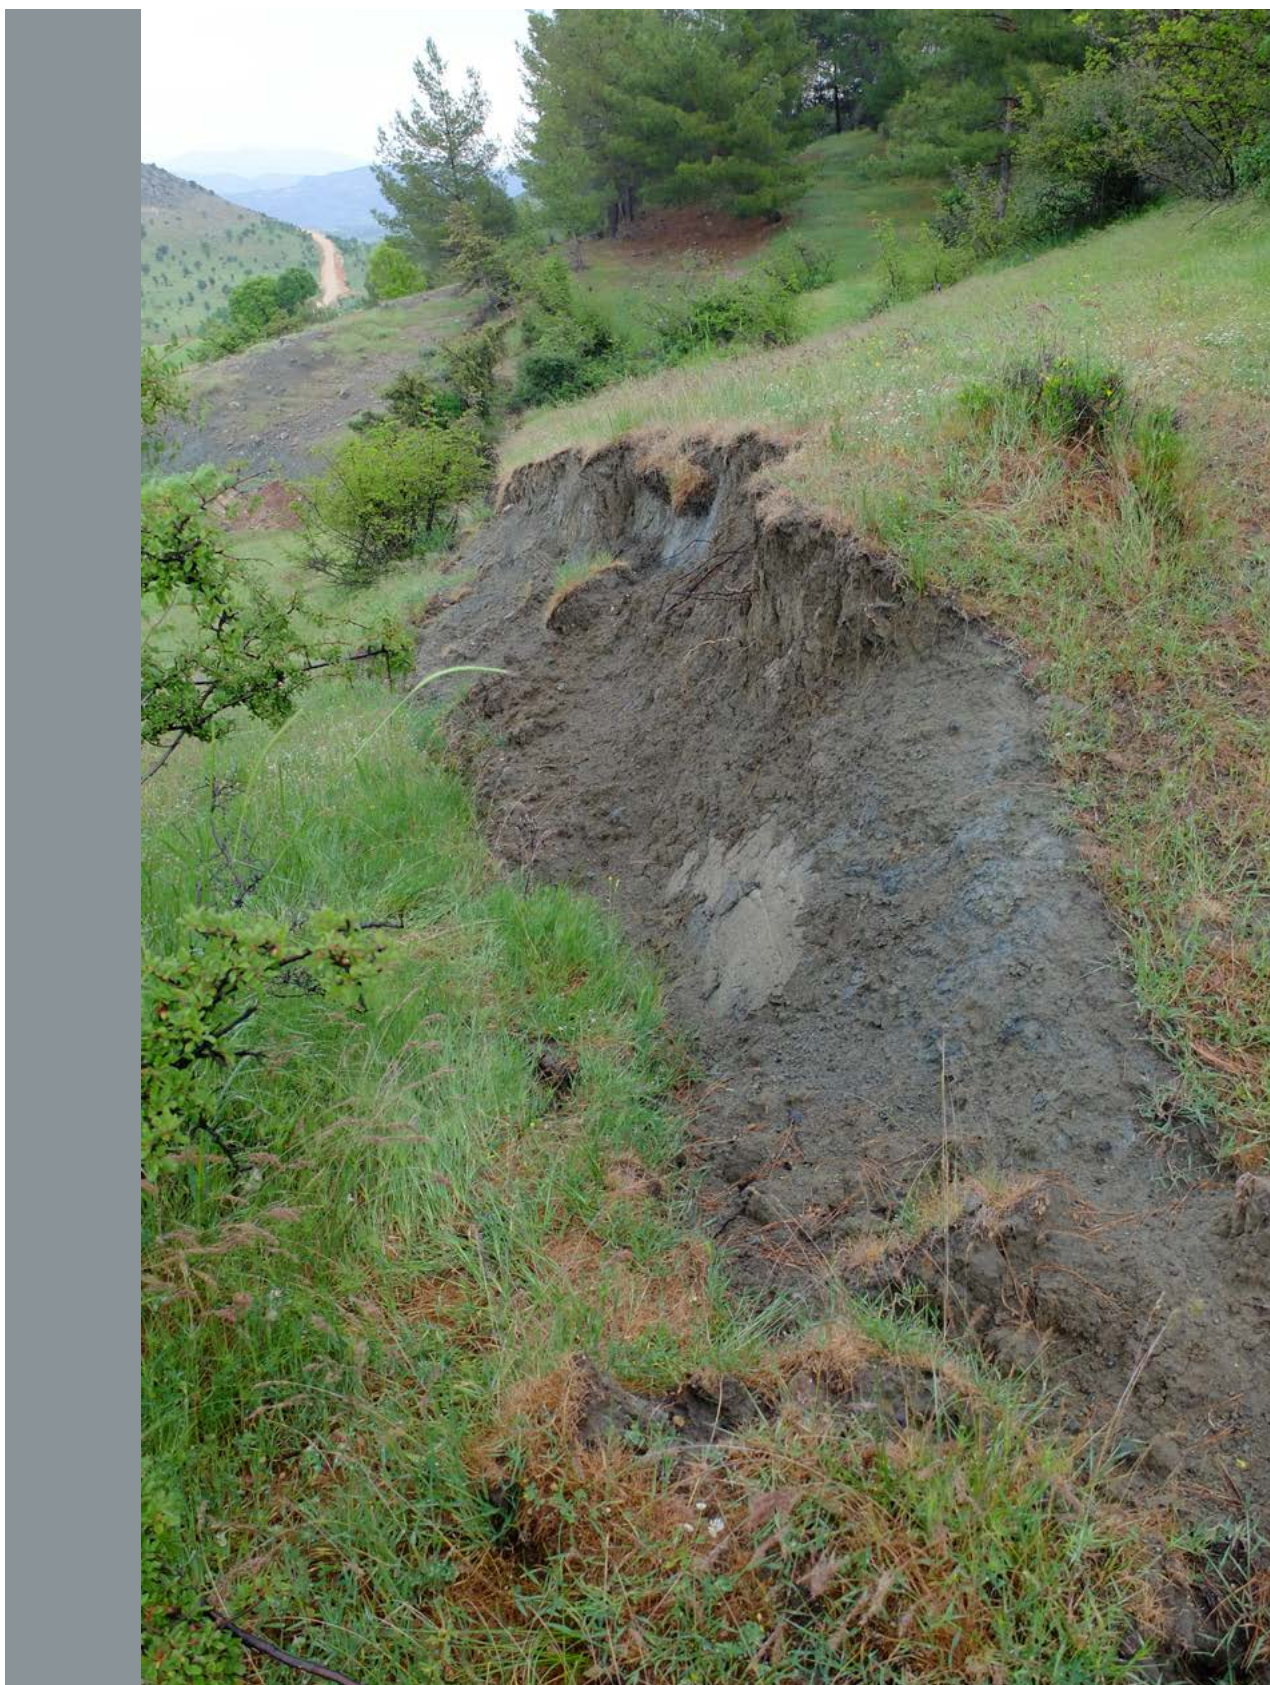
Photo 96 (37.795242°N, 37.682638°E) – Particular of the vertical dislocation component of the rupture shown in the previous photo (view from west).

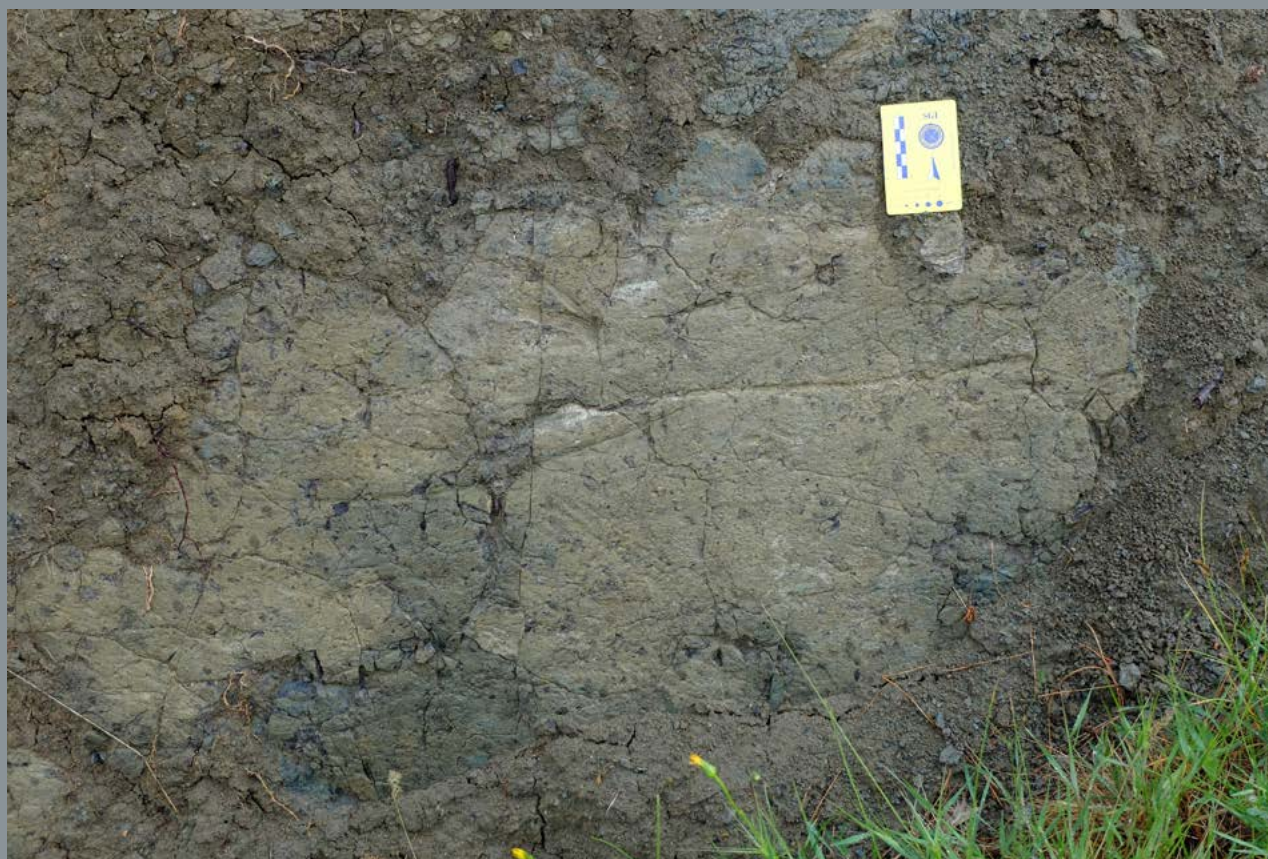
**Photo 97** (37.795257°N, 37.682698°E) – Detail of the previous photo.  
The clayey free face stores kinematics indicators (i.e. grooves).

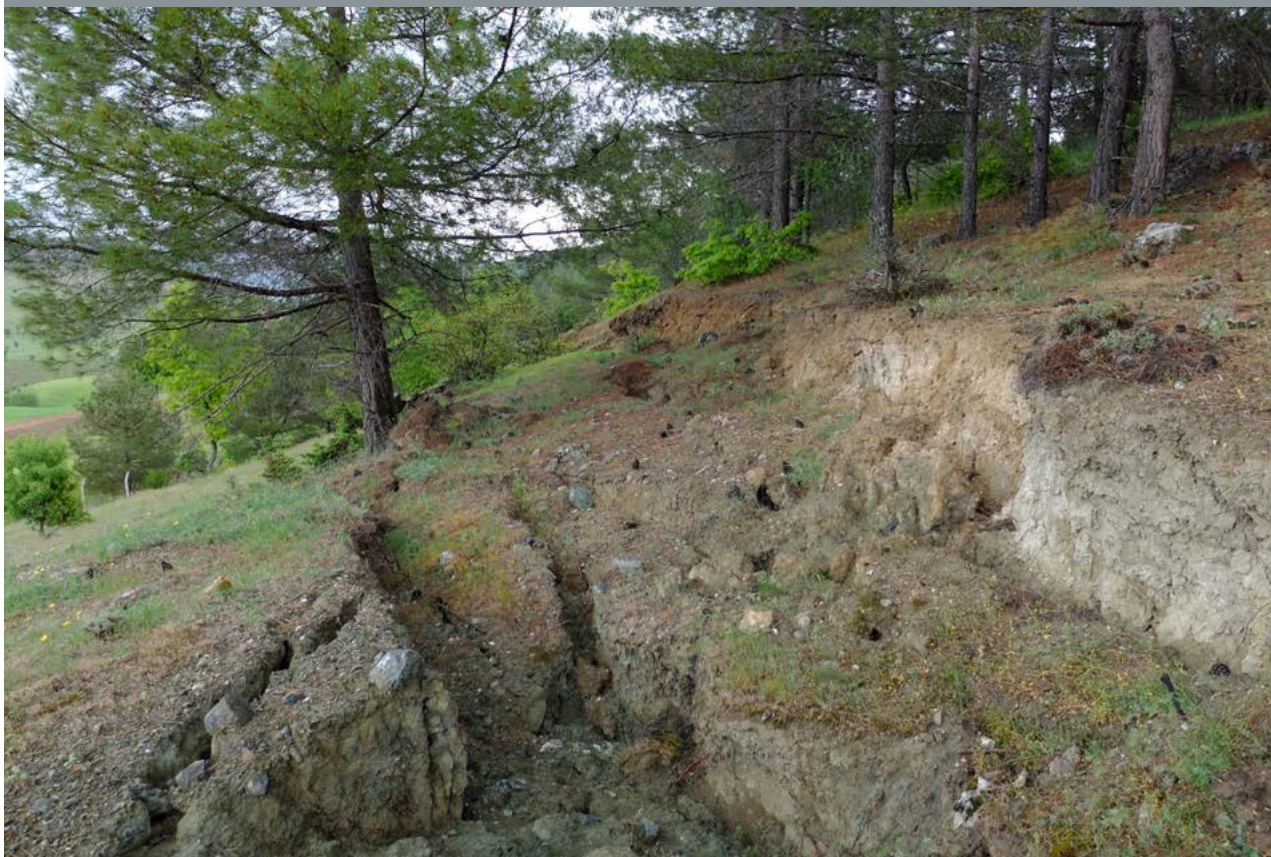
**Photo 98** (37.795373°N 37.683116°E) – Locally, the left bend of the rupture trend produced at the surface a significant extensional deformation, expressed by meter-wide grabens along the Riedel shears.

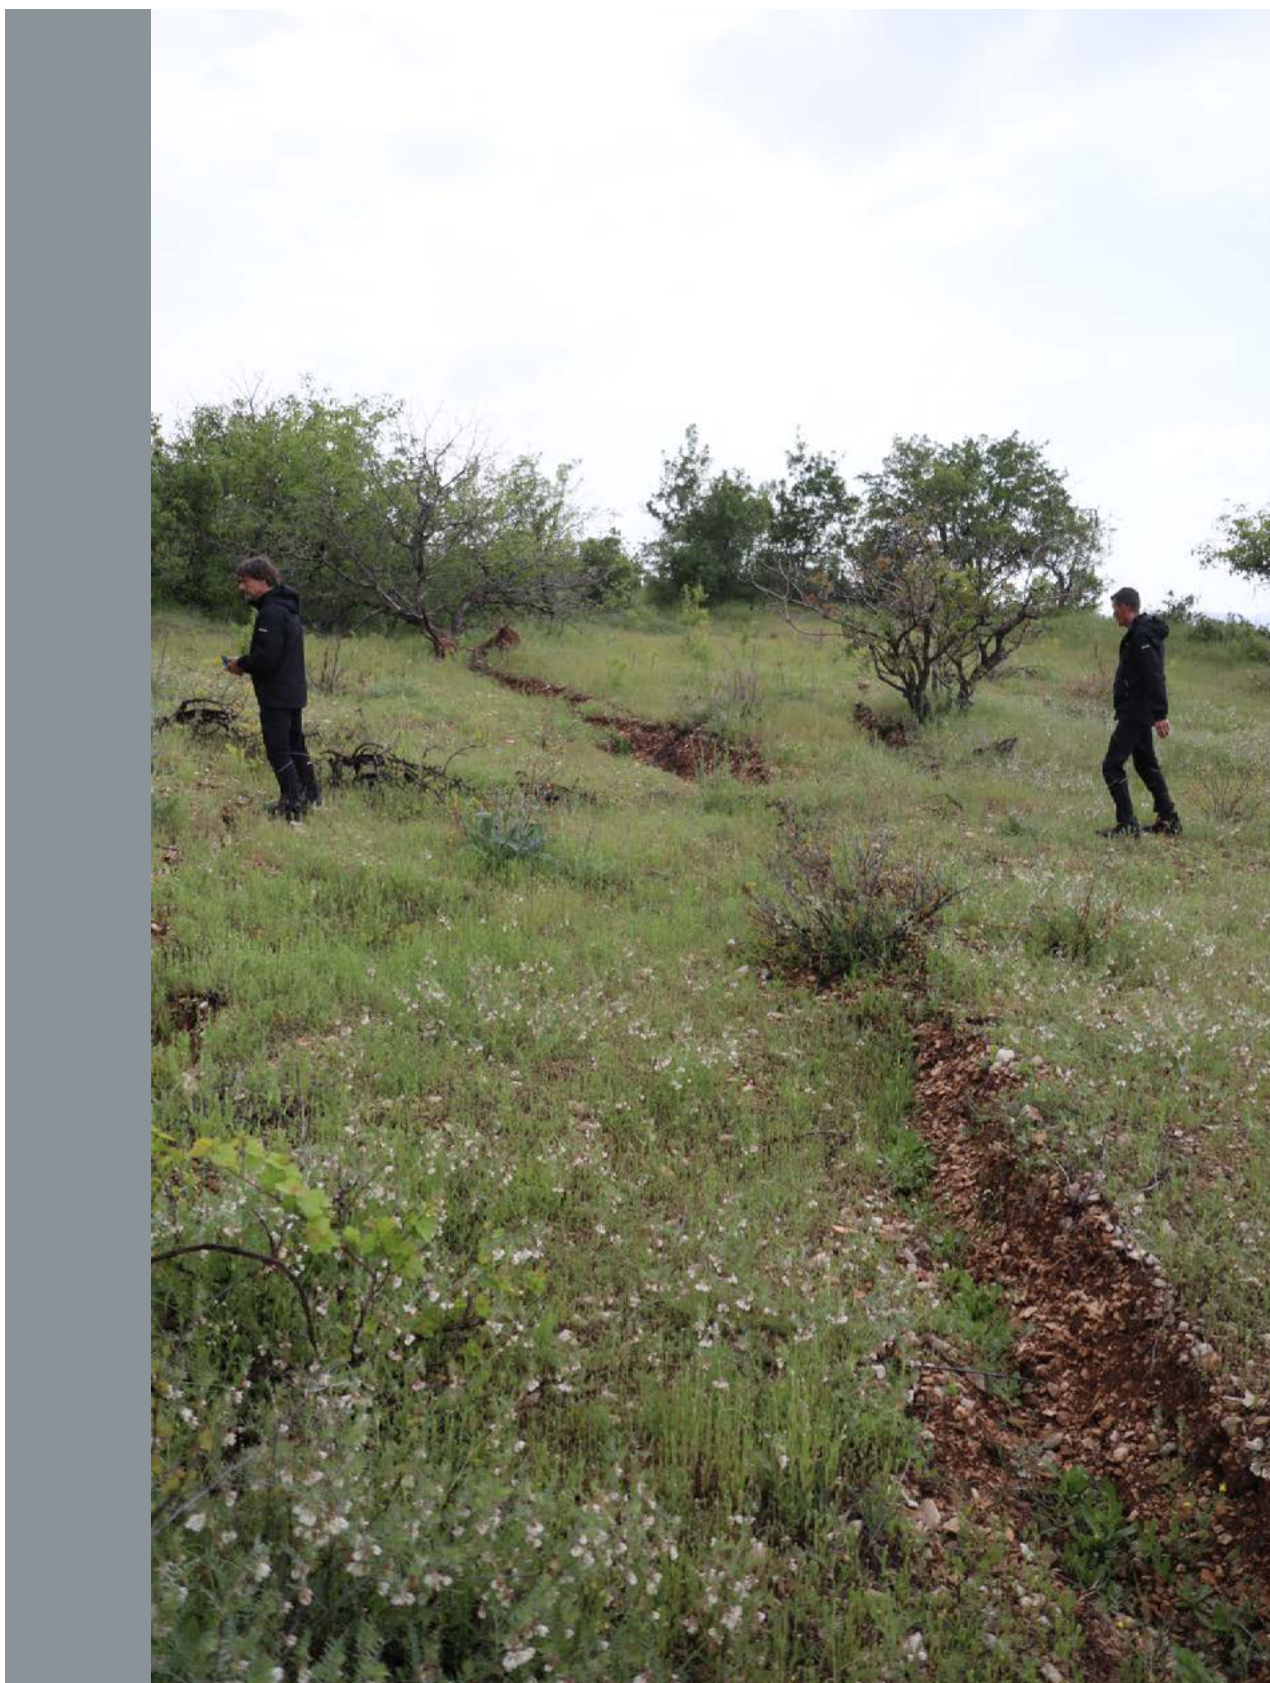
**Photo 99** (37.839273°N, 37.723895°E) – At this site, the coseismic rupture exhibits a relatively smaller displacement at the surface (~160 cm of left-lateral offset, with an average vertical component of 10-30 cm and a maximum opening of 40 cm).

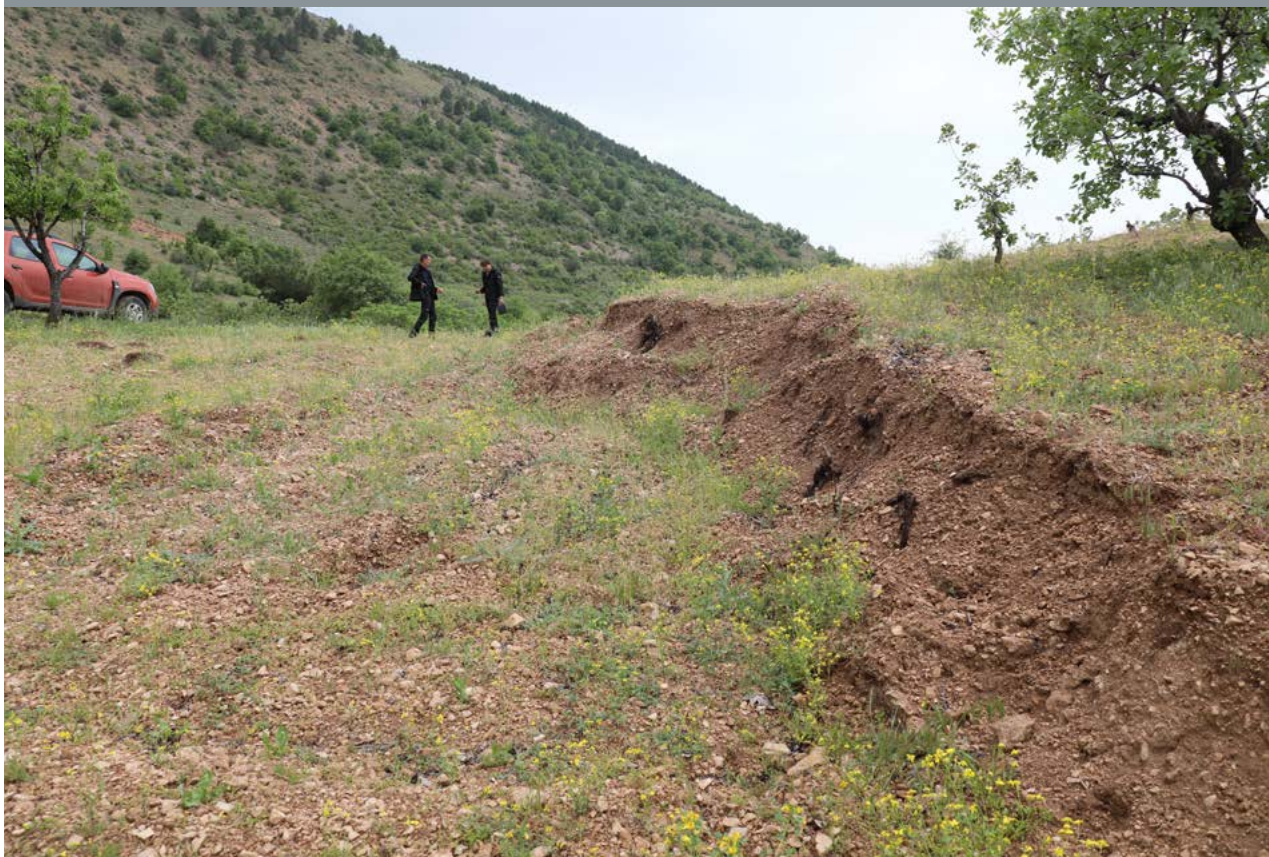
**Photo 101** (37.840082°N, 37.727873°E) – The coseismic free-face in colluvial deposits shows a significant vertical offset (here ~90 cm) and no opening component. The deposits of free face tend to collapse hindering the transpressional kinematics and producing a false dip direction of the rupture plane.

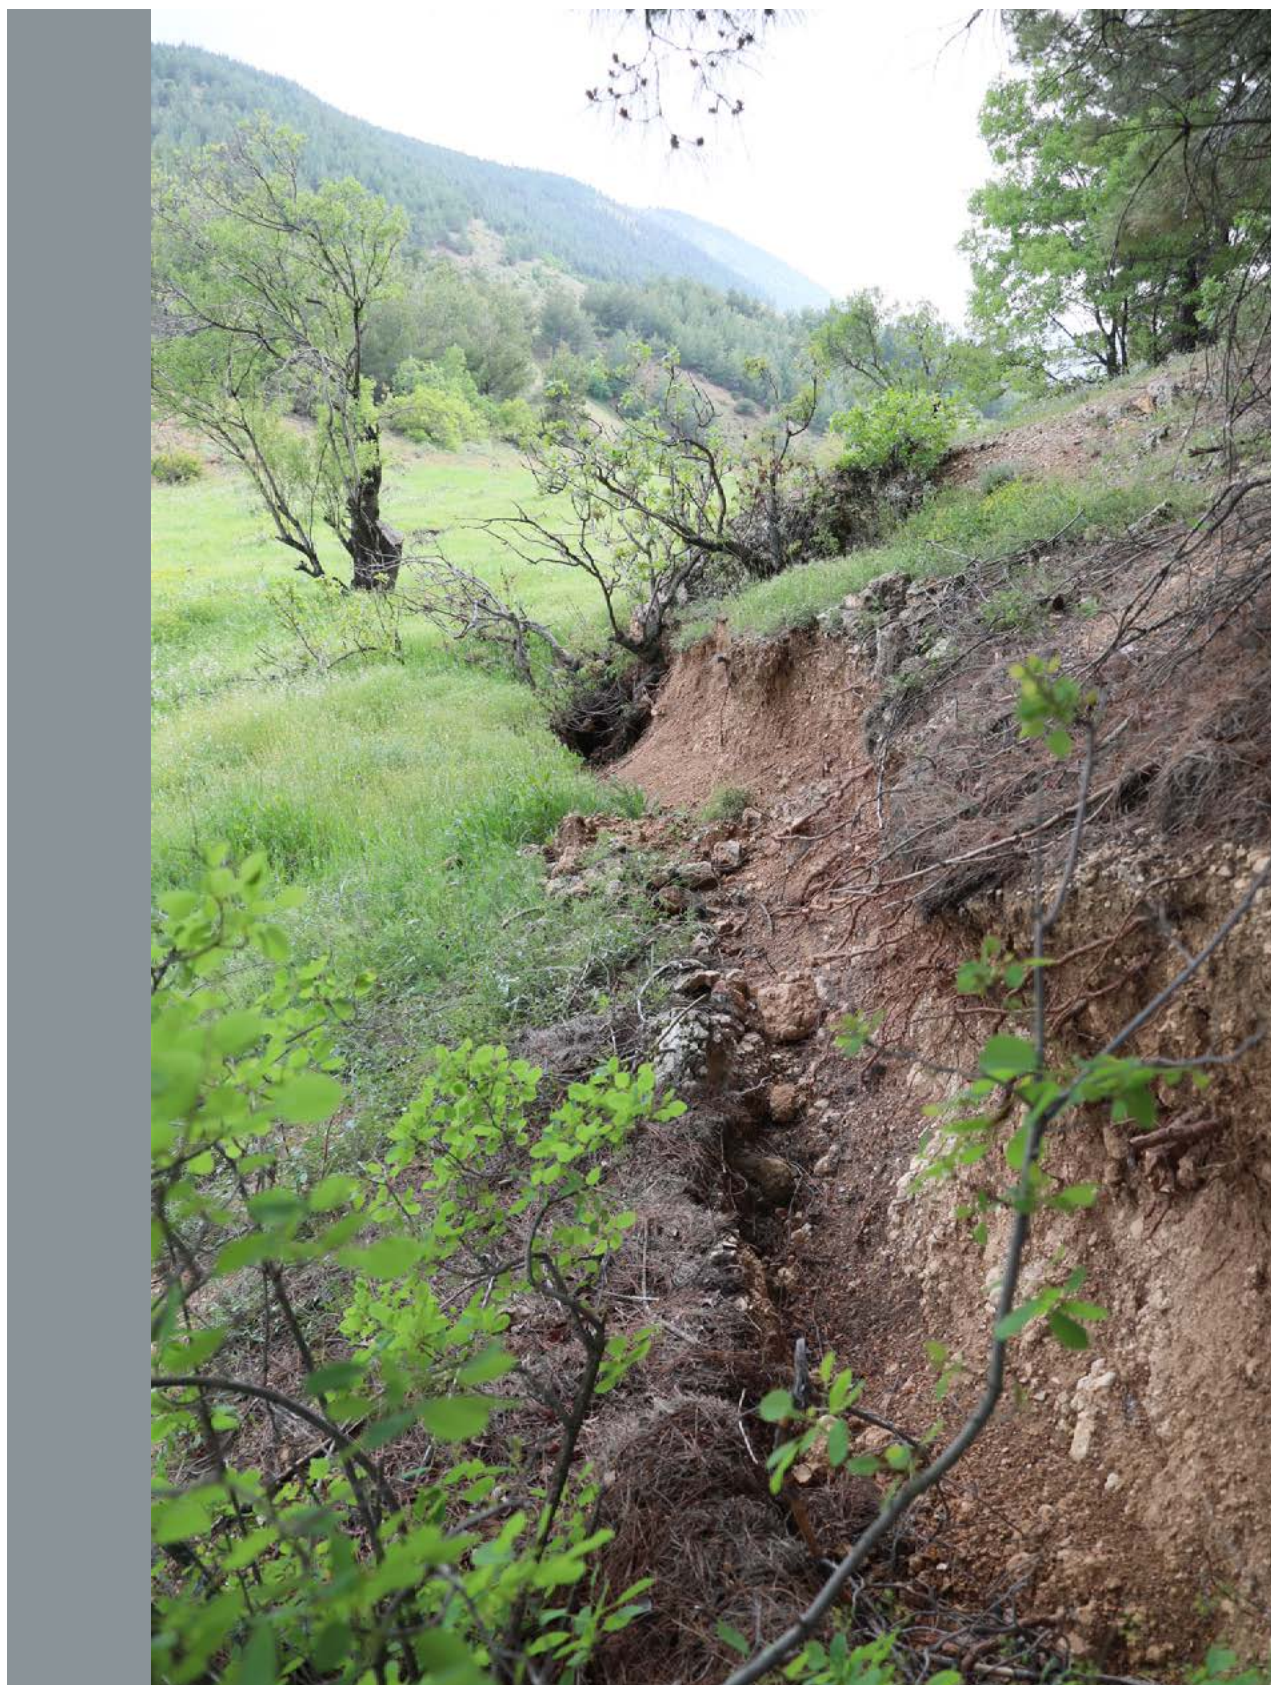
**Photo 103** (37.844836°N, 37.740426°E) – Detail (view from east) of the previous photo. The coseismic rupture at the surface shows a vertical offset of 160 cm, associated with a local transtensional kinematics.

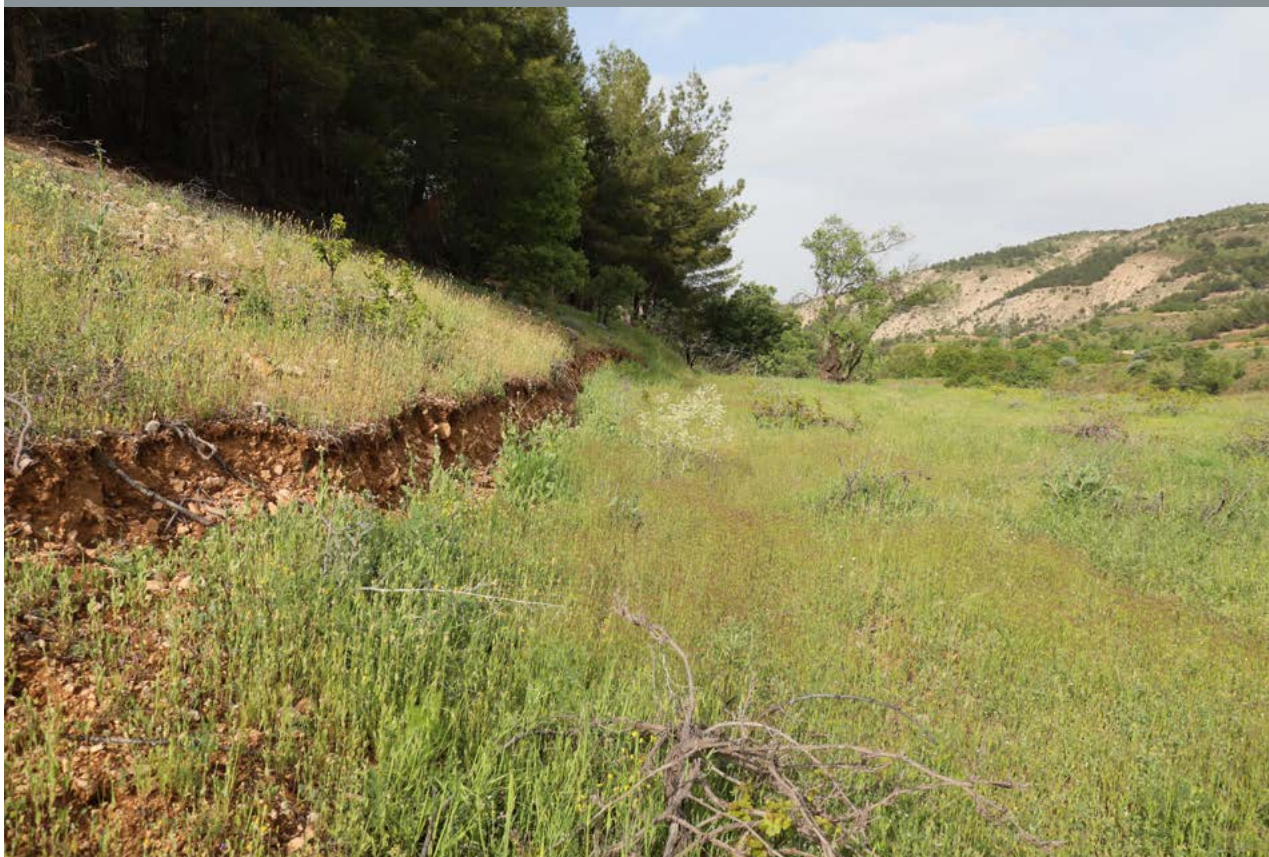
Photo 105 (37.844622°N, 37.739922°E) - Detail (view from west) of the main transtensional coseismic free-face: the average vertical offset is 70 cm.

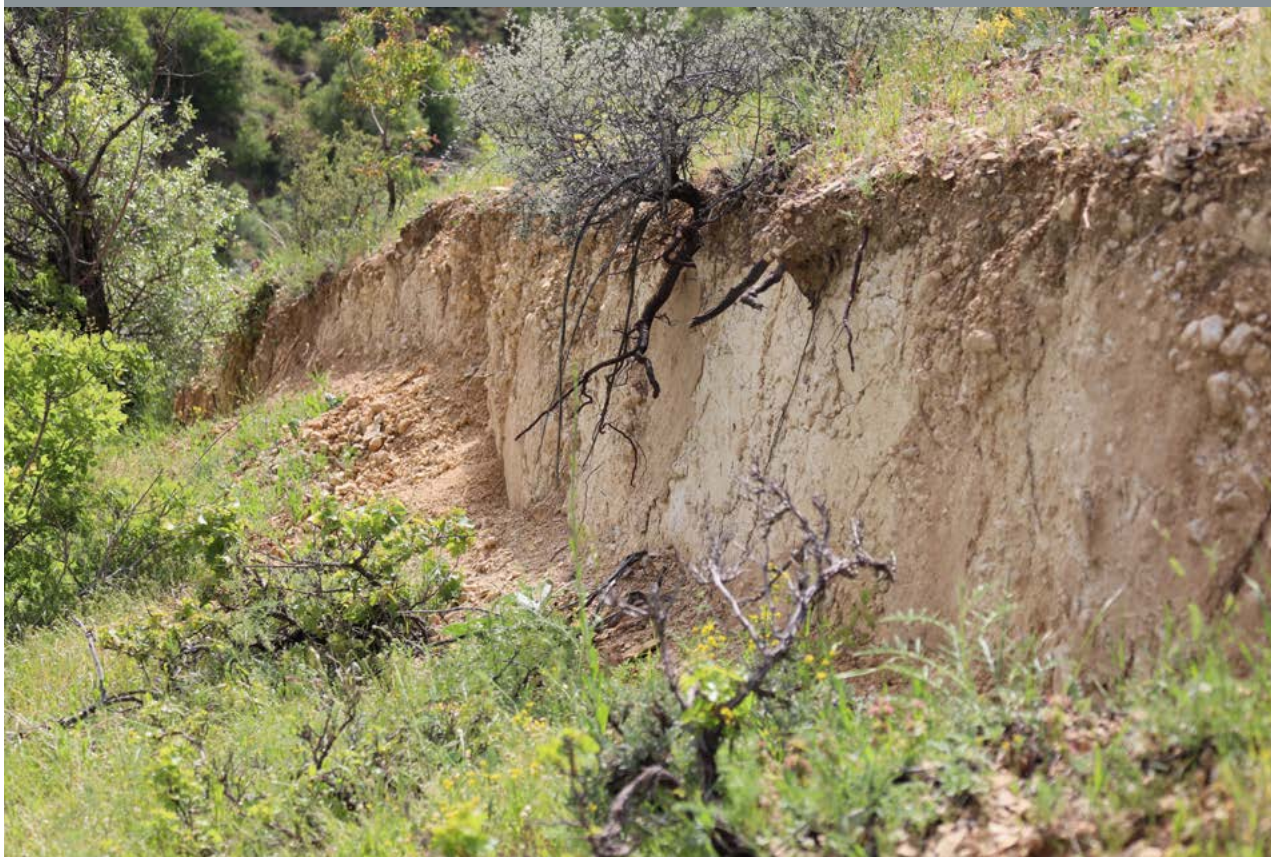
**Photo 107** (37.844530°N, 37.739502°E) – Detail of the free face (from east) shown in the previous photo: here the horizontal offset is 240 cm and the apparent vertical offset 120 cm.
