# MISCELLANEA INGV

A photo and video collection on the  
surface faulting: the Mw 7.8  
Kahramanmaraş (Turkey) earthquake  
of February 6, 2023

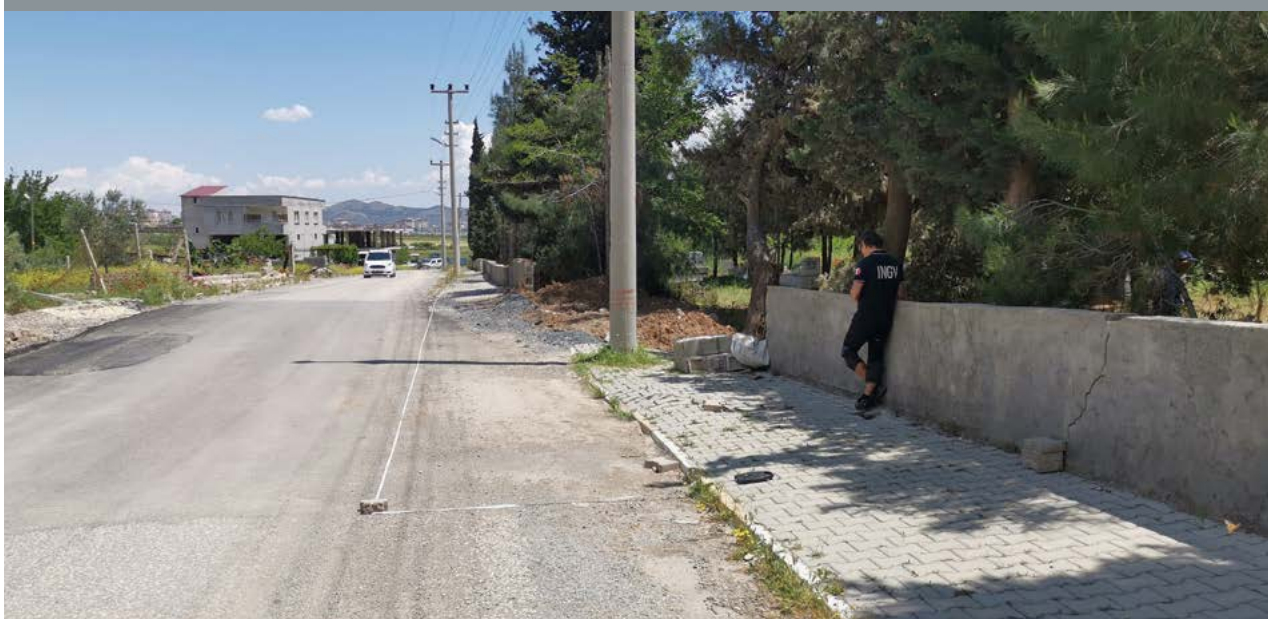
**Photo 15** (37.176261°N, 36.713990°E) – The coseismic displacement affected a road (just repaired) in the town of Nurdağı: the cumulative left lateral offset is 210 cm, estimated by projecting on the fault trace the dislocated road side.

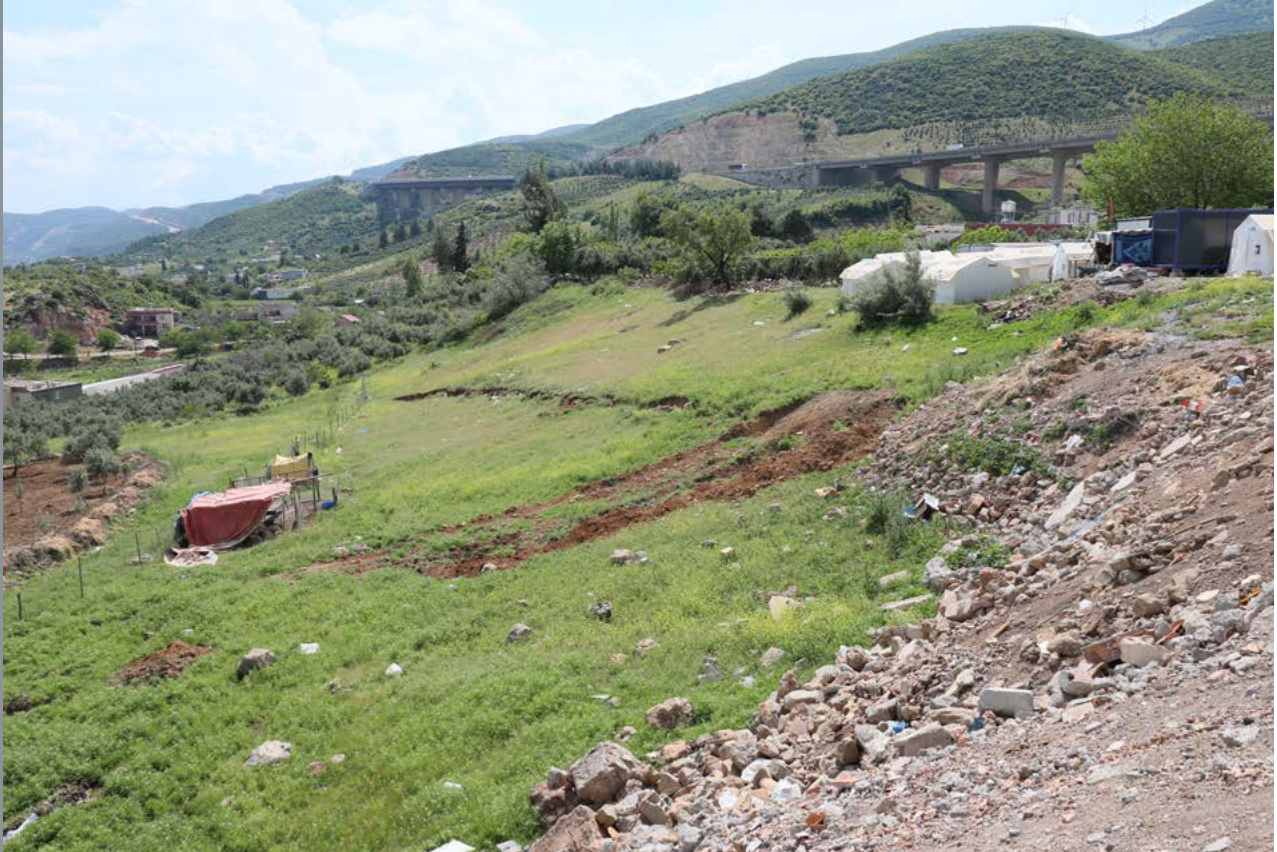
**Photo 16** (37.195202°N, 36.726757°E) – Panoramic view (from northwest) showing the coseismic surface rupture near the village of Başpınar (Nurdağı district/Gaziantep province).

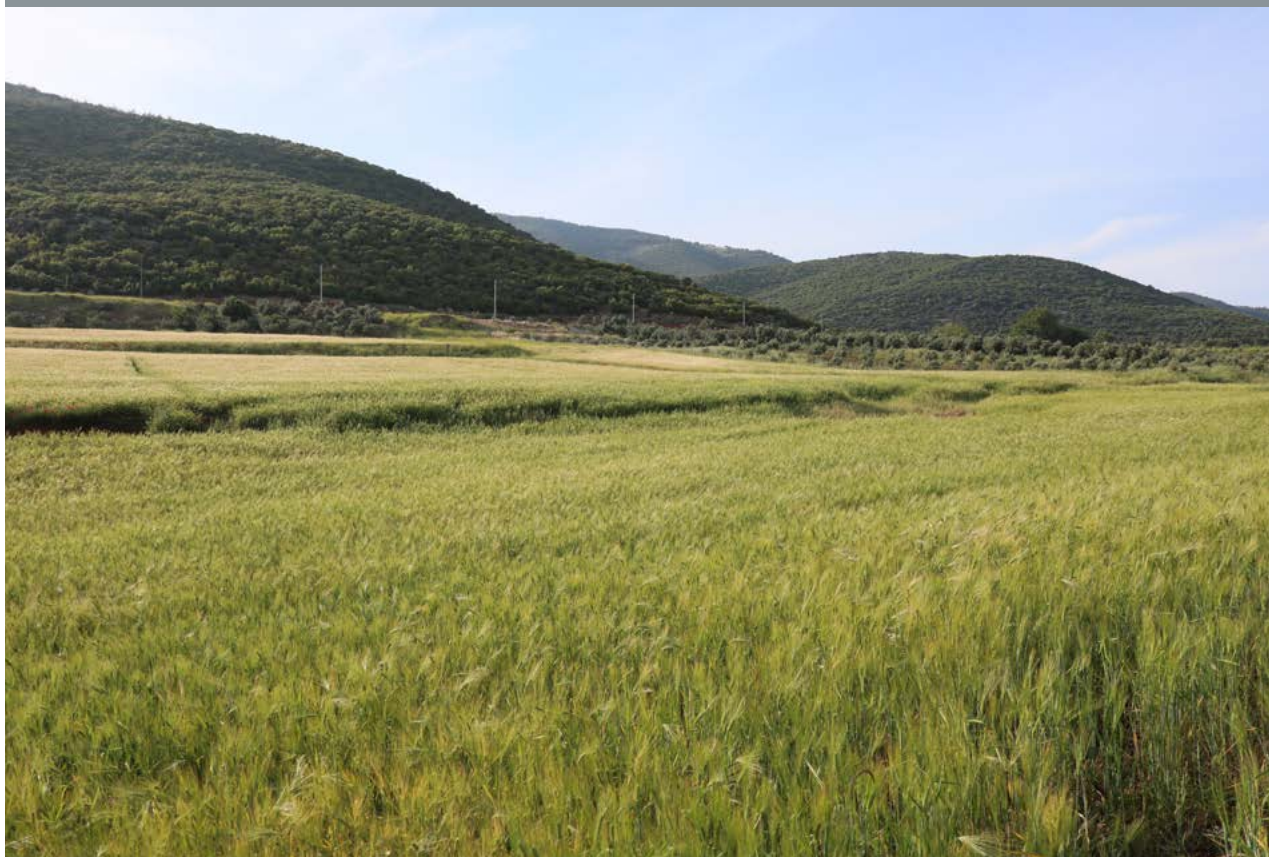
**Photo 21** (37.205771°N, 36.737026°E) – Panoramic view (from southwest) of the coseismic surface rupture running on a wheat field near the village of Bademli (Nurdağı district/Gaziantep province), (see also photographs from 22 to 28).

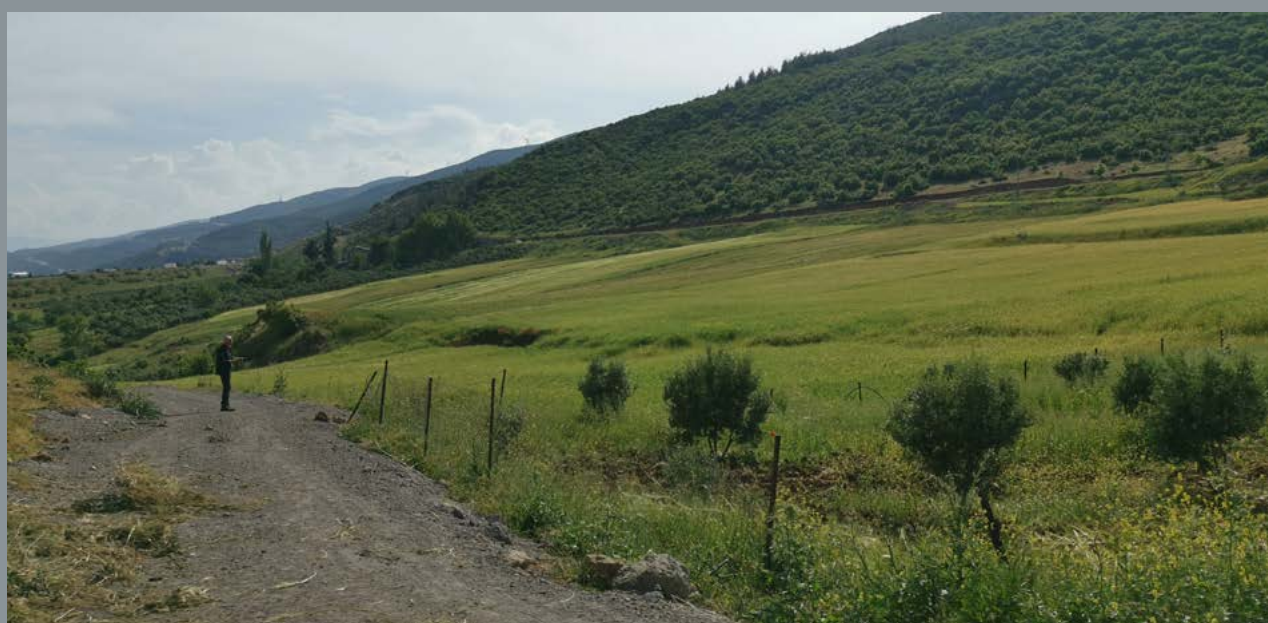
**Photo 22** (37.205811°N, 36.737076°E) – Panoramic view (from northeast) of the same site shown in photo 21.

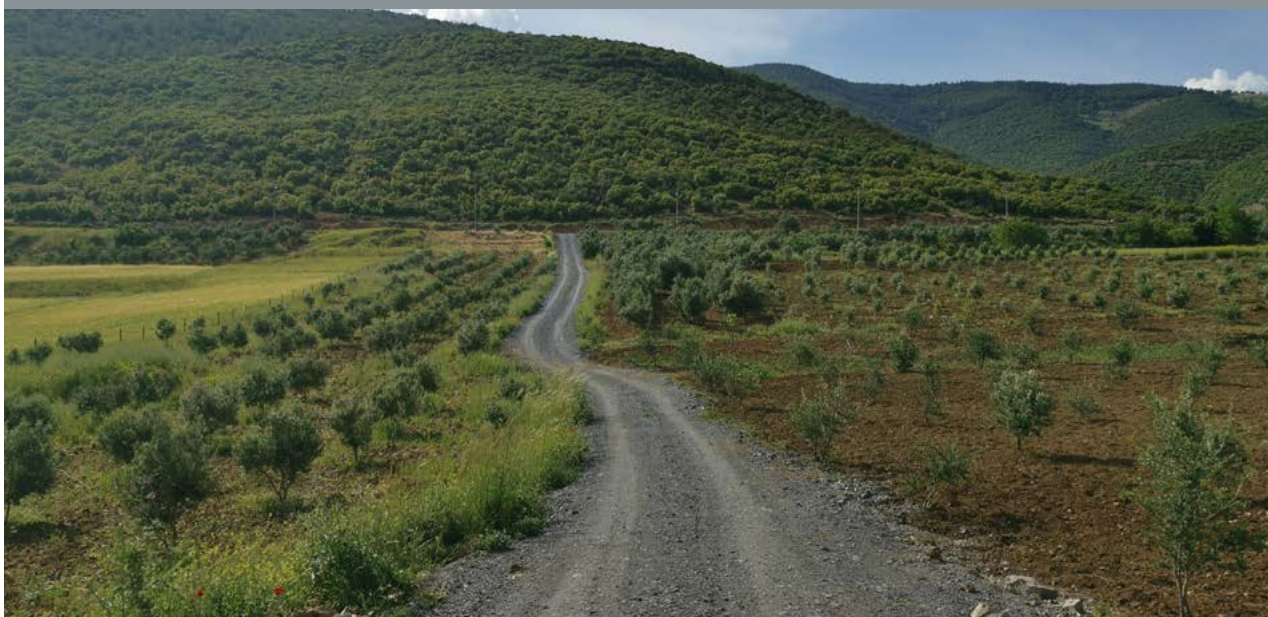
**Photo 23** (37.206023°N, 36.737299°E) – 420 cm of cumulative left-lateral offset of a dirt road.  
The gentle bend is due to early repairs necessary to reconnect the dislocated road sections.

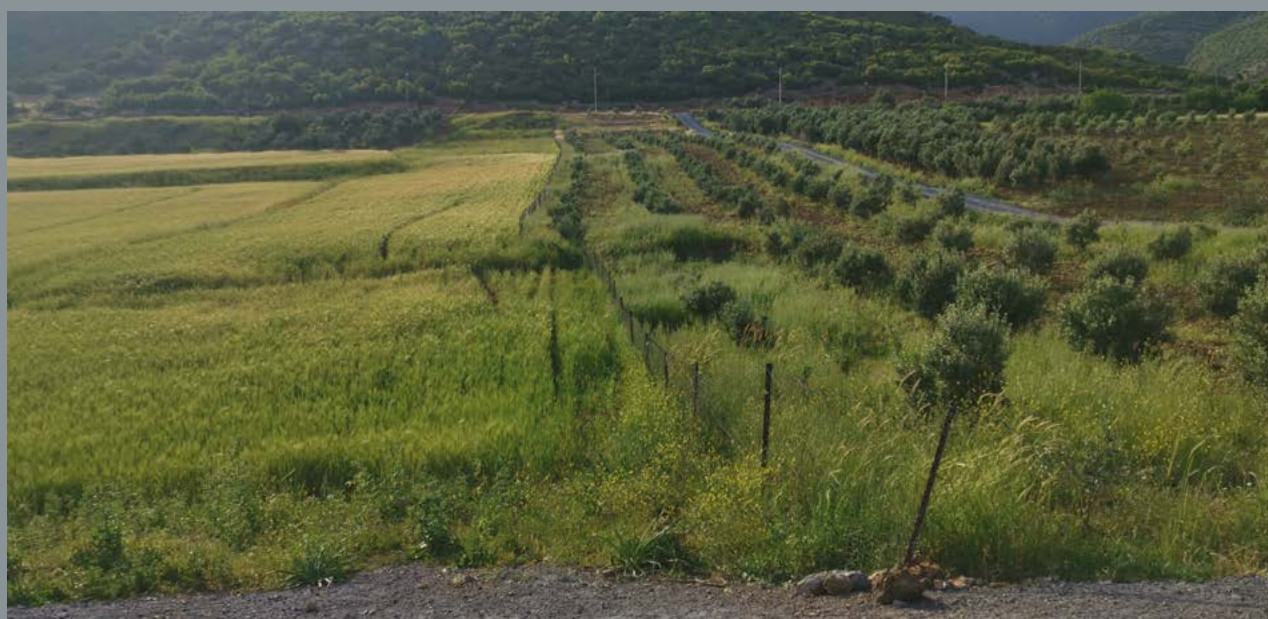
**Photo 24** (37.205886°N, 36.737132°E) – A closer view of the olive grove from photo 23. The coseismic fault rupture at the surface displaces a fence line and the rows of olive trees with approximately 380 cm of aggregated left-lateral motion.

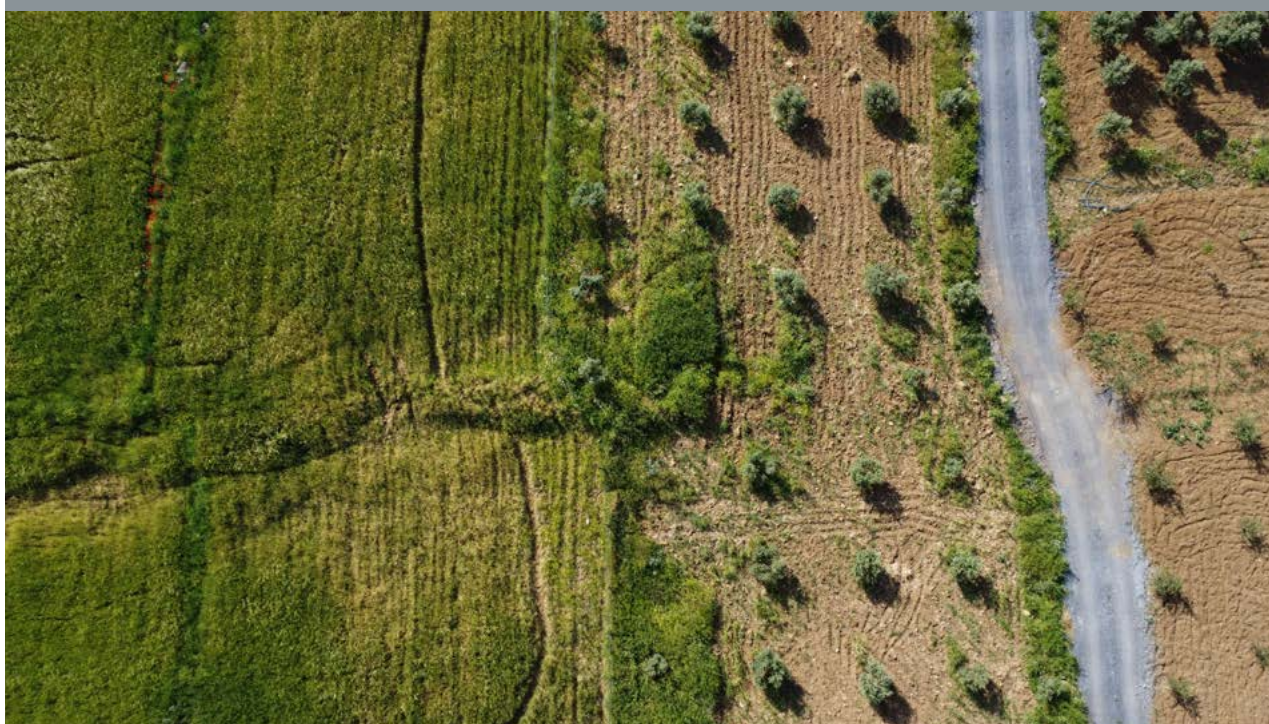
**Photo 25** (37.206083°N, 36.736885°E) – Drone view (from southeast) of the coseismic rupture shown in photos 23 and 24: note on the left (grassy area) the compound scarp north of the fault trace.

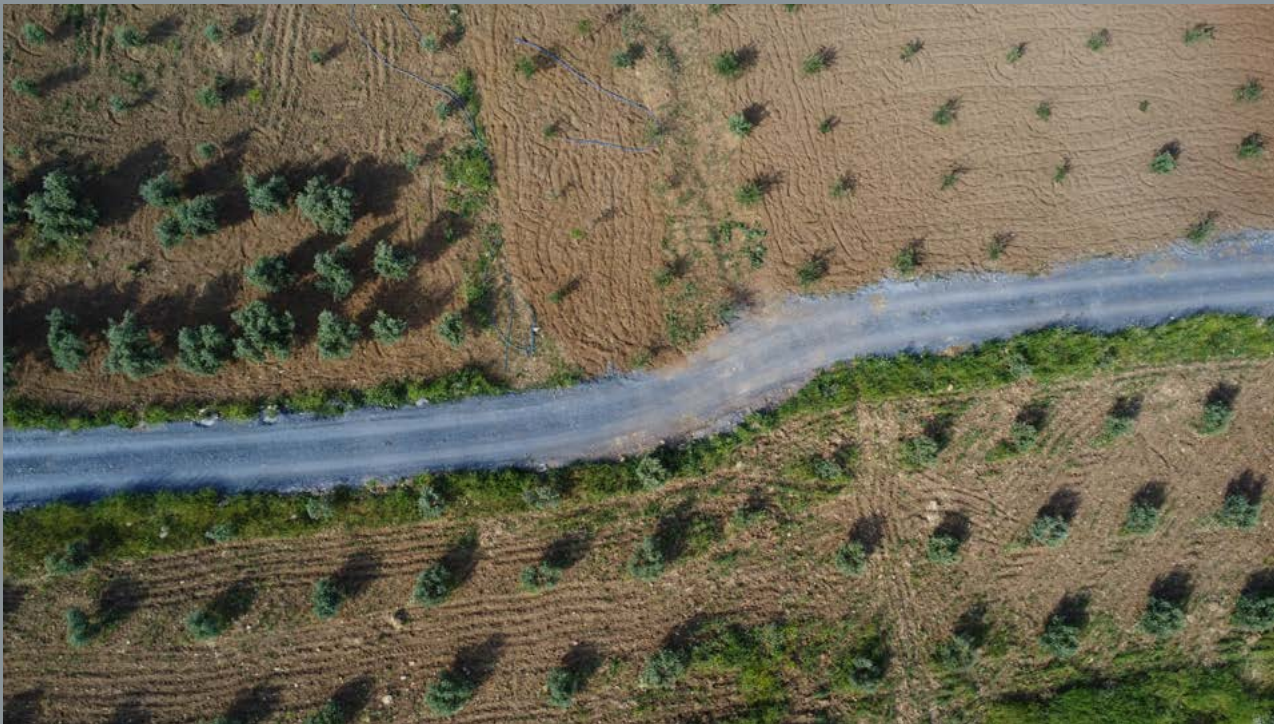
**Photo 26** (37.206252°N, 36.736804°E) – Drone view (from southwest) of the dirt road displaced by the coseismic rupture in photograph 23: the left-lateral component of movement of the fault is clearly visible also in the fields paralleling the road.

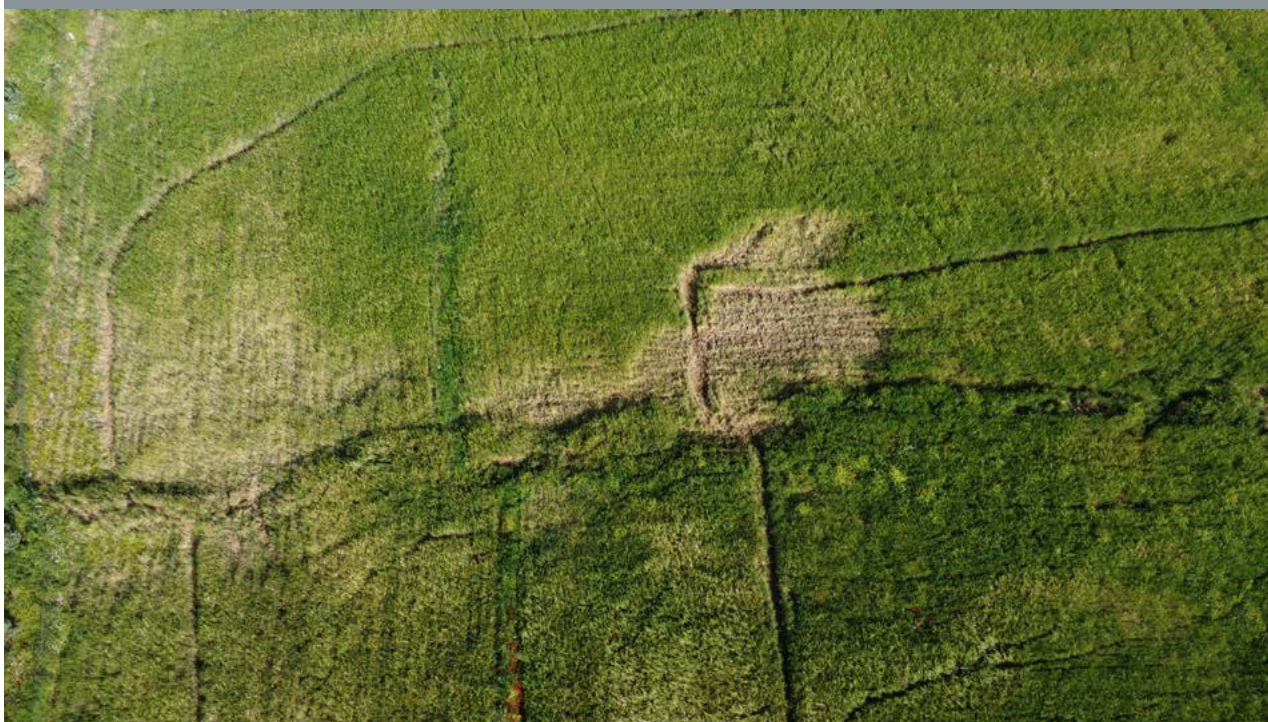
**Photo 27** (37.205923°N, 36.736528°E) – Drone view (from northwest) of the surface rupture (see photos 21–22). Displaced ditches evidence a 300–380 cm left-lateral offset. Despite low vegetation, the rupture trace and offset partitioning across fault splays remain clearly discernible.

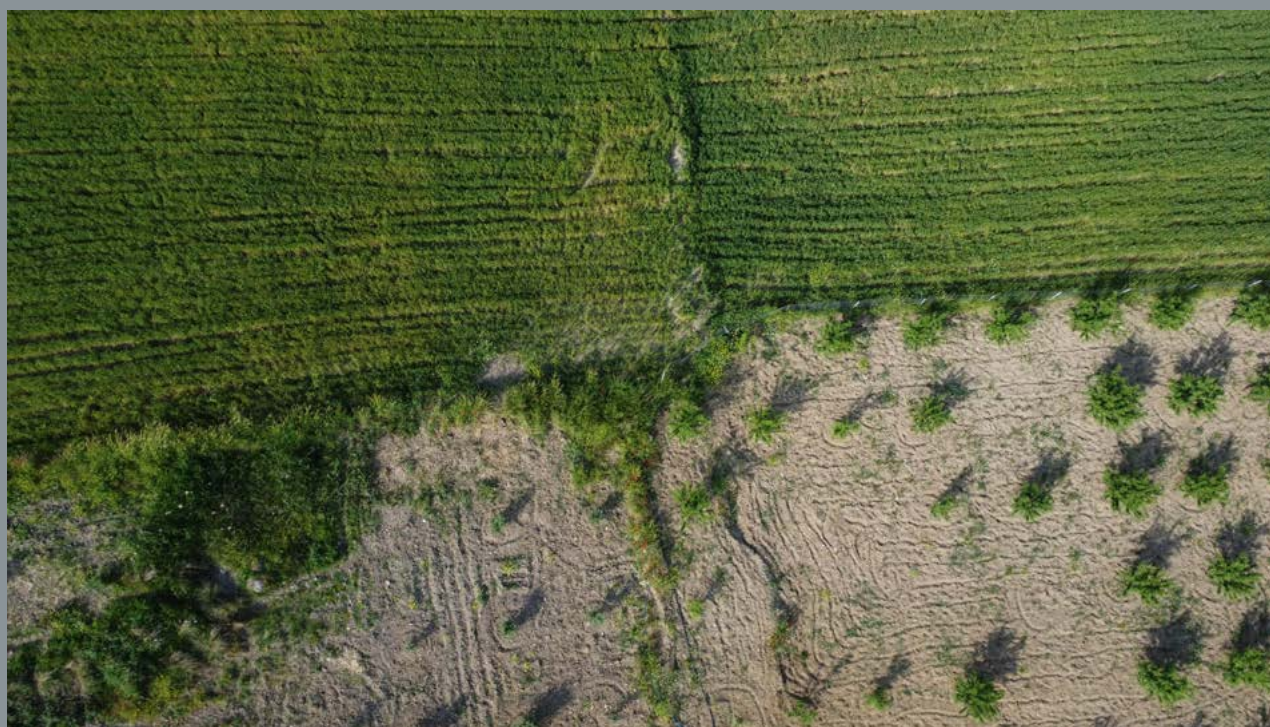
**Photo 28** (37.206844°N, 36.737263°E) – Drone view (from northeast) of the coseismic rupture of photo 24. Note the left-lateral displacement (ca. 310 cm) of the field boundaries.

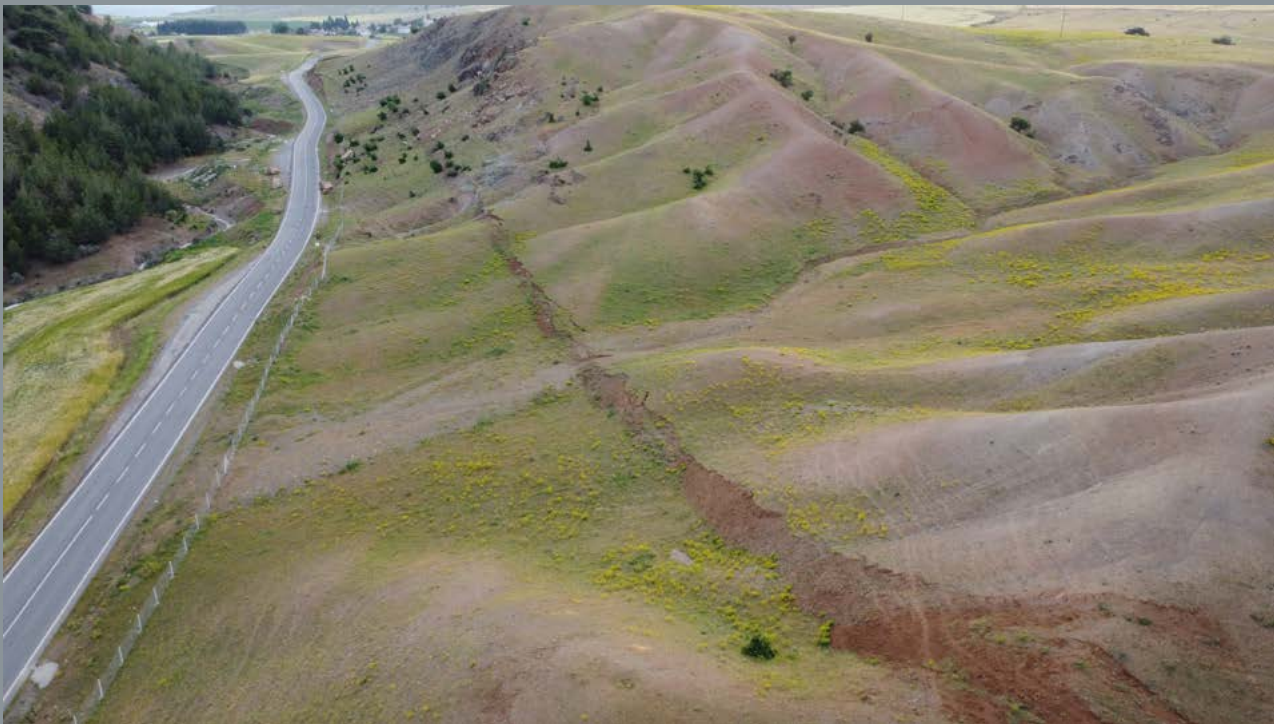
**Photo 31** (37.452509°N, 36.985112°E) – Drone view (from northeast) of the coseismic escarpment. The narrow fault zone shows few en-echelon arrangements of Riedel shears, absence of opening components and up to 250 cm of apparent vertical offset due to lateral juxtaposition of slopes.

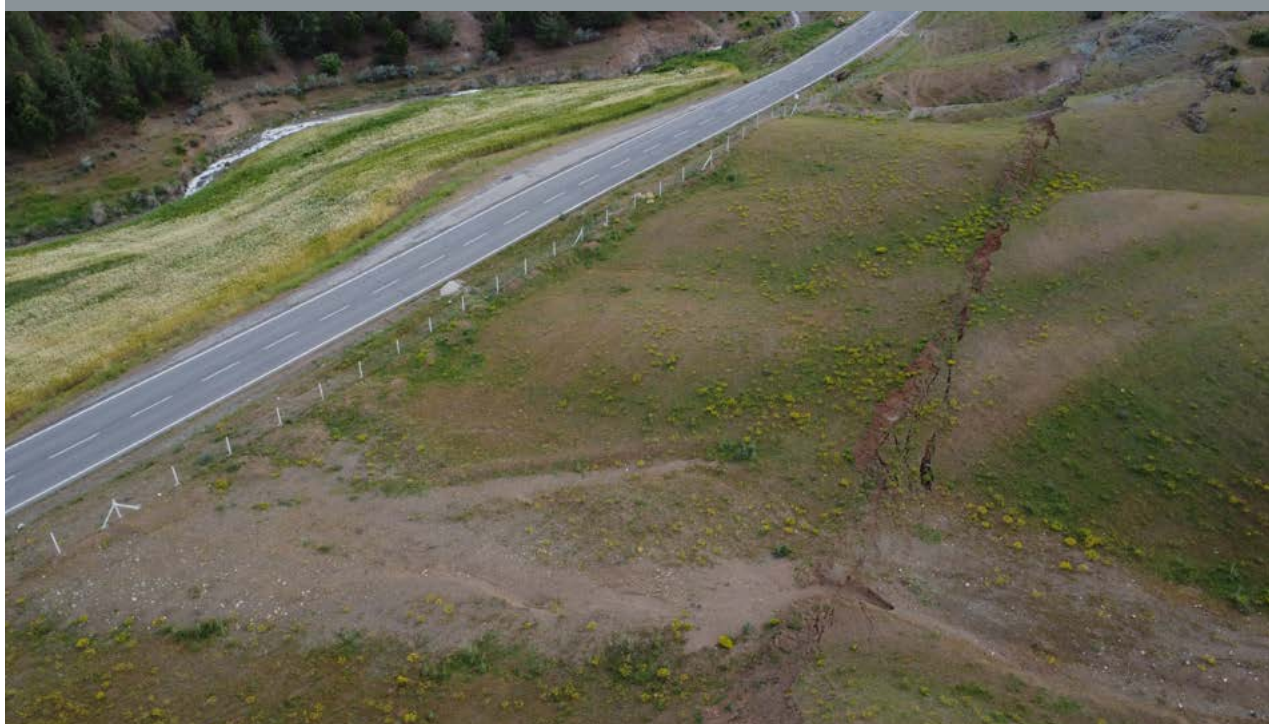
**Photo 32** (37.452677°N, 36.984166°E) – Detail of the coseismic rupture viewed from northeast.  
Note the left-lateral deflection of the gully (~320 cm) at the right bottom corner.

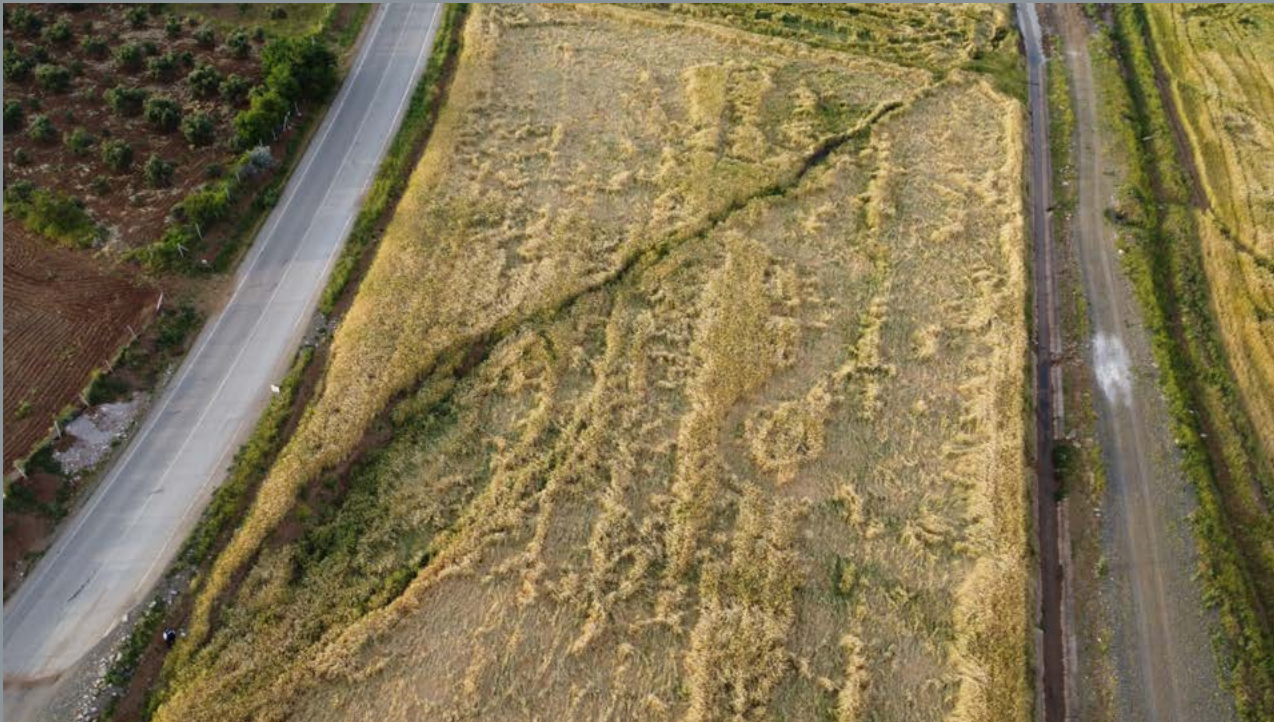
**Photo 33** (37.453997°N 36.989798°E) – Some hundreds of meters northeast of the previous photos, the coseismic rupture enters a plain: here, the left step of two fault strands produced a spectacular pull-apart (picture's bottom left), resembling a negative flower structure.

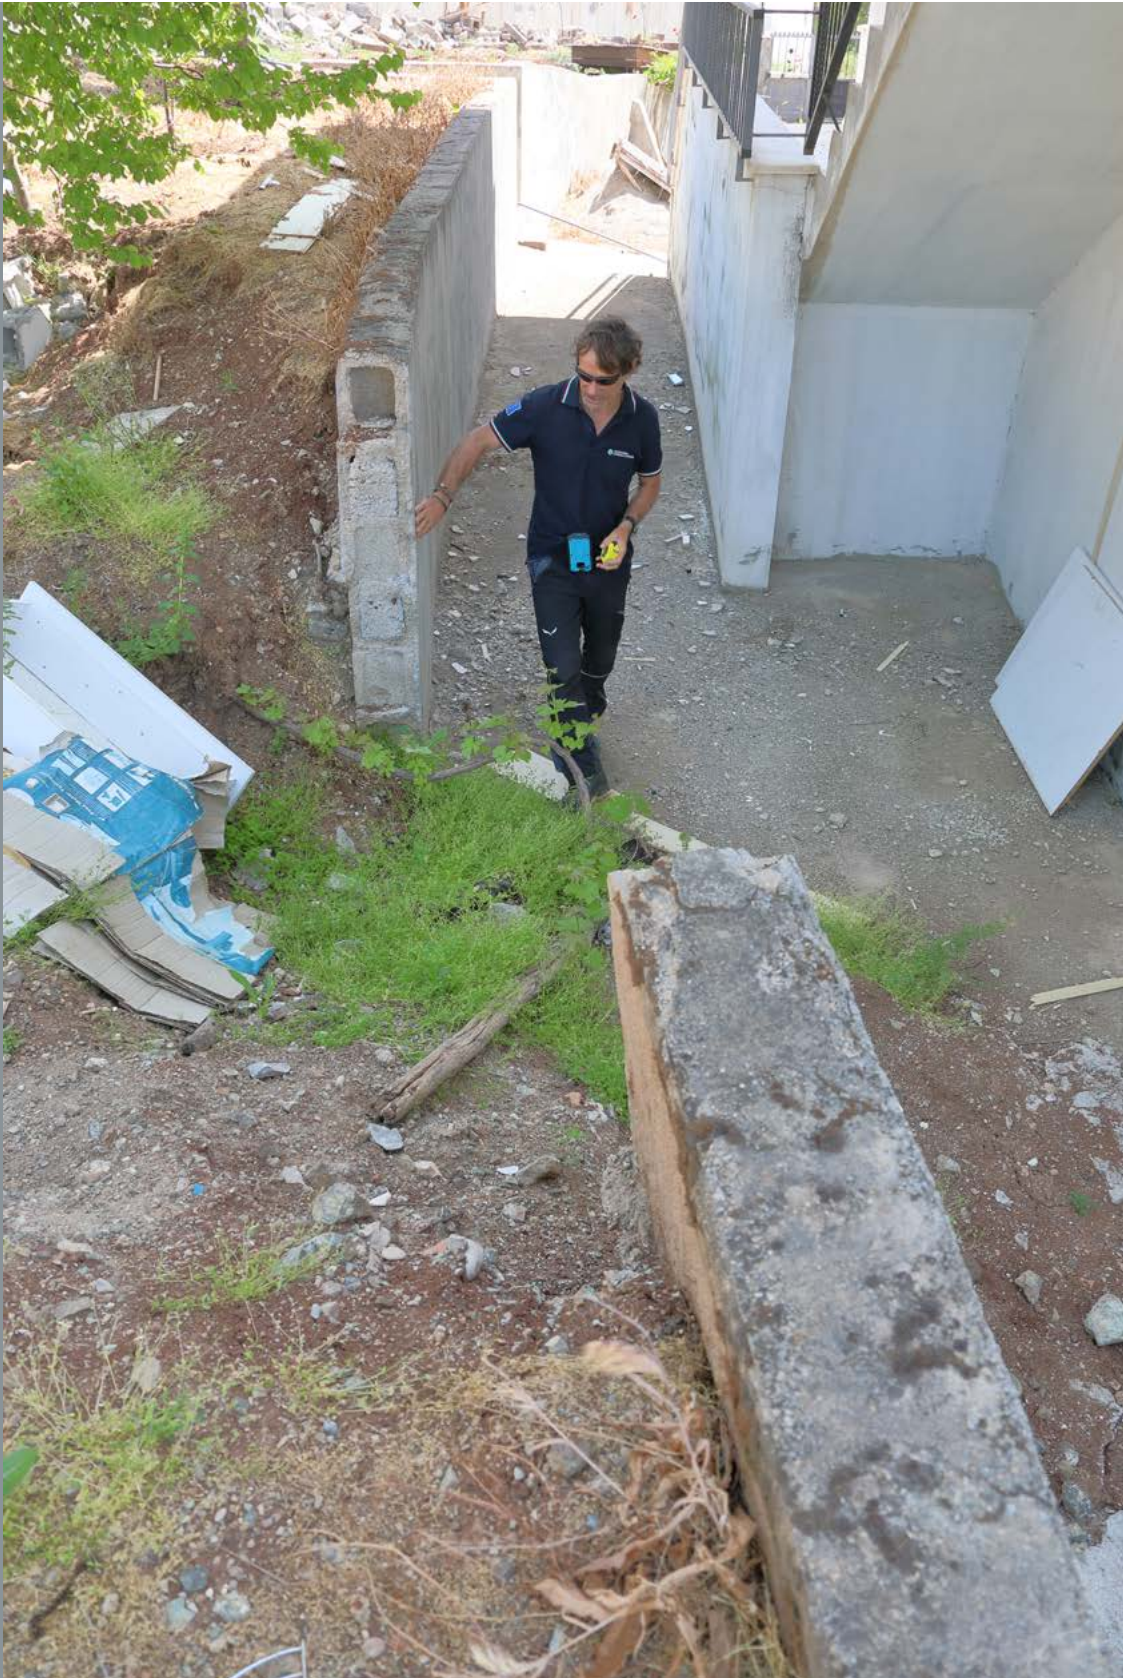
**Photo 35** (37.490467°N, 37.066978°E) – Retaining wall in the Çiğli village affected by coseismic surface faulting displaying a pure left-lateral offset of 260 cm.

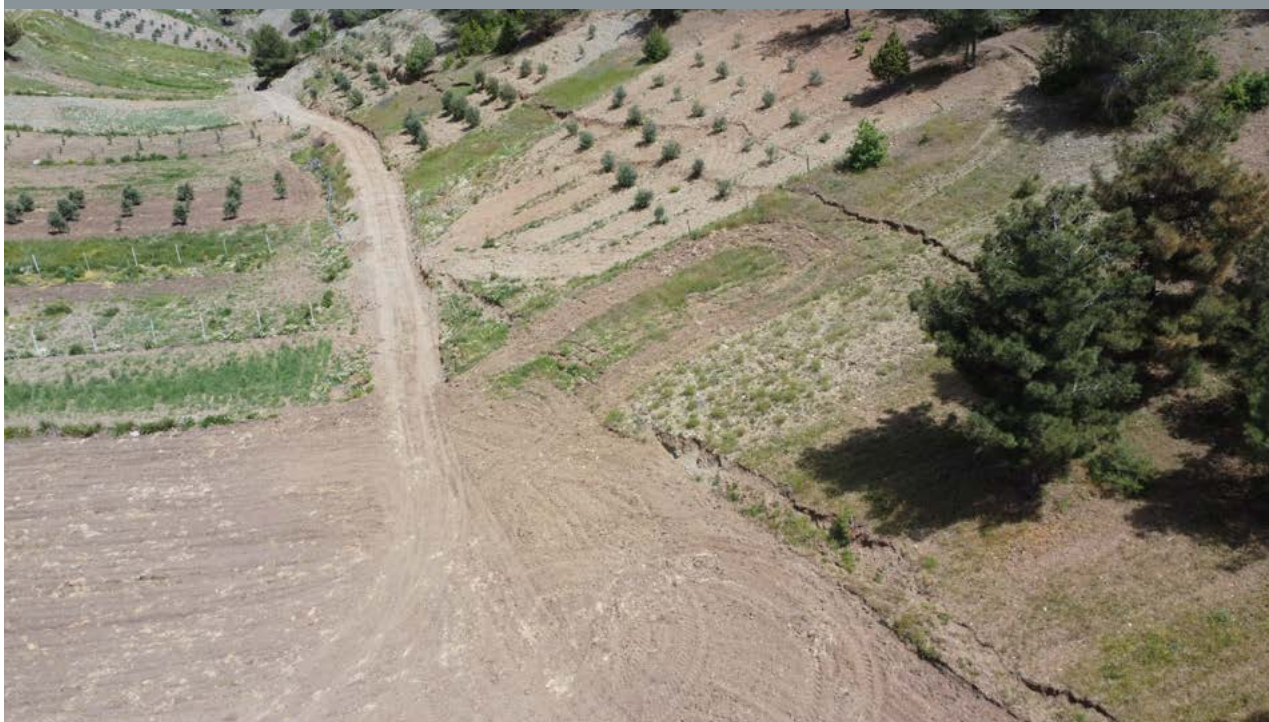
**Photo 40** (37.508917°N 37.121052°E) – Drone view (from west) of the same rupture section of photographs 37-38-39. Note the en-echelon arrangement of the parallel, right stepping coseismic rupture strands defining a deformation zone width of up to 25 m.

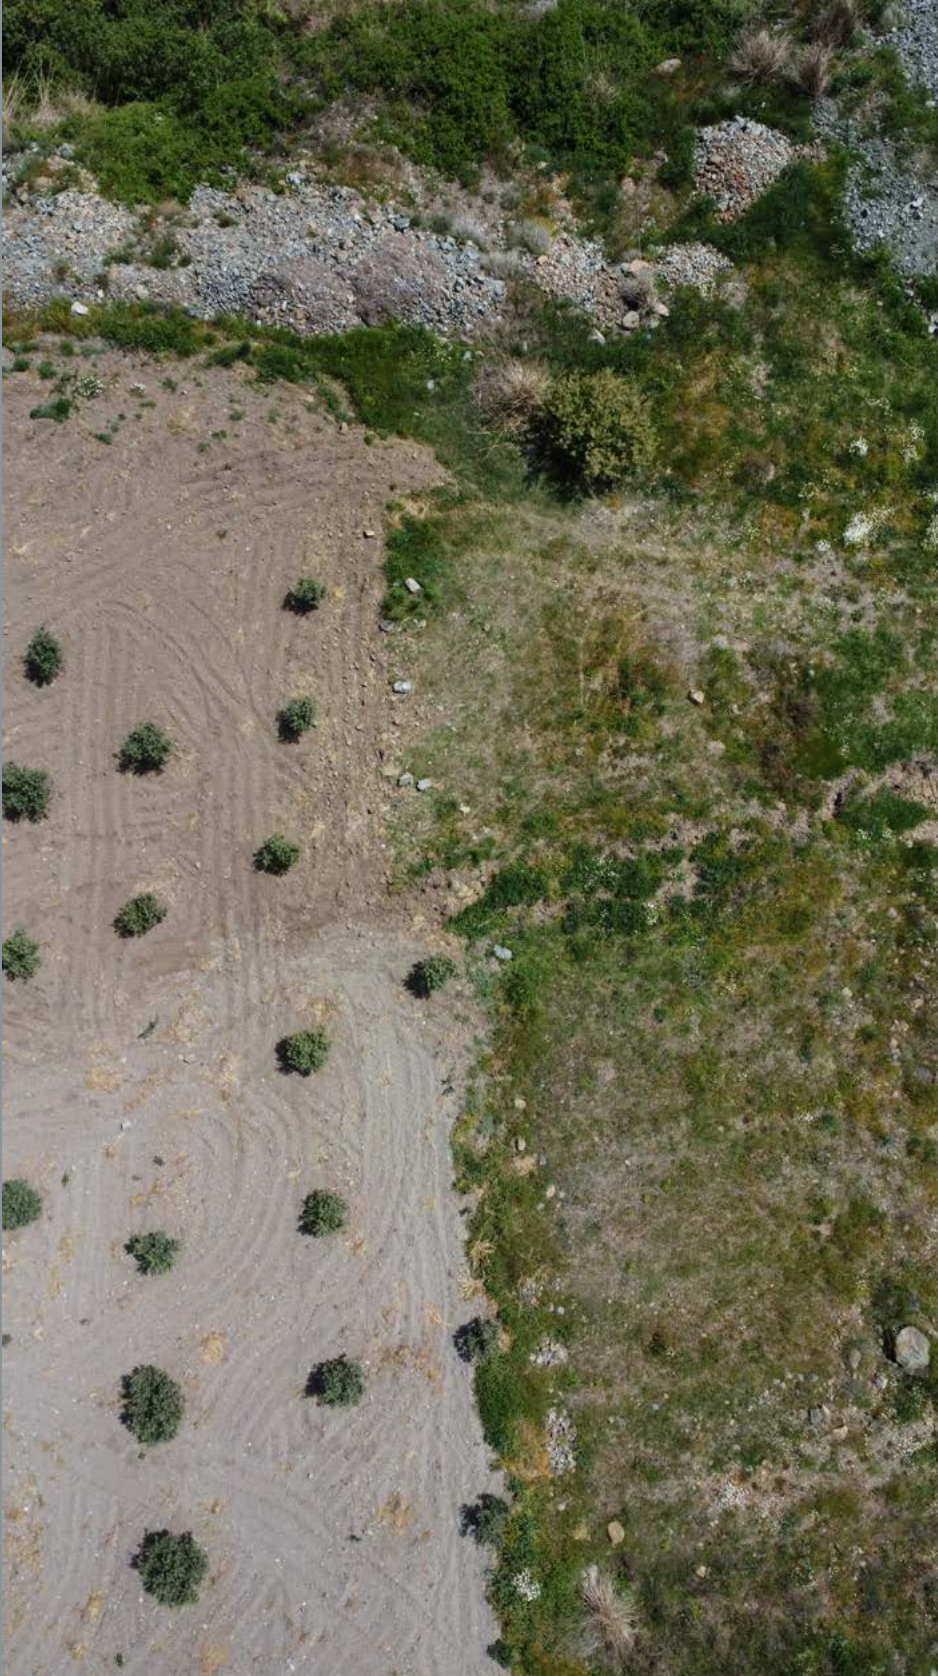
**Photo 43** (37.509487°N, 37.123761°E) – Drone azimuthal view of the previous photo. The olive tree field boundary was reworked by the owner to recover the left-lateral displacement.

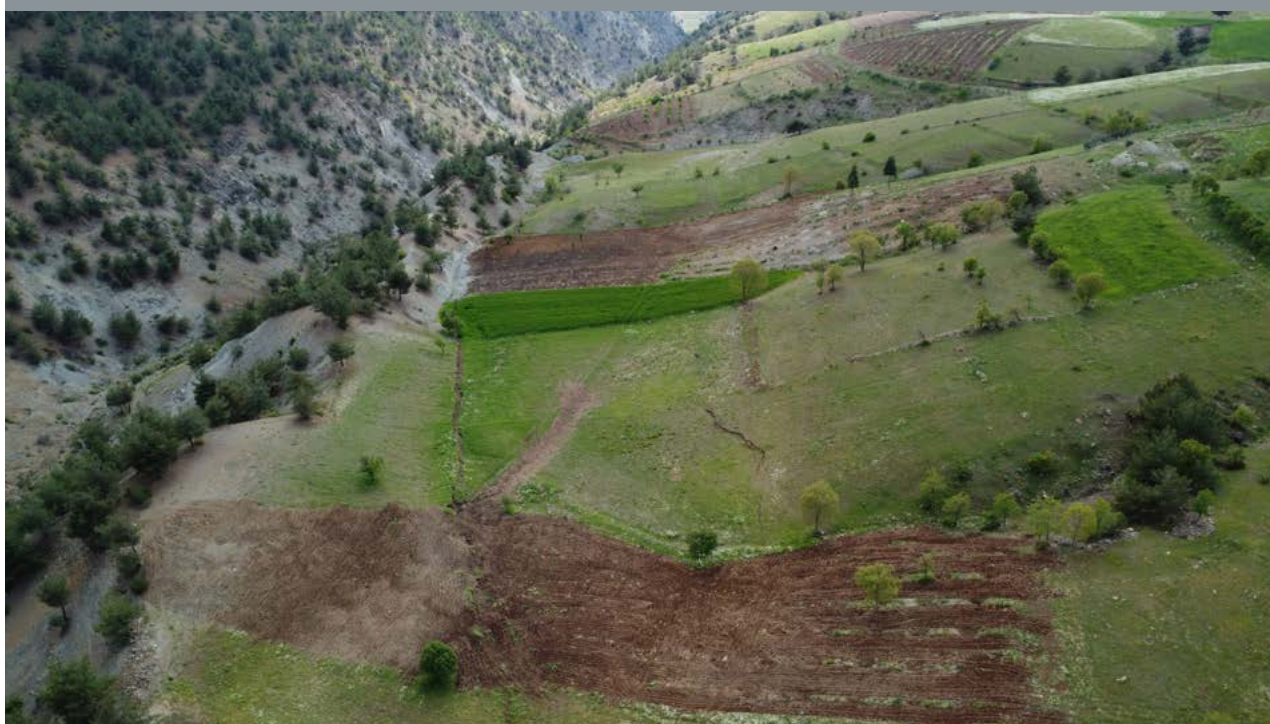
**Photo 44** (37.512861°N, 37.145044°E) – Drone view (from northeast) of the coseismic rupture east of the Kartal village. Note that the rupture trace parallels the drainage incision and flanks an elongated pressure ridge, probably representing the long-term expression of transpressional kinematics.

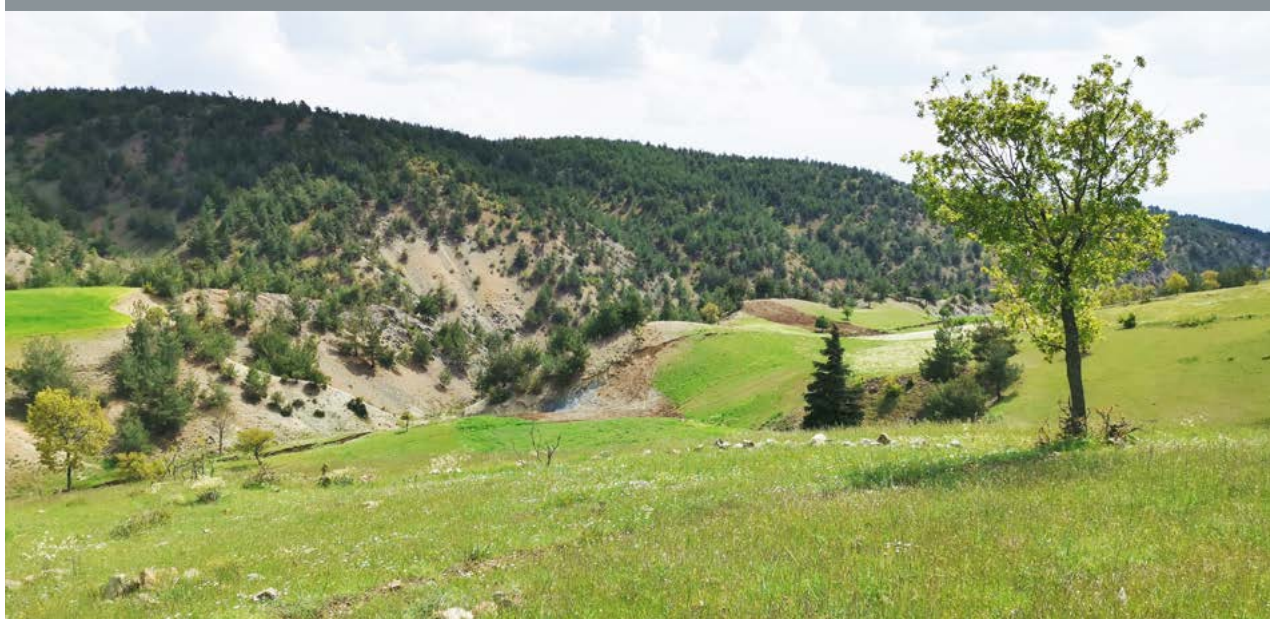
**Photo 46** (37.514374°N, 37.146404°E) – View (from the northeast) of the coseismic rupture of photo 44 deforming different morphological elements of the environment.

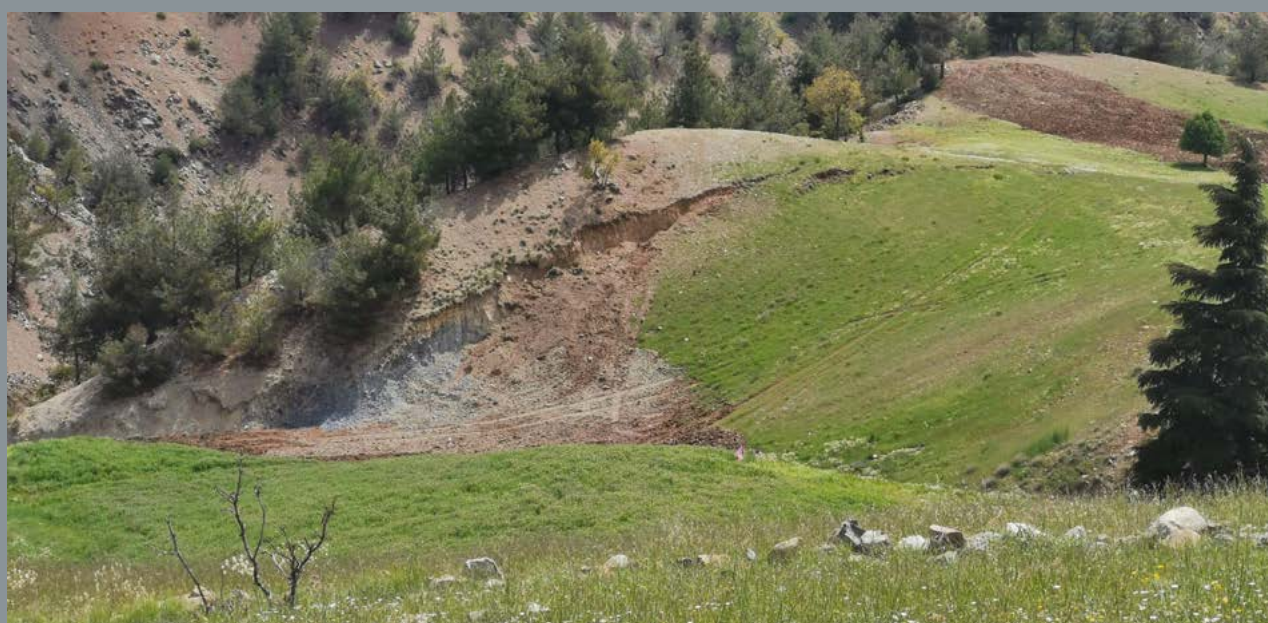
**Photo 47** (37.514374°N 37.146404°E) – Detail of the previous photo. The vertical component is mostly apparent, and results from the left-lateral displacement that juxtaposes an oblique slope.

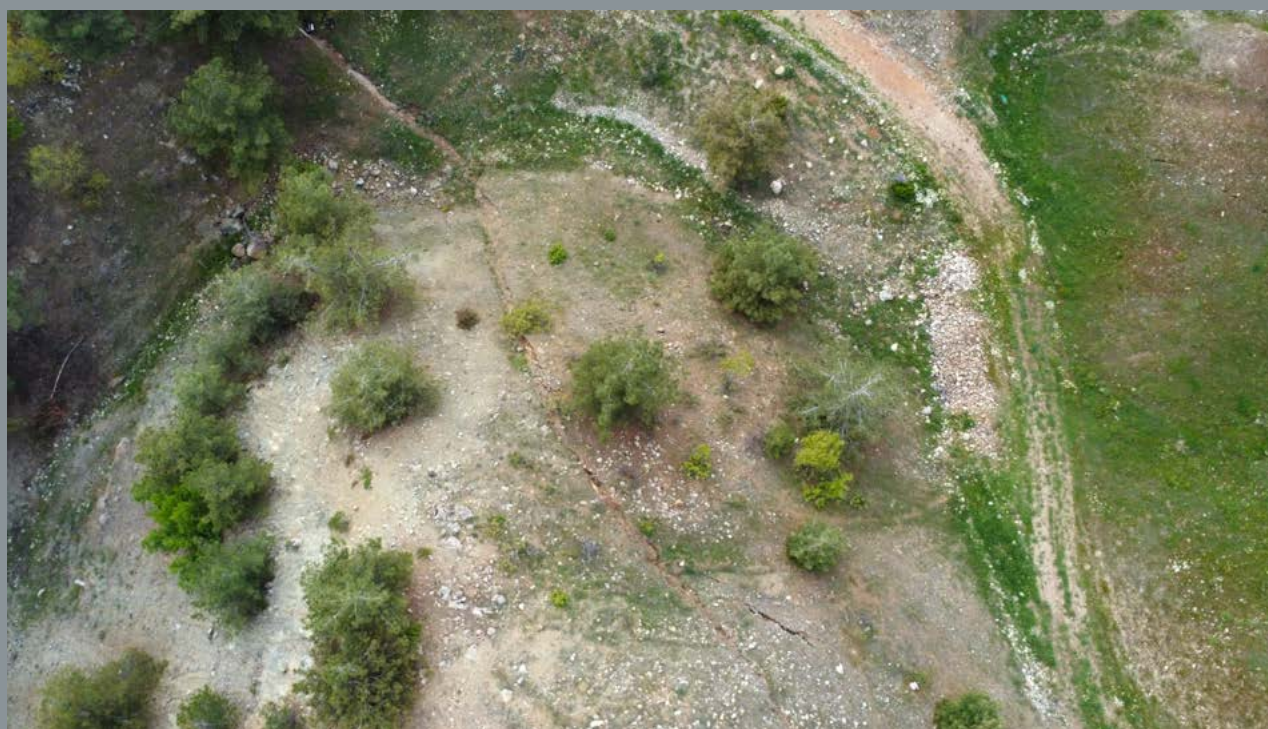
**Photo 49** (37.513719°N, 37.149131°E) – Drone view (from east) of the coseismic rupture crosscutting a small valley, deflecting and damming the stream talweg (see also photo 50).

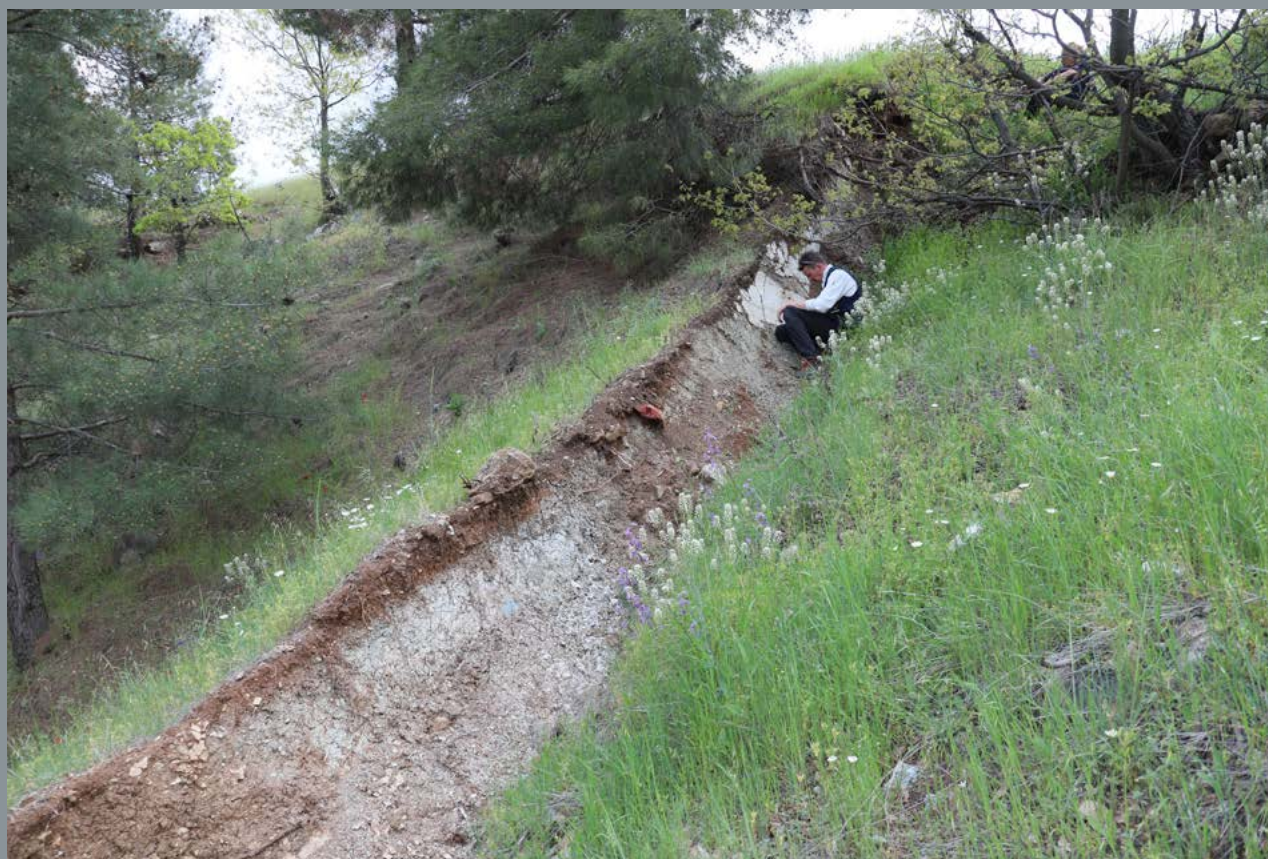
**Photo 51** (37.513745°N, 37.148705°E) – The coseismic free face marked by an impressive clear-cut plane (view from north).

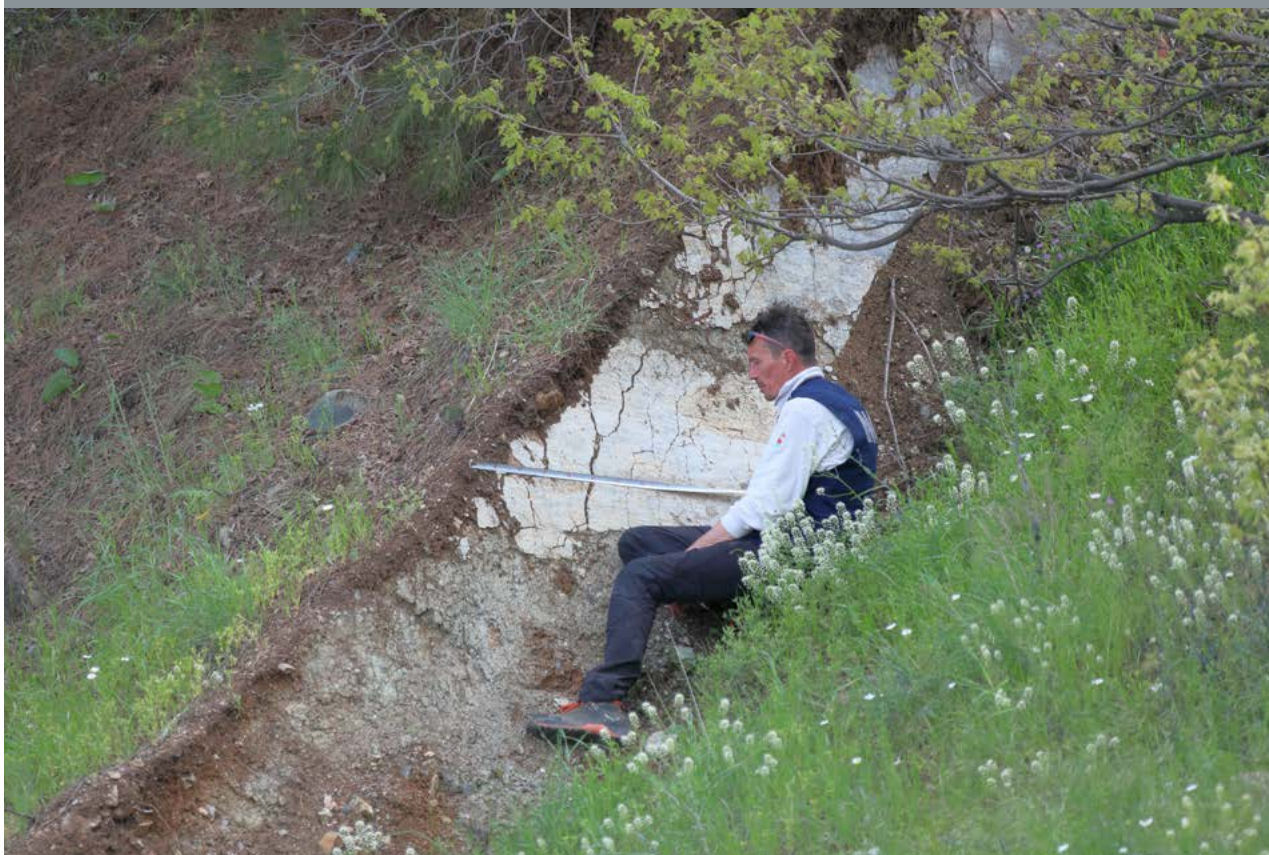
**Photo 52** (37.513708°N, 37.148664°E) – Particular of the fault plane in photo 51. The slickenlines are locally well preserved; the ruler is aligned with the strike of the striae.
