# MISCELLANEA INGV

A photo and video collection on the  
surface faulting: the Mw 7.8  
Kahramanmaraş (Turkey) earthquake  
of February 6, 2023

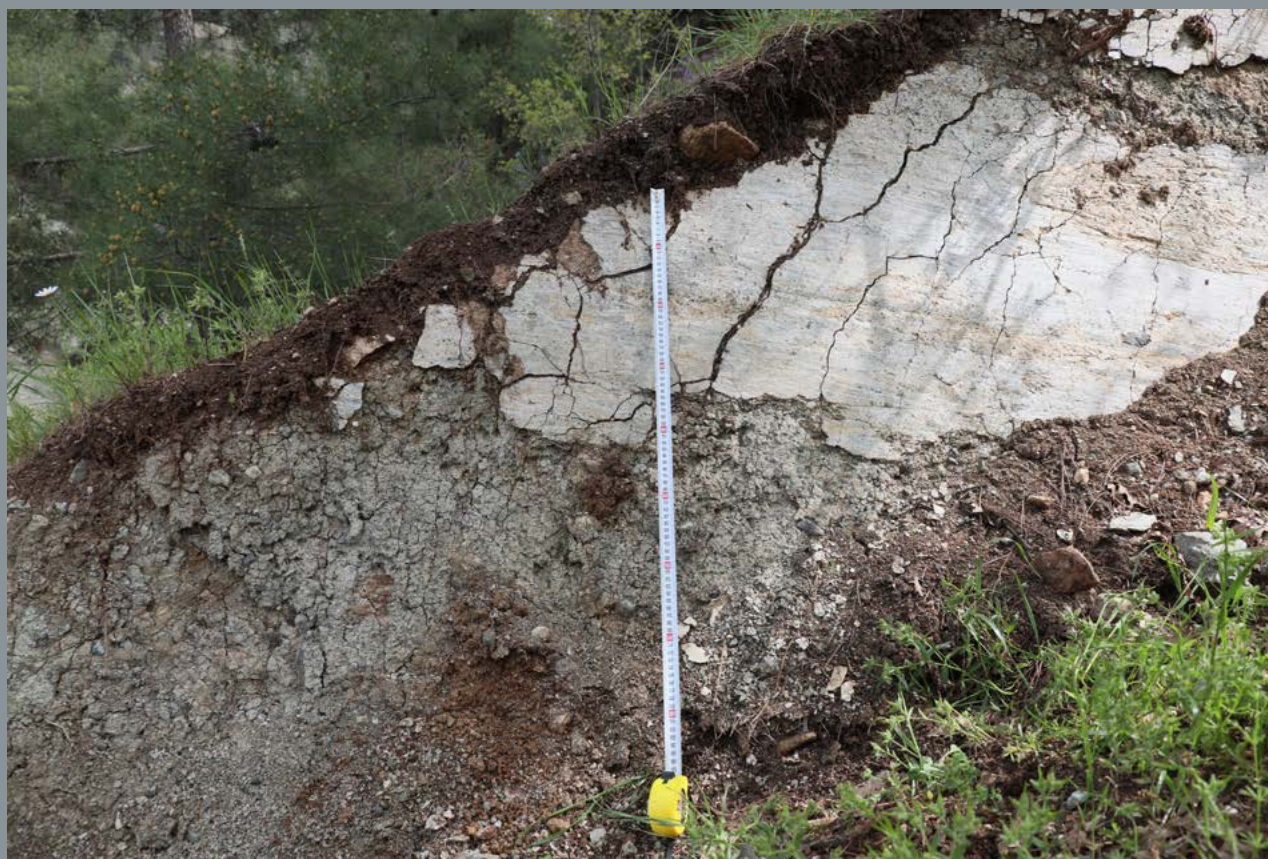
**Photo 53** (37.513708° N, 37.148664° E) – Detail of the previous photo.  
The ruler indicates the apparent vertical displacement of more than 90 cm.

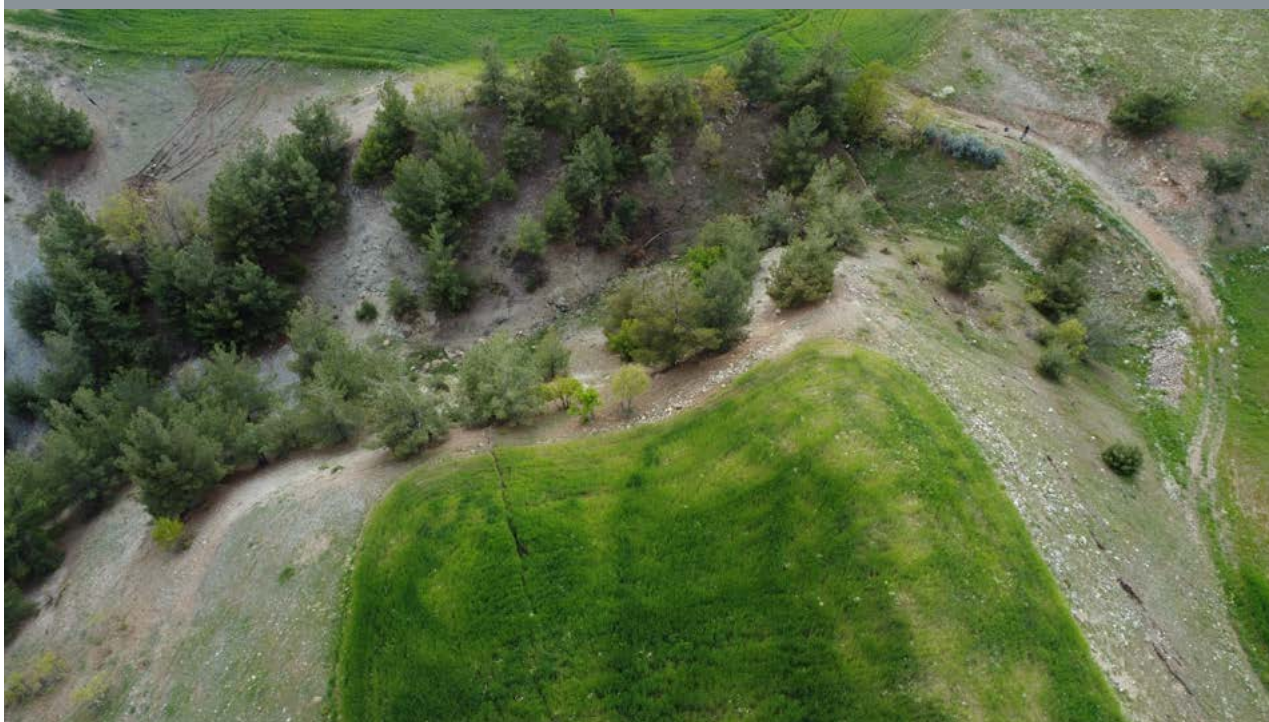
**Photo 54** (37.514044°N, 37.150936°E) – Panoramic view (from east) of the area in photo 49.  
Note the pressure ridge affected by secondary parallel rupture strands.

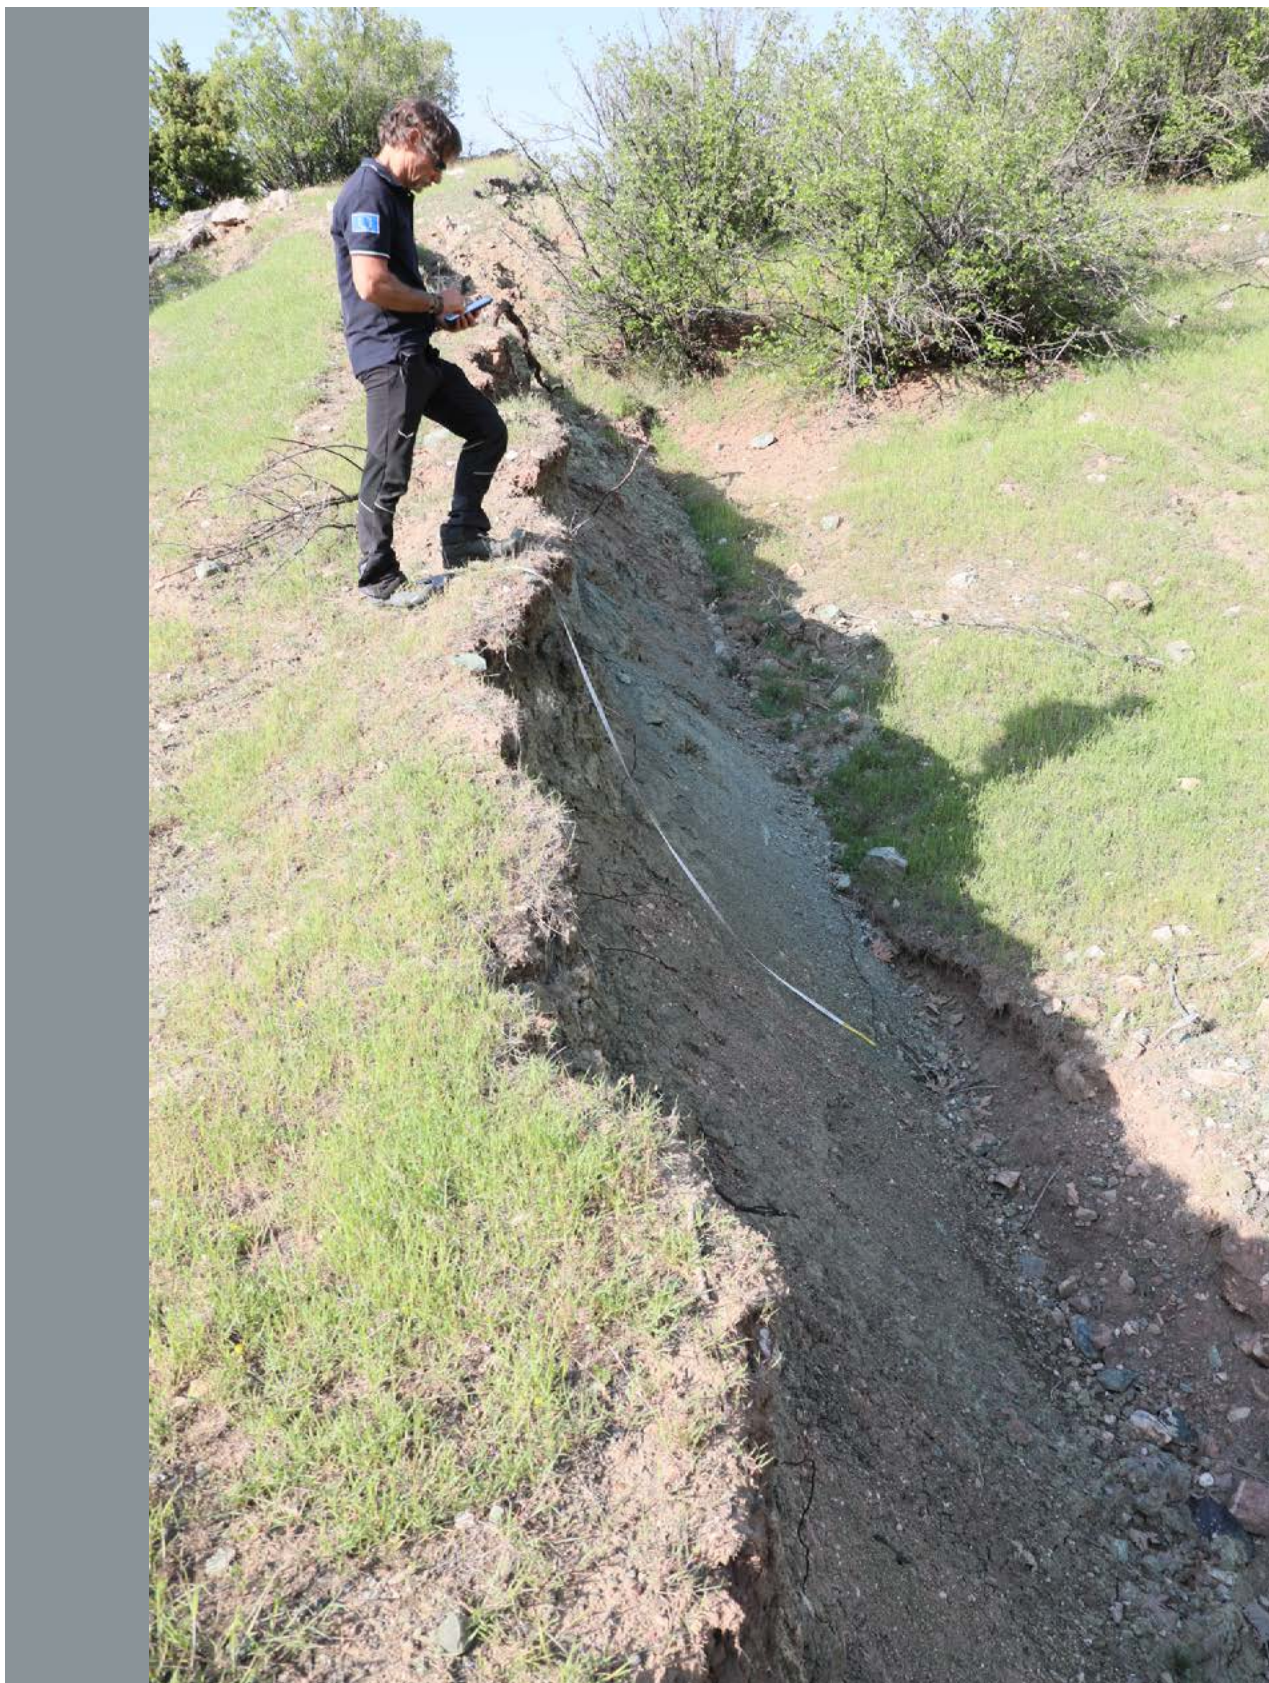
**Photo 58** ( $37.615554^{\circ}\text{N}$ ,  $37.383393^{\circ}\text{E}$ ) – Different view of photo 57. The sharp left-lateral offset of 370 cm is responsible for the large apparent vertical offset, with no opening component.

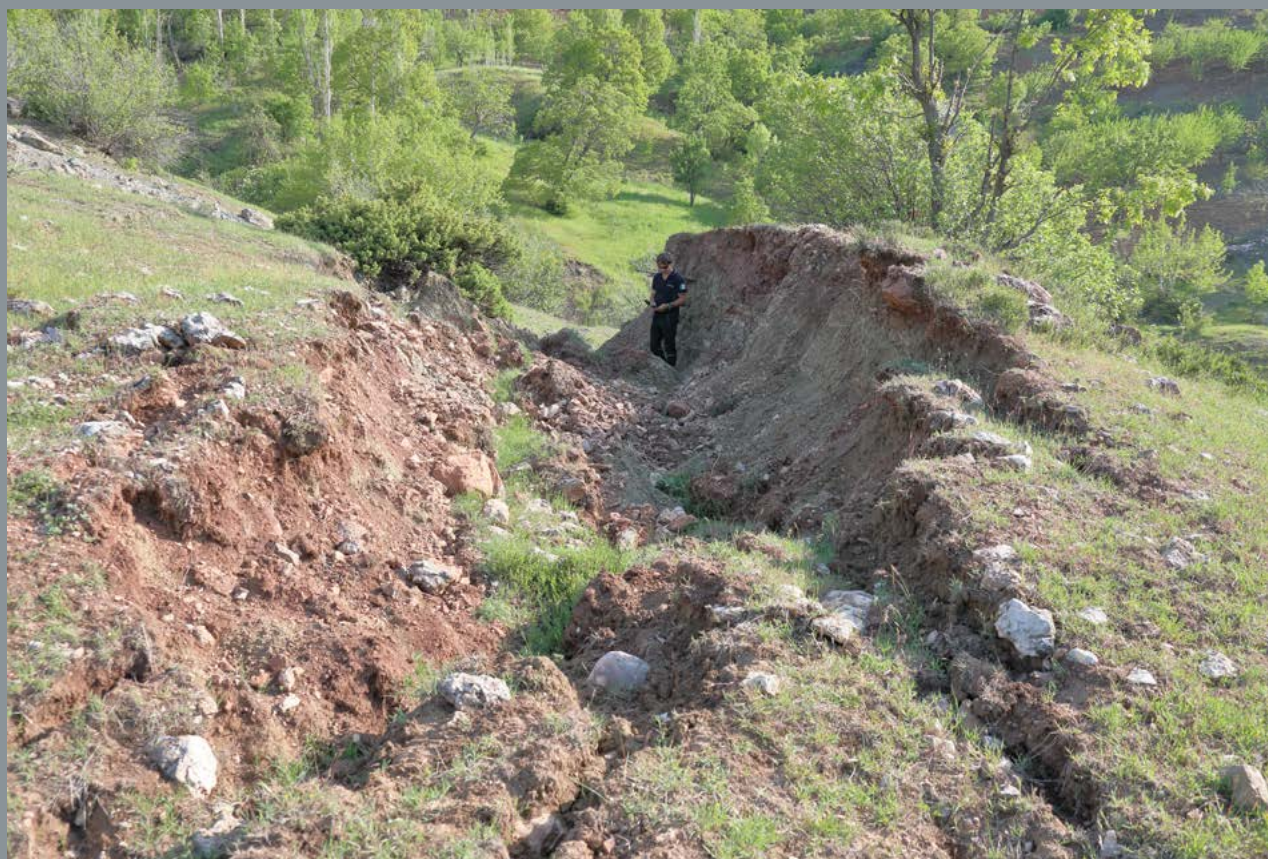
**Photo 59** (37.615834°N, 37.383714°E) – View of a coseismic graben due to a pull-apart characterised by a width of 7 m and apparent vertical offset reducing uphill.

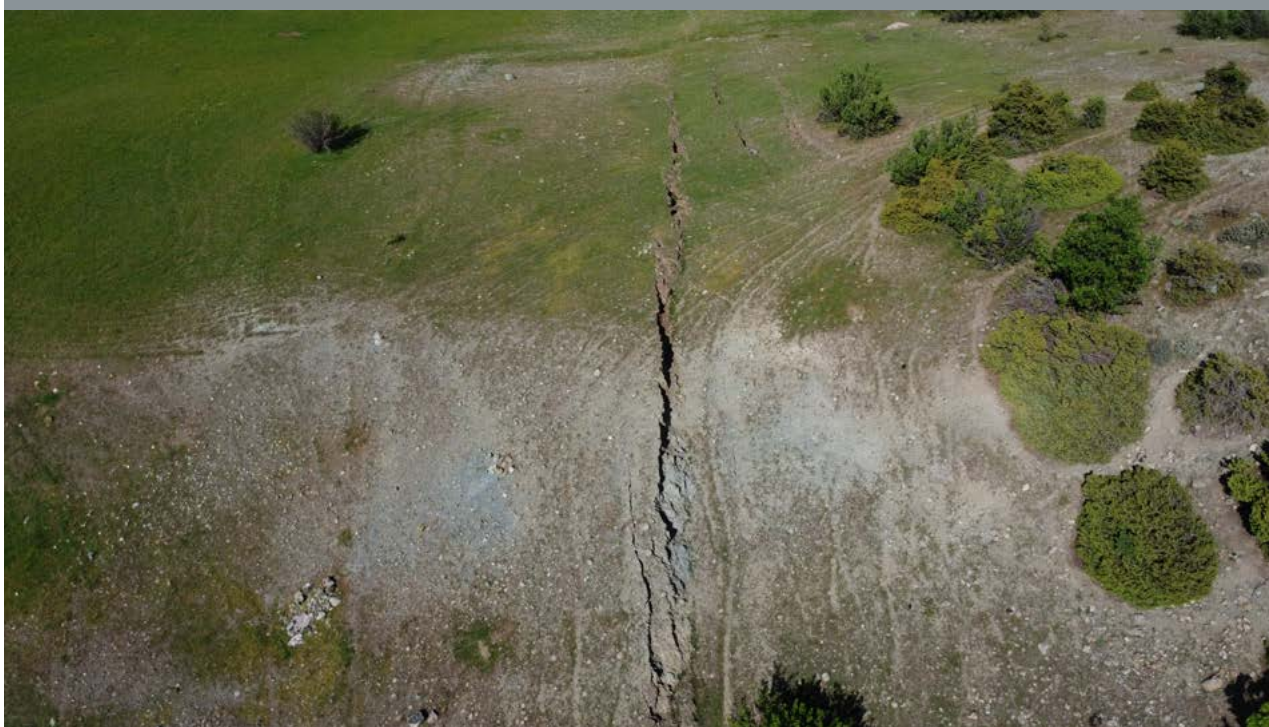
**Photo 60** (37.615957°N, 37.383808°E) – Drone view (from northeast) of the surface rupture characterized by left-lateral displacement of 300 cm and right-stepping strands.

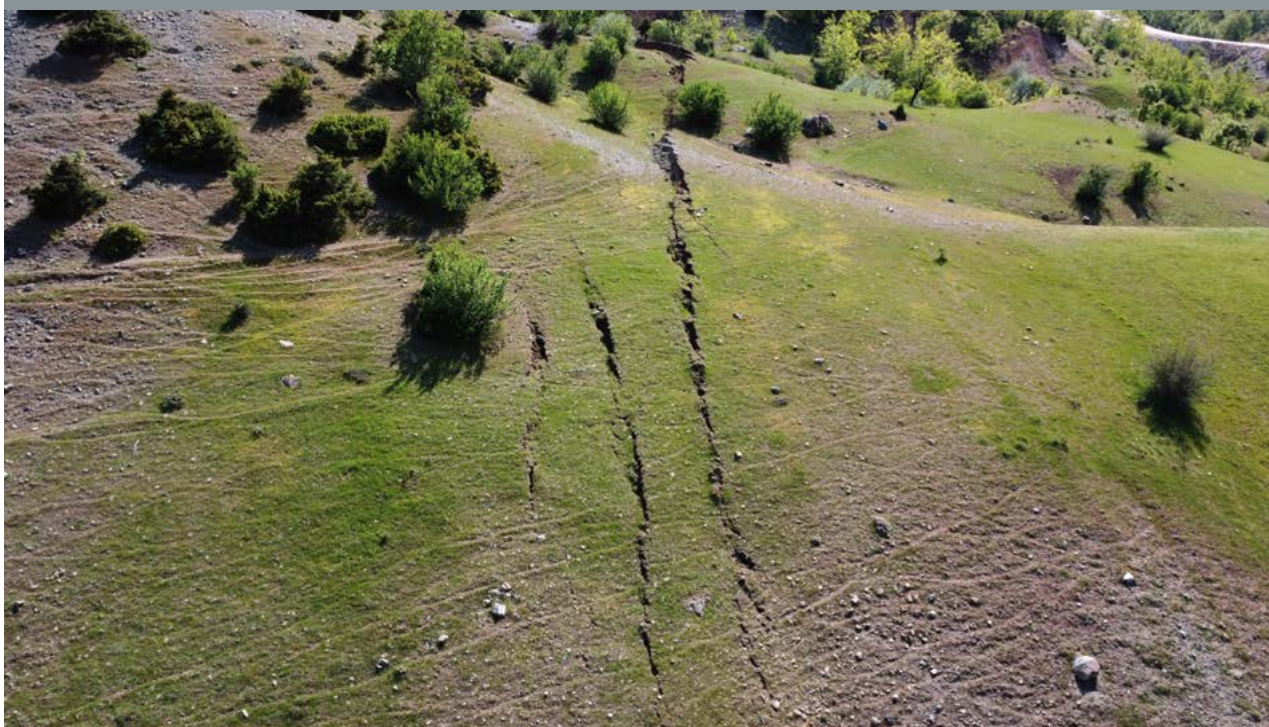
**Photo 62** (37.616531°N, 37.384623°E) – Drone view (from northeast). 8.5 m-wide right step of the coseismic surface rupture through en-echelon parallel strands.

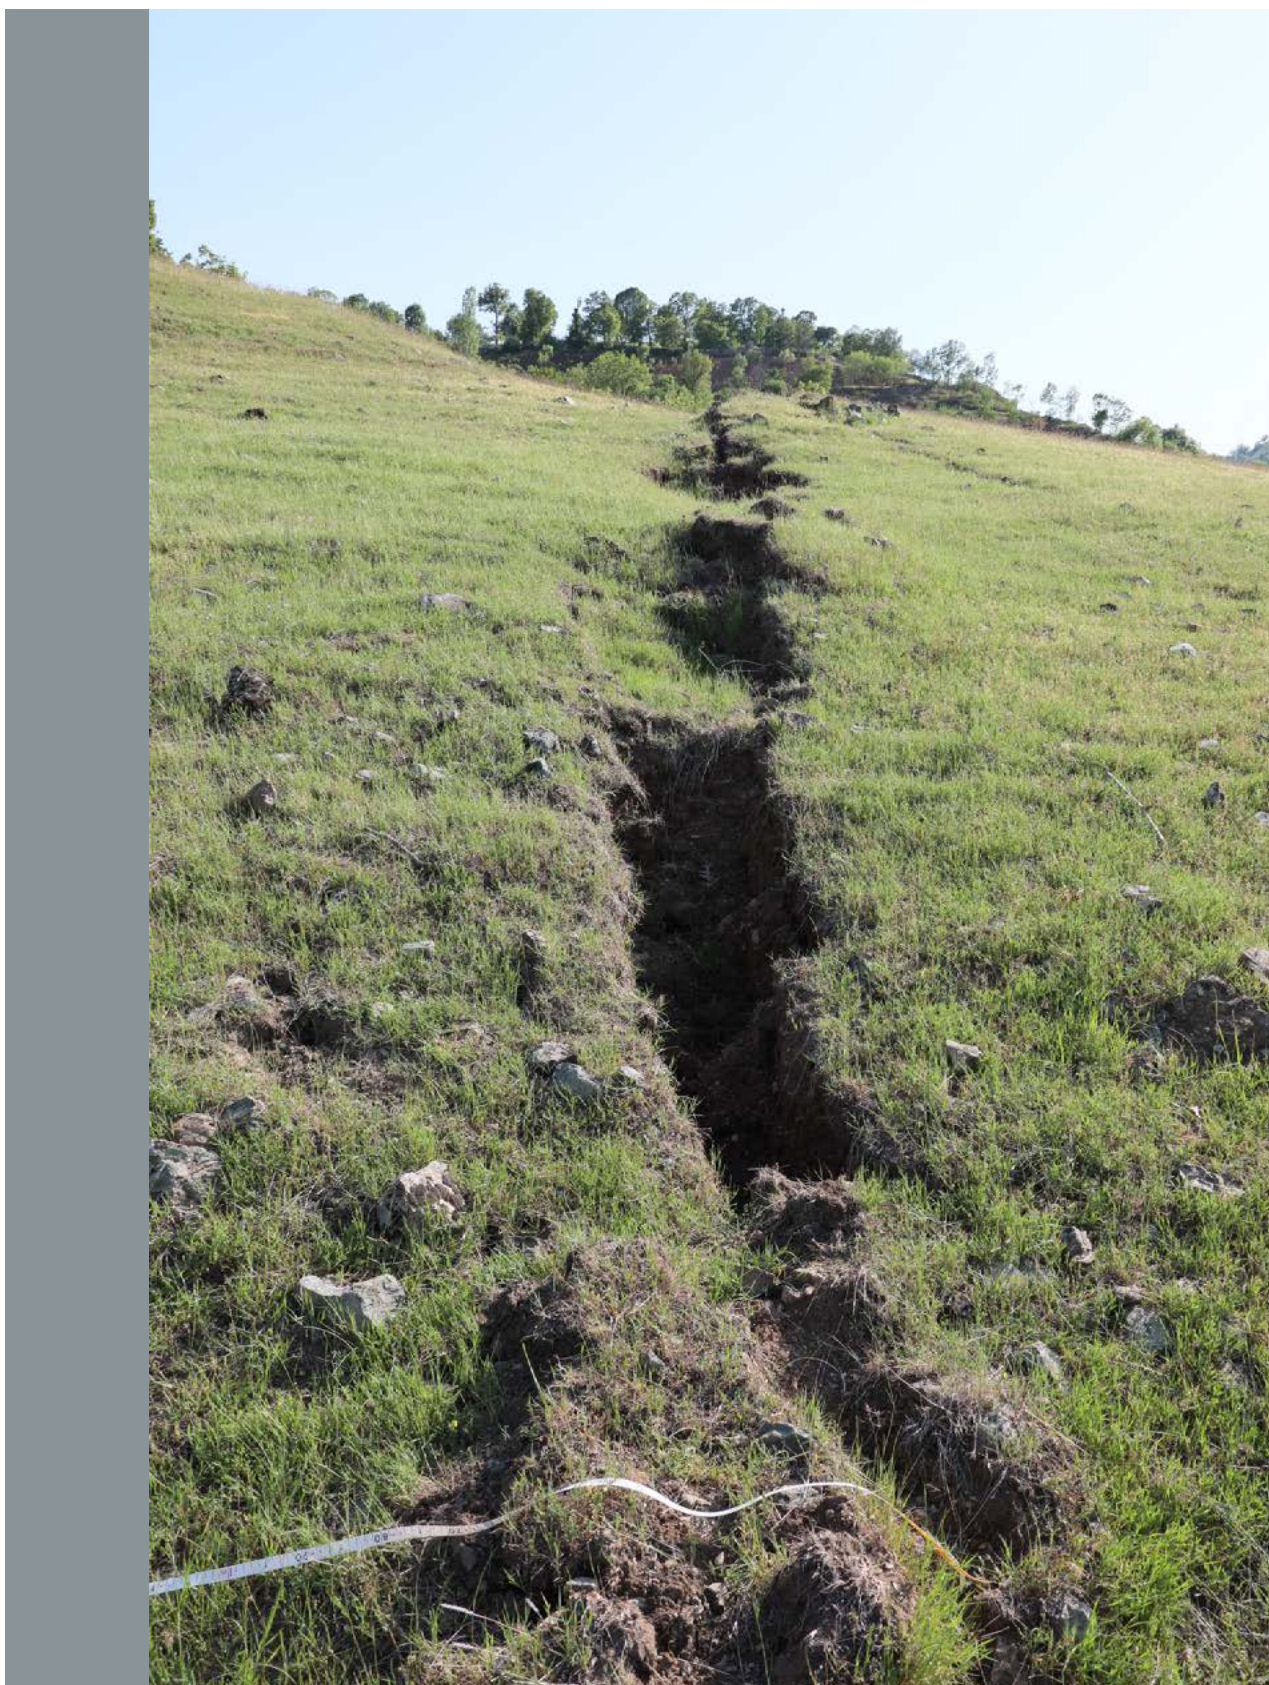
**Photo 64** (37.616343°N, 37.384361°E) – Detail of a coseismic mole-track (view from northeast) where the right-stepping Riedels present an opening component of 30 cm.

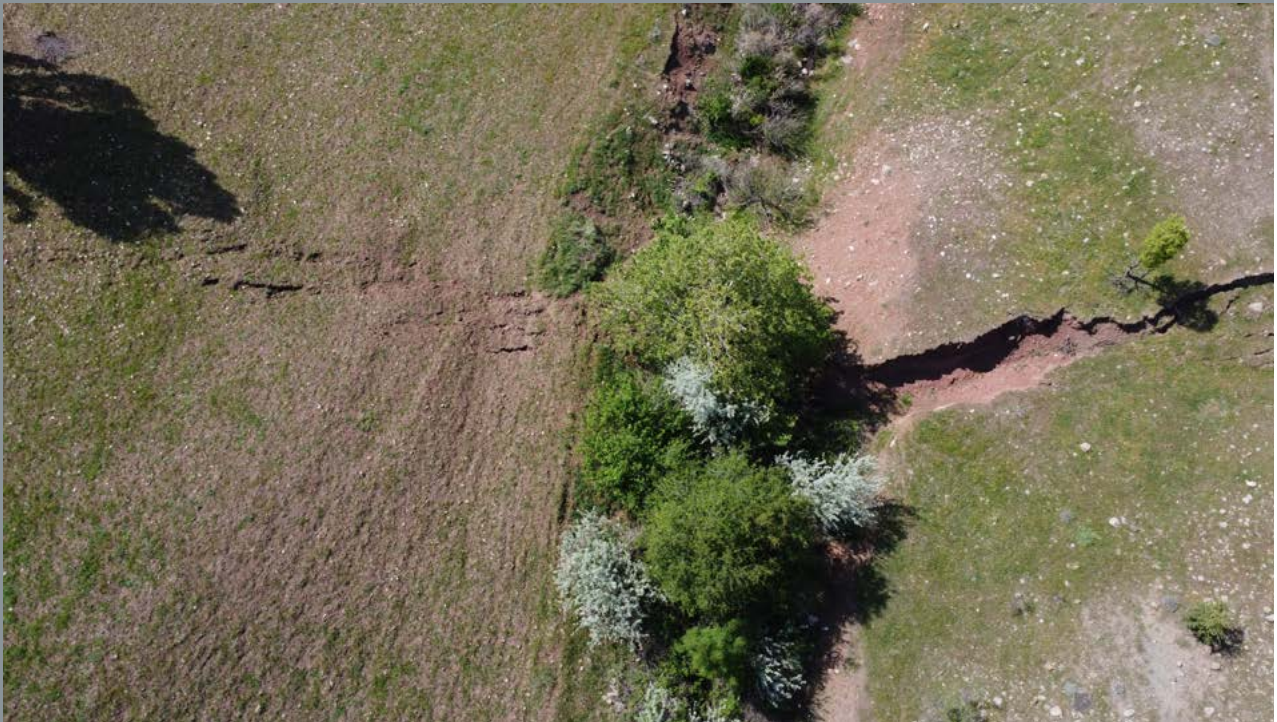
**Photo 65** (37.616735°N, 37.385413°E) – Azimuthal drone view of the coseismic rupture. A 370 cm offset of the transtensional Riedel (right) forms a meters-wide graben; conversely, a right bend in the rupture trace produces a mole-track dominated by push-ups (left).

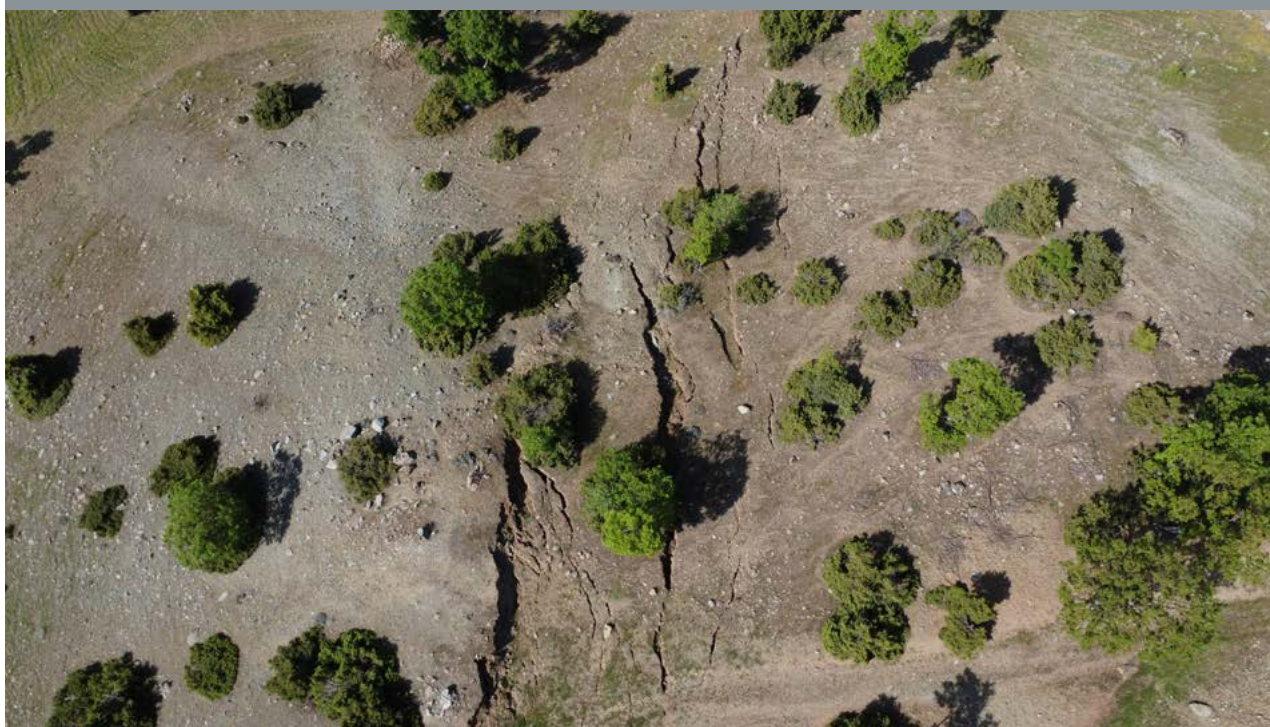
Photo 66 (37.617402°N, 37.386010°E) – Typical extensional-dominated transtension defining a negative flower structure composed of right-stepping en-echelon grabens.

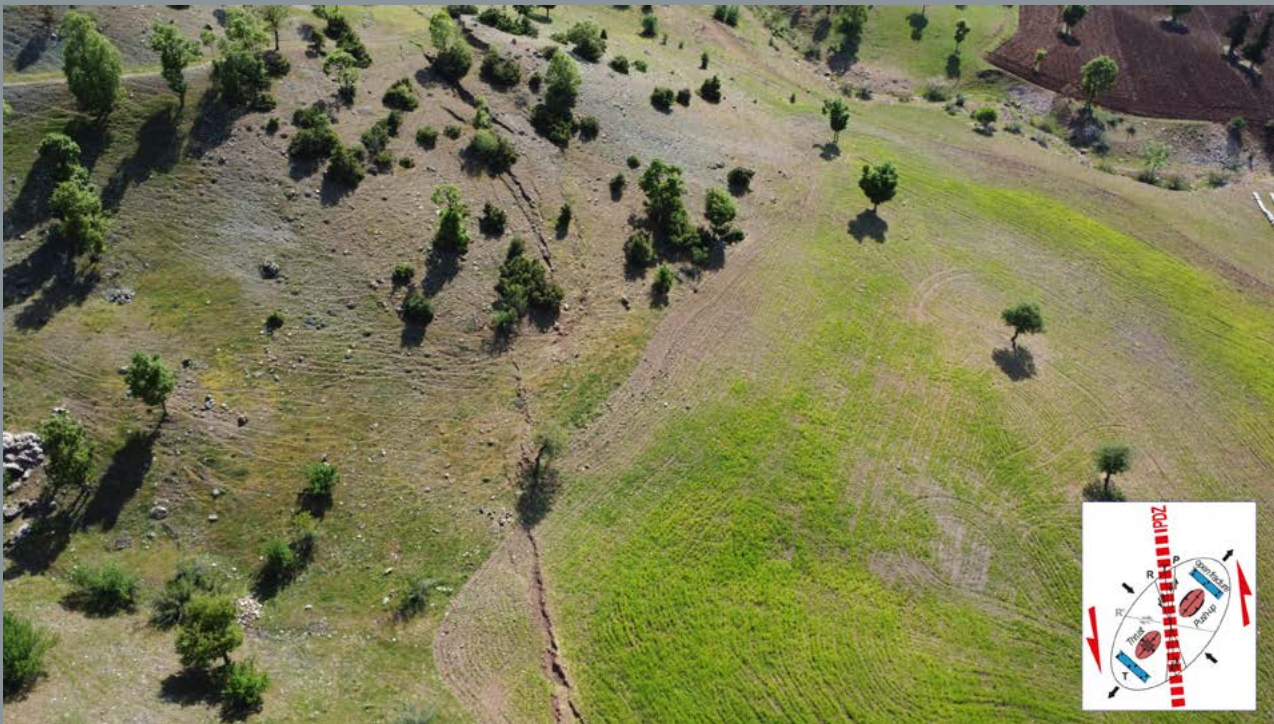
**Photo 67** (37.618305°N 37.387104°E) – Panoramic view (NE to SW) of coseismic ruptures (photos 62–66). Note the counterslope downthrowing and along-strike variability, featuring (bottom to top): pure strike-slip Y-shears, push-ups, and en-echelon Riedel shears with tensional grabens. Inset: theoretical rupture typology from infinitesimal plane strain (symbols/sketch in Figure 2); non-observed typologies are opacified.

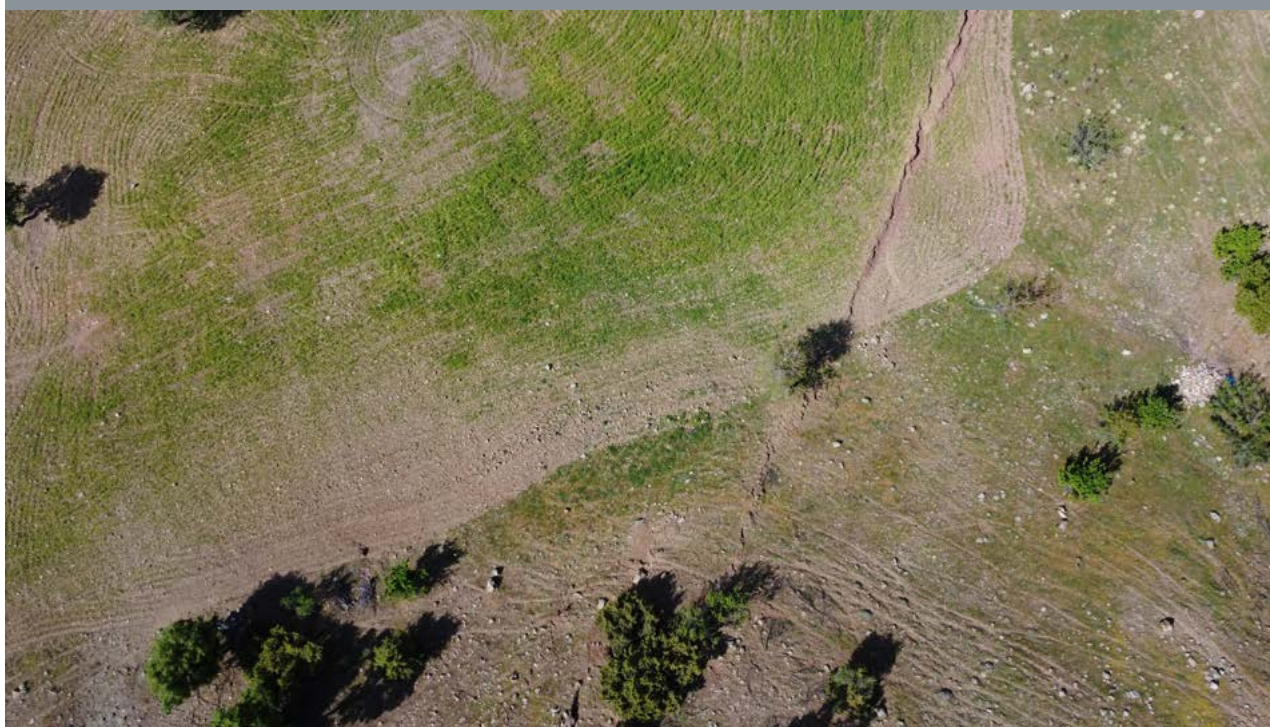
**Photo 68** (37.617806°N, 37.386329°E) – Drone view of the narrow coseismic rupture pattern along a straight Y-shears. Note the left-lateral displacement of the field's border.

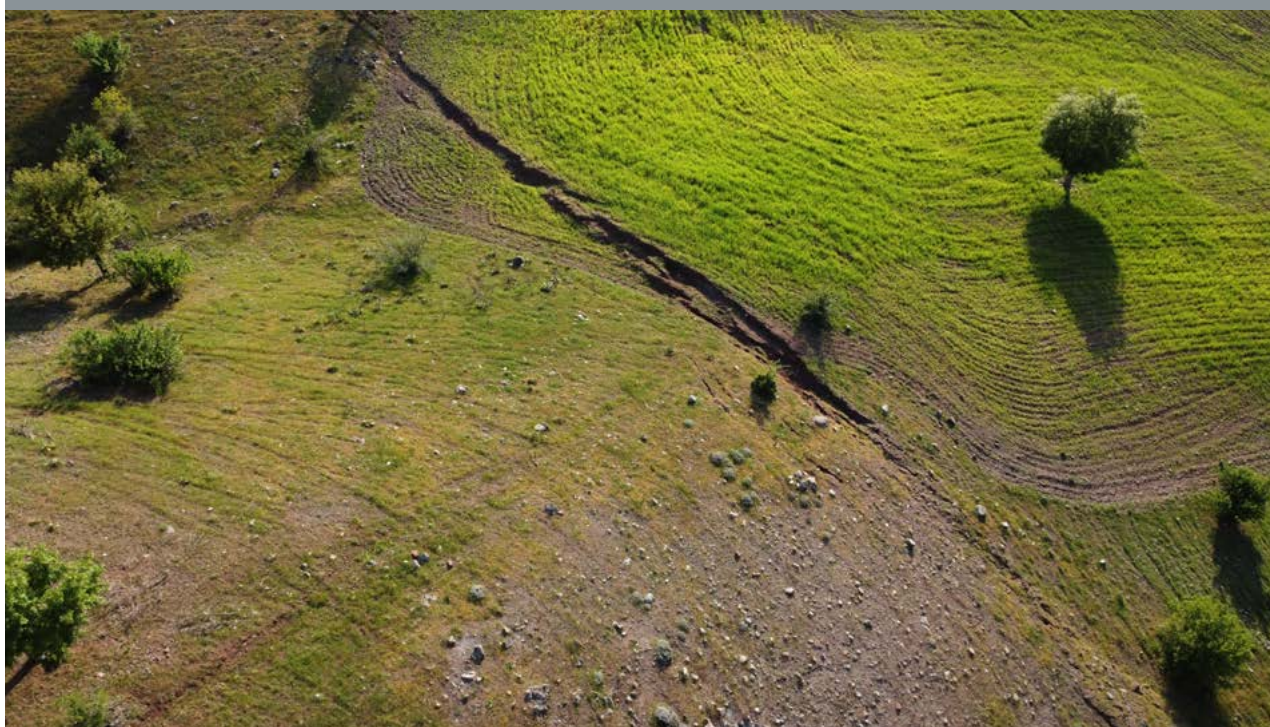
**Photo 70** (37.618113°N, 37.387282°E) – Drone view (from east) of the Y-shear. The rupture pattern presents small complexities here characterised by narrow branching into parallel strands enclosing short Riedel shears.

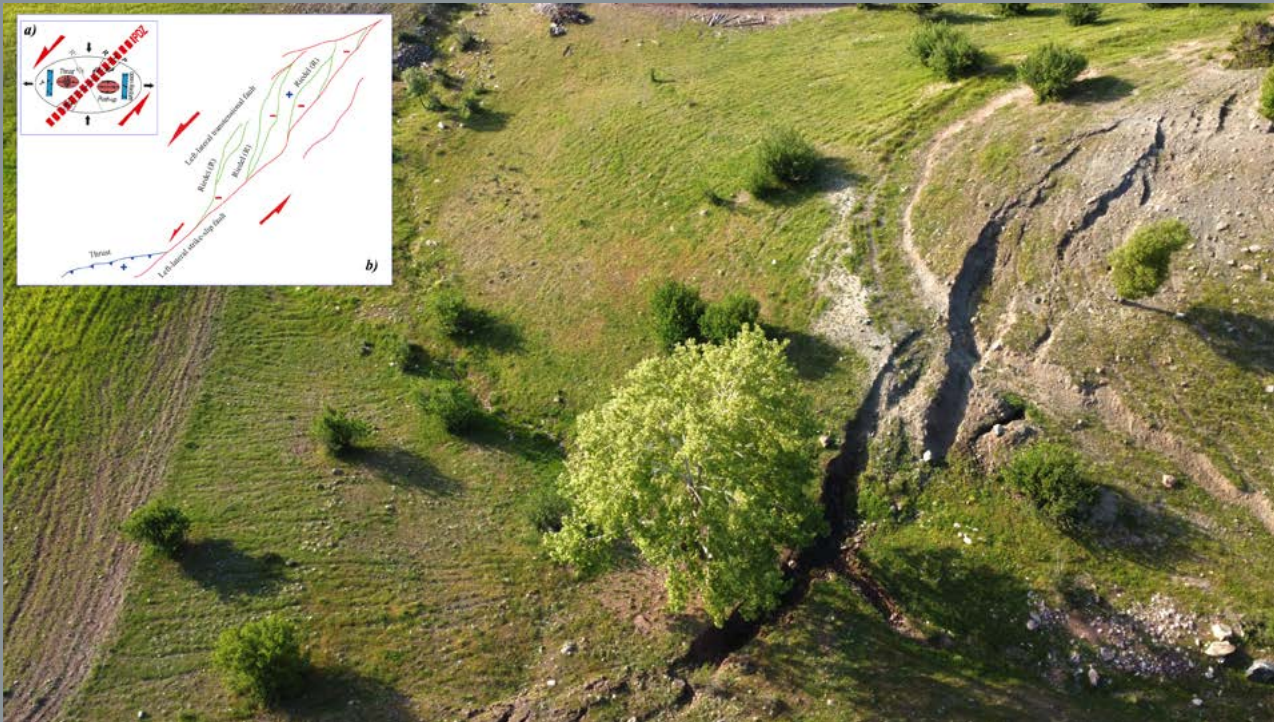
**Photo 73** (37.618230°N, 37.387288°E) – Azimuthal view of the fault trace characterised by dominant en-echelon right-stepping grabens of a left lateral transtensional fault. In the box: a) the theoretical typology of ruptures from infinitesimal plain strain. The ruptures not visible in the photo are made opaque (See Figure 2 for the symbol explanation); b) sketch map of the typology of ruptures.

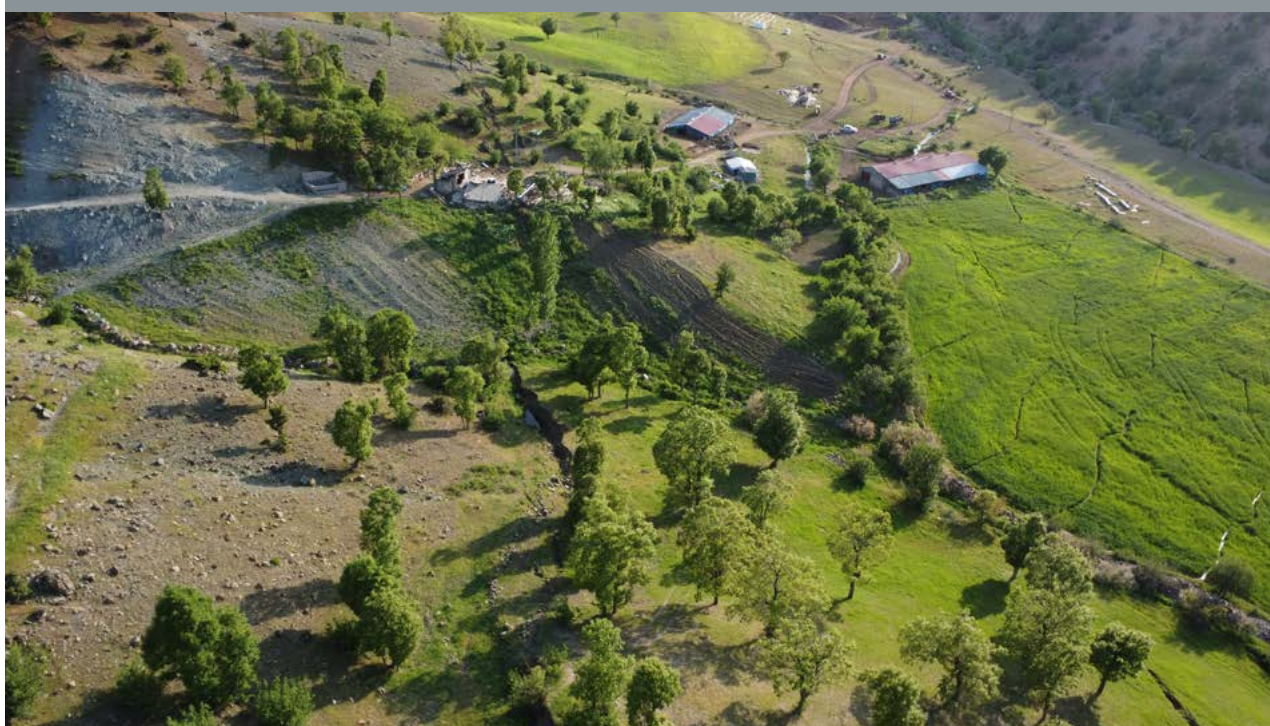
**Photo 78** (37.620463°N, 37.389613°E) – Drone view (from northeast) of the coseismic rupture.  
Note the collapsed farm shown in the previous photo.

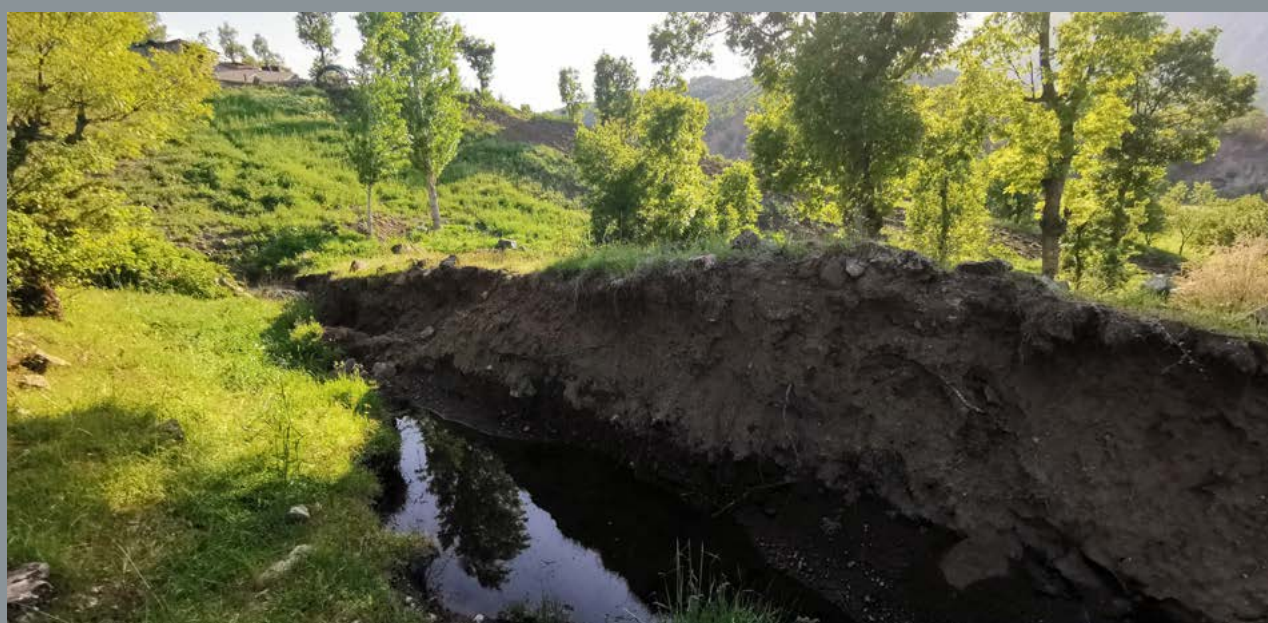
**Photo 79** (37.619827°N, 37.388798°E) – Detail of the coseismic dislocation shown in the previous photo. At this site, a net left-lateral offset of 320 cm was recorded, the important apparent vertical offset together with the coseismic graben induced a stream piracy, forming a natural pool.

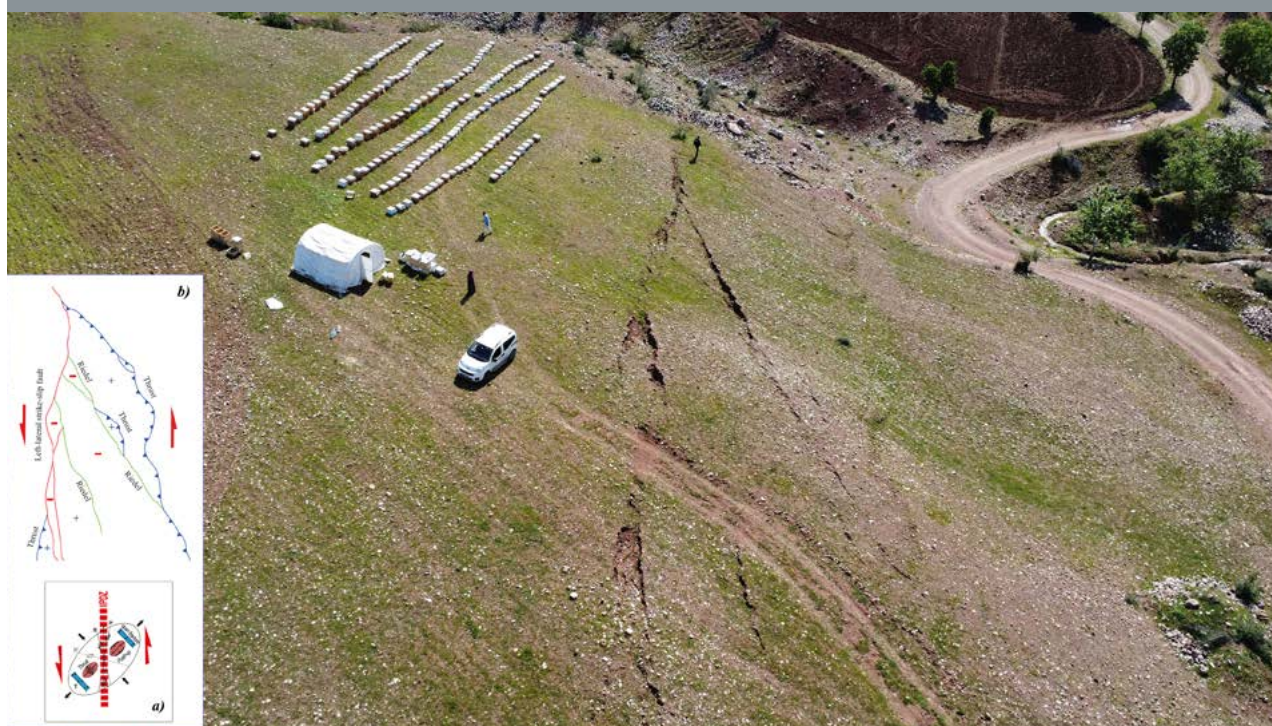
**Photo 80** (37.619048°N, 37.385829°E) – Drone view (from SE) of parallel rupture strands (~300 cm left-lateral displacement). The decametric deformation zone comprises a ground flexure (faint thrust component, on the right), a left-lateral strike-slip zone with alternating grabens and push-ups (on the left), and connecting en-echelon right-stepping Riedel shears. The assemblage forms a gentle positive flower structure. Inset: a) theoretical rupture typology from infinitesimal plane strain (non-observed typologies opacified; see Figure 2 for symbols); b) rupture typology sketch map.

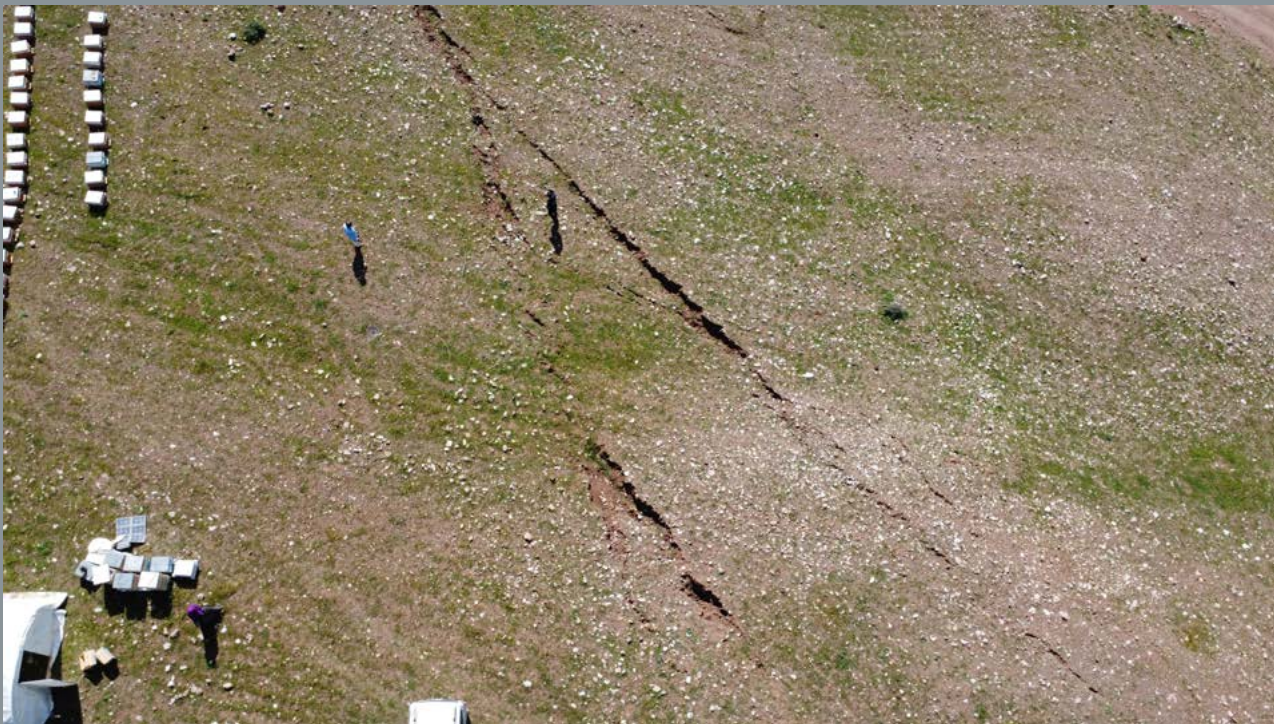
**Photo 81** (37.618793°N, 37.385469°E) – Detail (azimuthal view) of the oblique en-echelon right-stepping Riedel shears connecting to the left-lateral strike-slip. Usually, the junctions express increasing features with transtensional character.

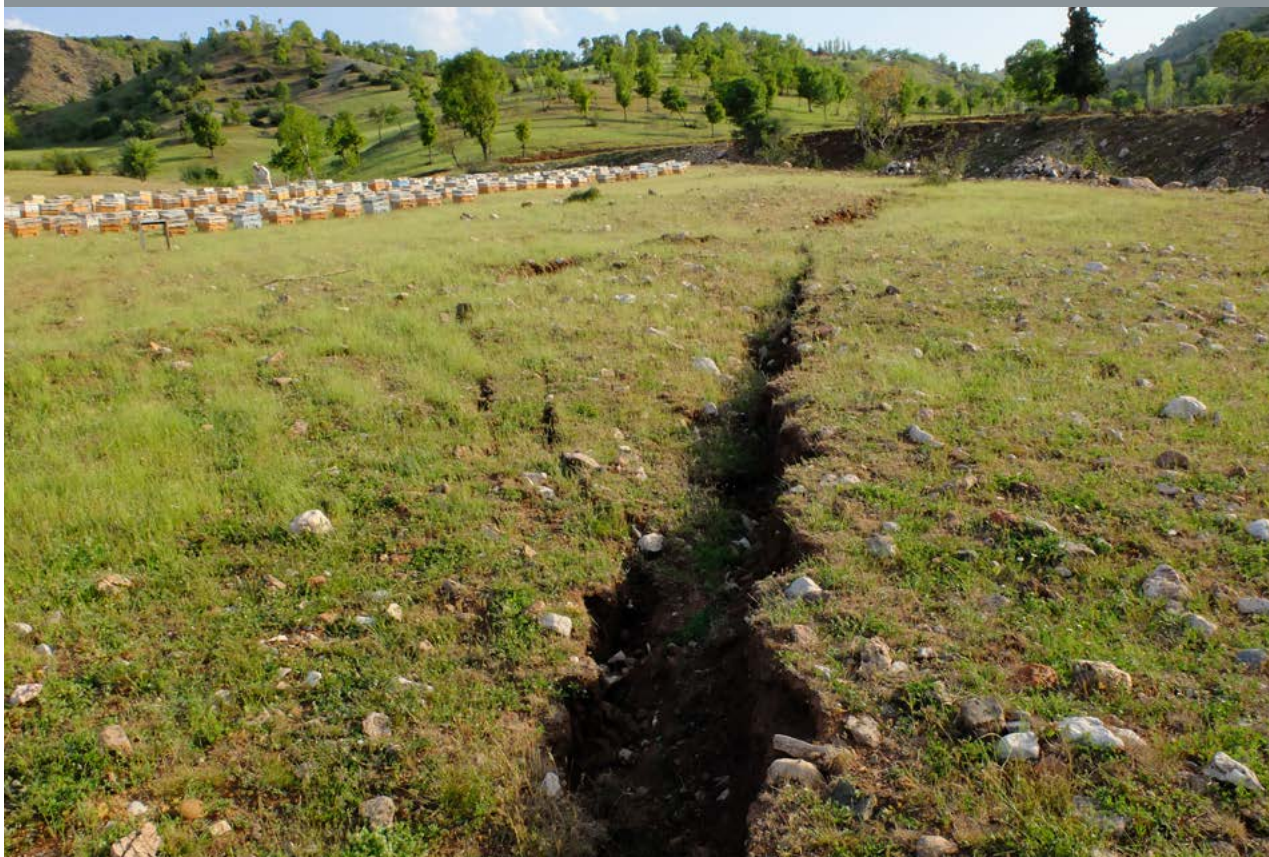
**Photo 82** (37.618856°N, 37.385382°E) – Particular of the oblique en-echelon Riedel shear in the previous photo.

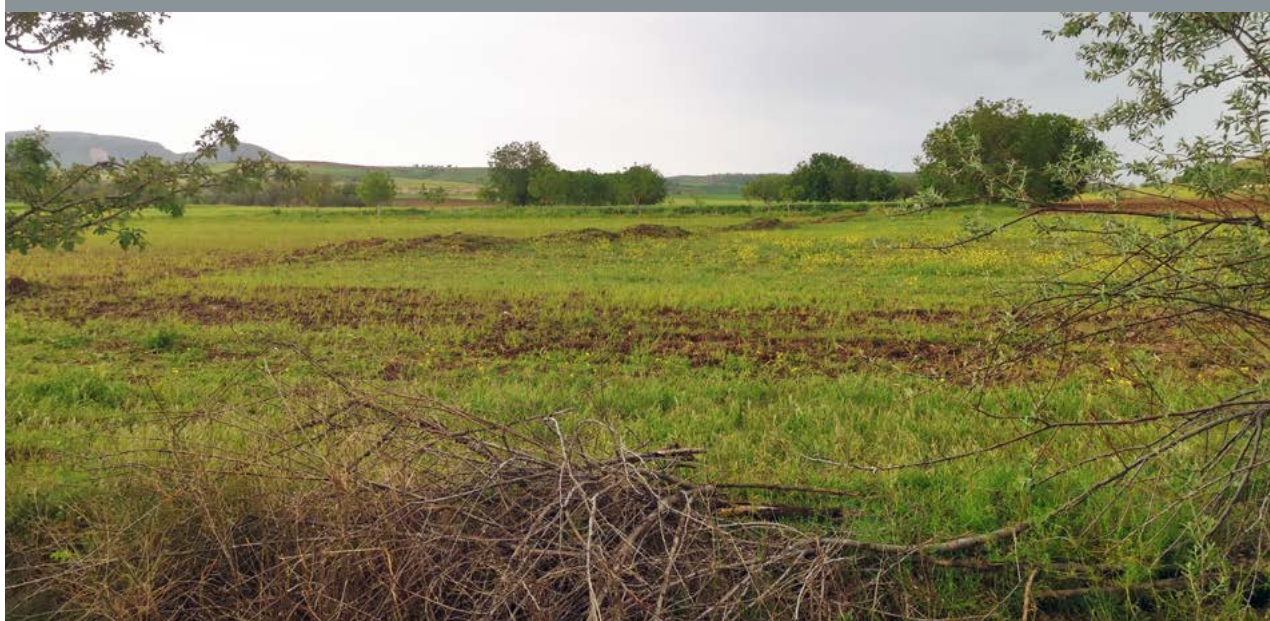
**Photo 83** (37.726267°N, 37.548959°E) – Panoramic view (from north) of the coseismic mole-track with widespread presence of the push-ups that testify to an increased transpressional kinematics.

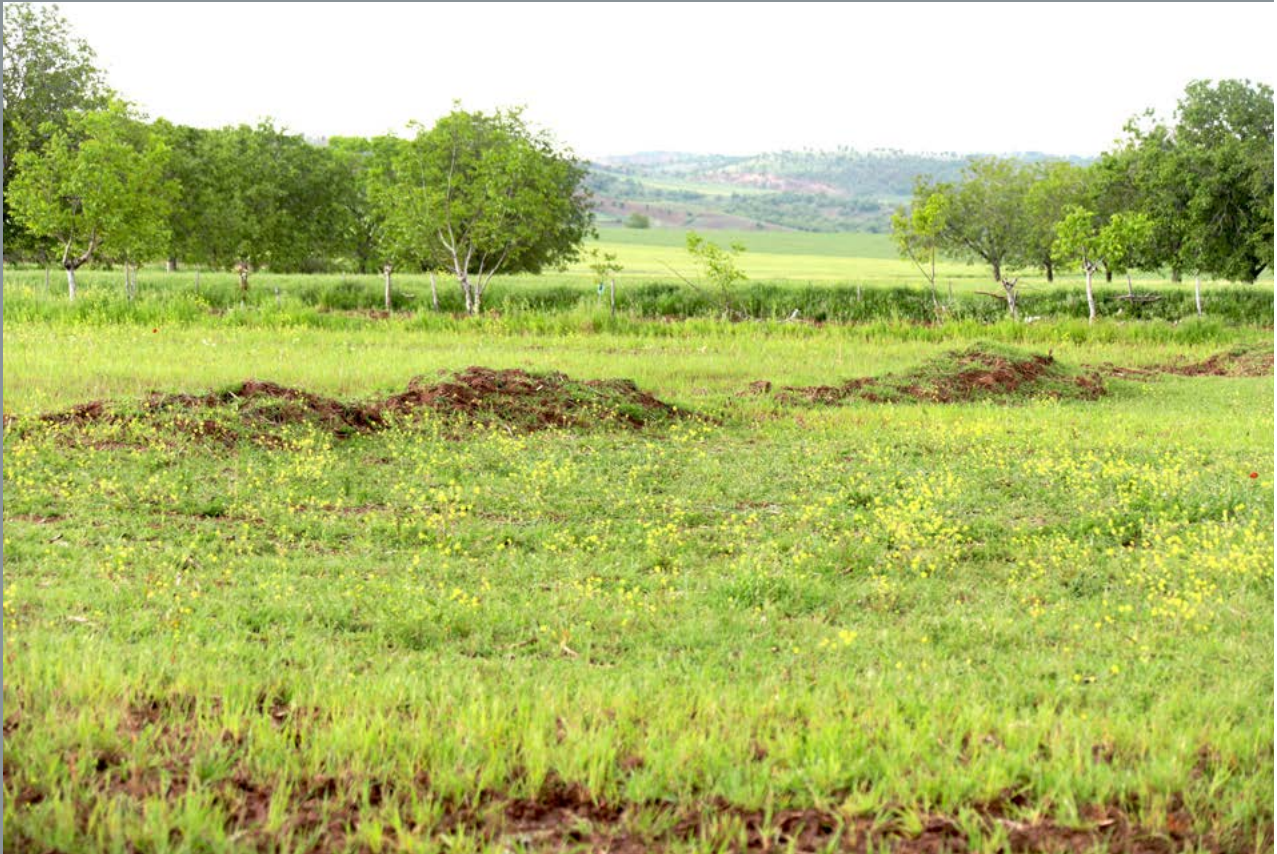
**Photo 84** (37.726257°N, 37.549059°E) – Detail of the mole-track.  
The dominant push-ups are expressed as meters-wide turf rolls.
