# MISCELLANEA INGV

A photo and video collection on the  
surface faulting: the Mw 7.8  
Kahramanmaraş (Turkey) earthquake  
of February 6, 2023

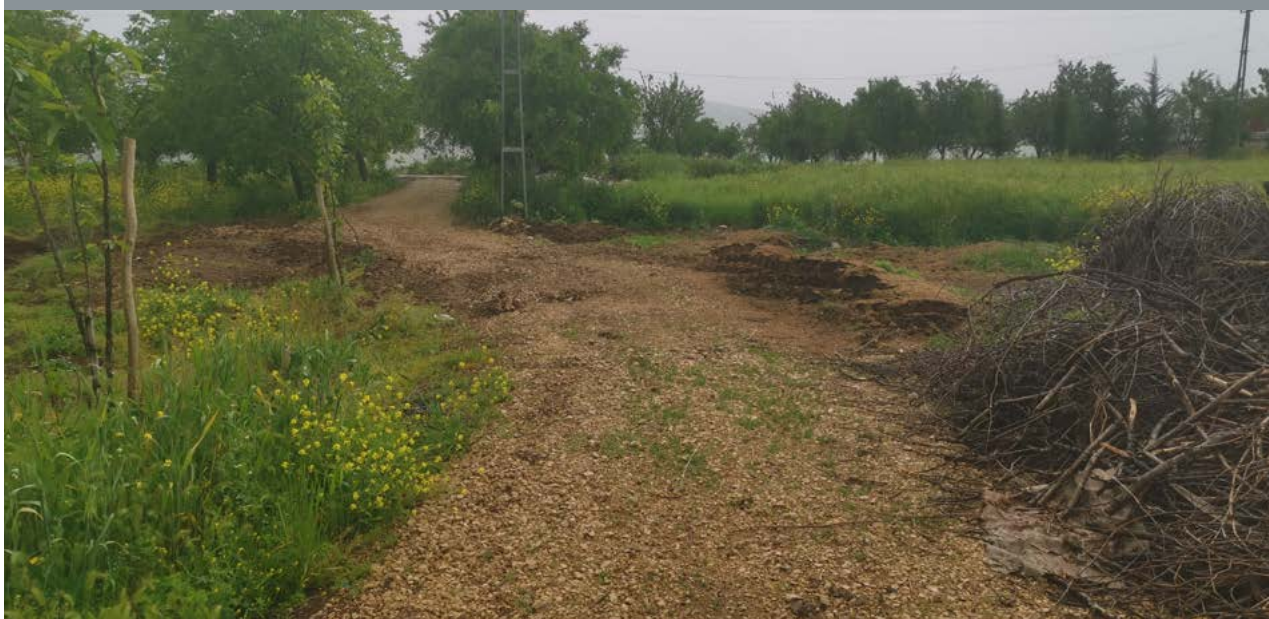
**Photo 89** (37.730082°N, 37.558543°E) – Dirty road deformed at the surface by the coseismic fault rupture (view from southeast): here the left-lateral displacement is 400 cm.

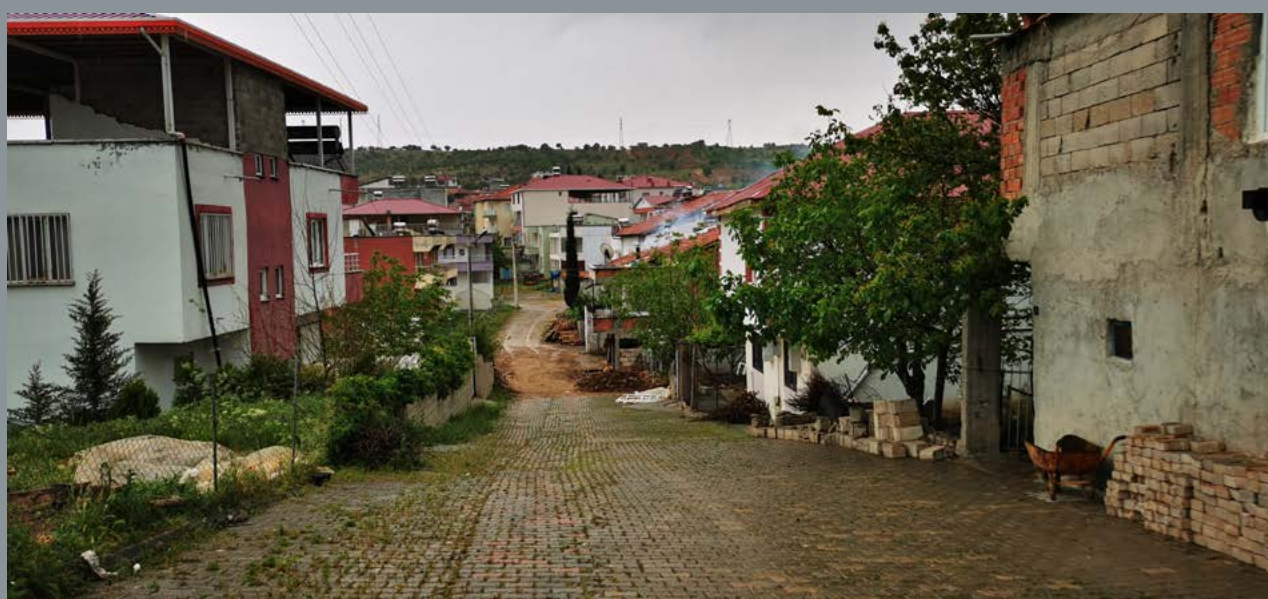
**Photo 90** (37.731386°N, 37.560029°E) – A road dislocated by the earthquake fault in the village of Balkar (view from northwest): most of the severely damaged buildings appear confined to the near-fault area.

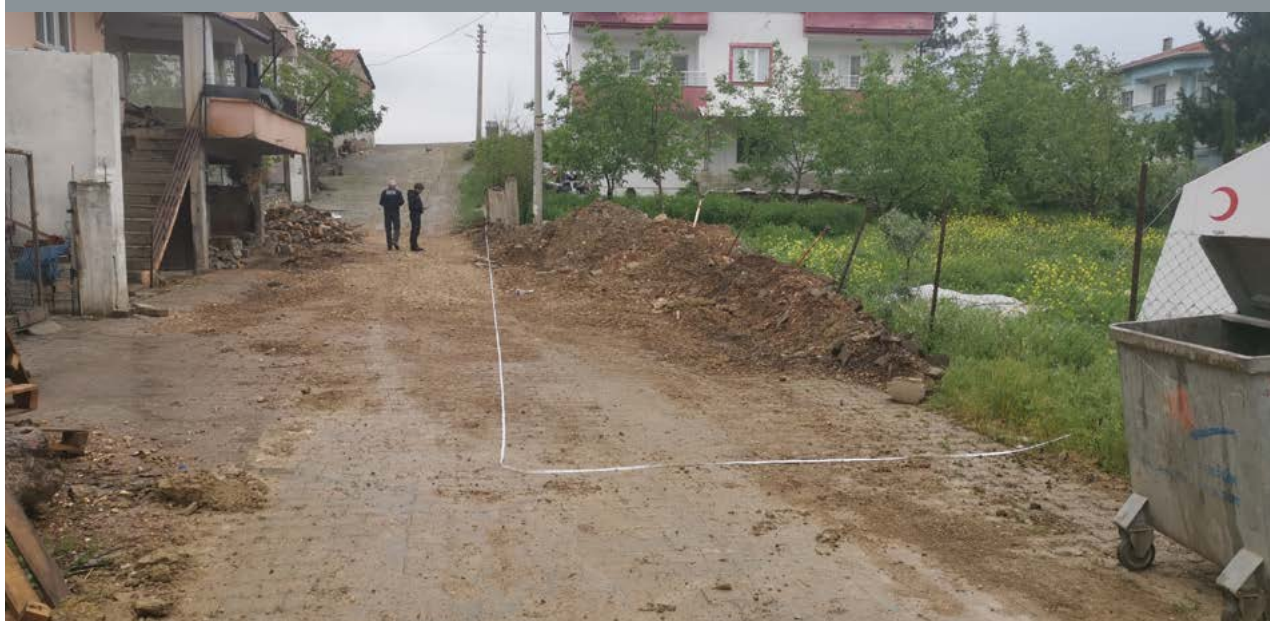
**Photo 91** (37.730973°N, 37.560585°E) – The same road as in the previous photo (view from southeast). The left-lateral offset is 360 cm.

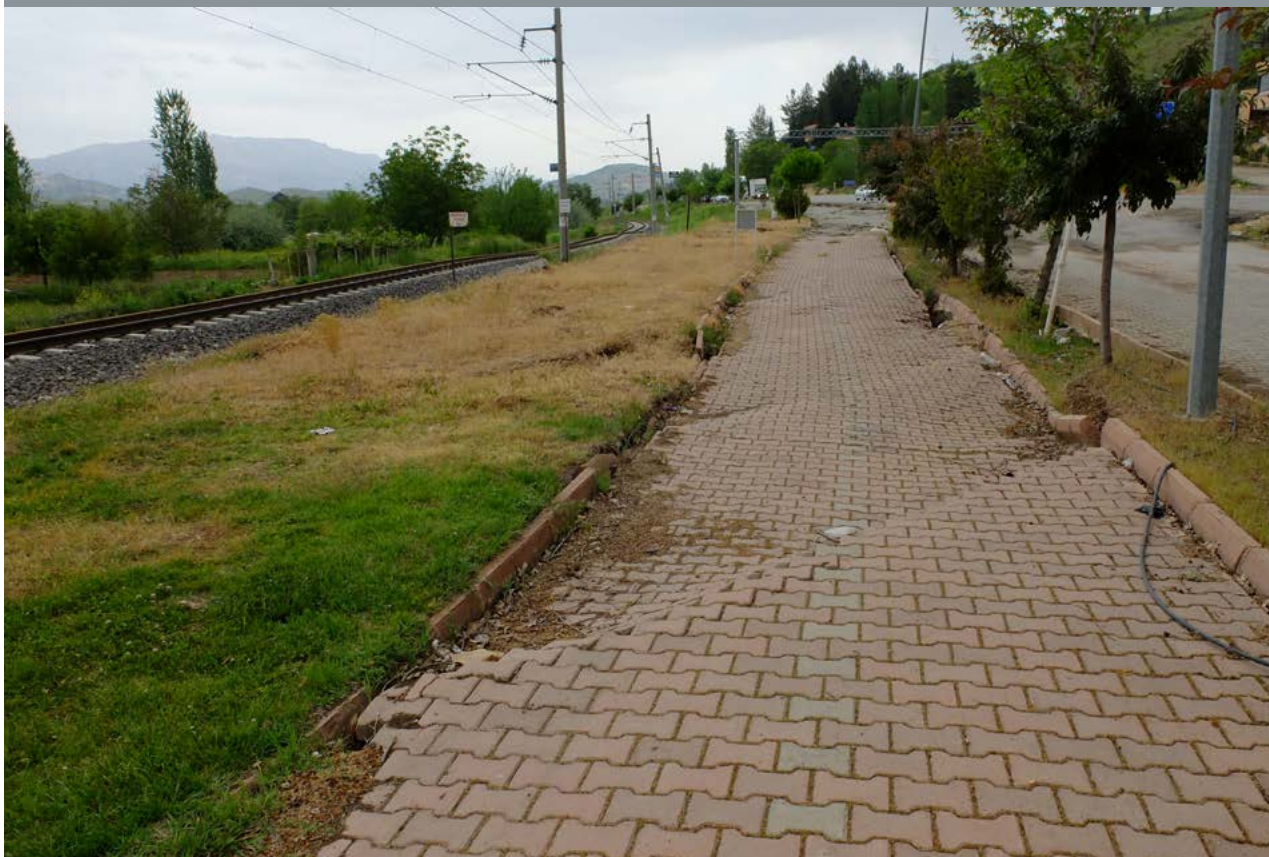
**Photo 92** (37.795348°N 37.659133°E) – Decametric-scale en-echelon Riedel shears affecting a paved sidewalk in the urban area (view from southwest). The deflected centerline recorded the coseismic kinematics and offset partitioning (note the front Riedel accommodating the vertical component).

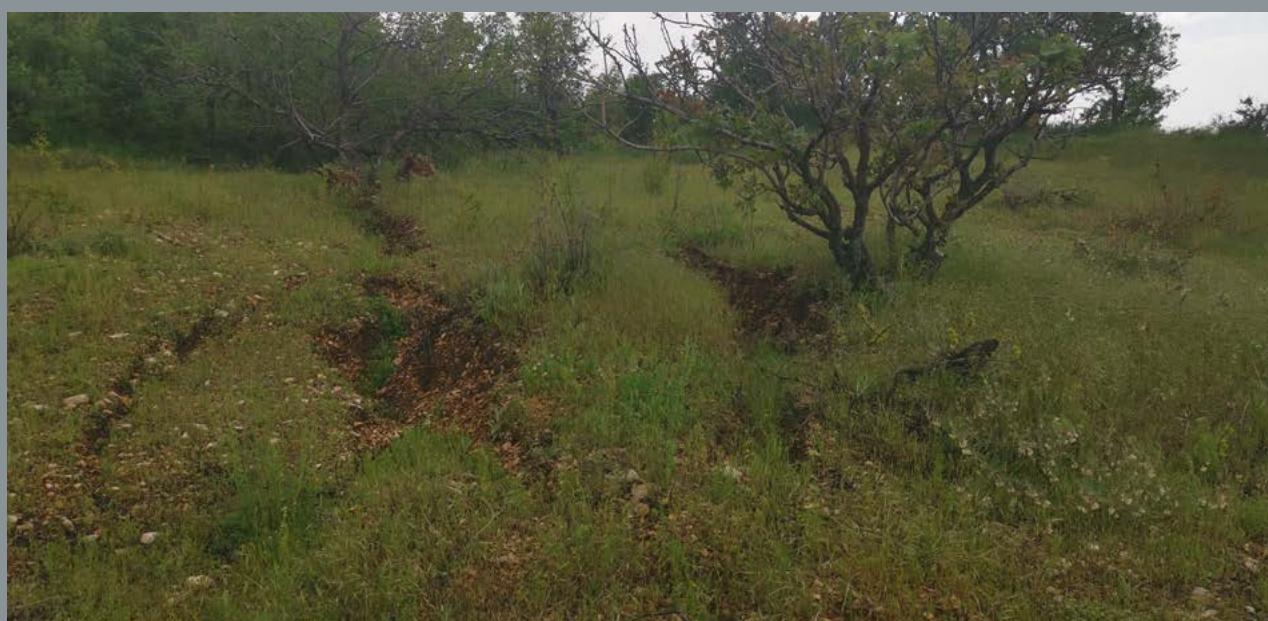
**Photo 100** (37.839629°N, 37.724545°E) – The rupture pattern consists of a set of multiple strands, with right-stepping en-echelon arrangement, composing a ~60 m-wide deformation zone, well outside the photo.

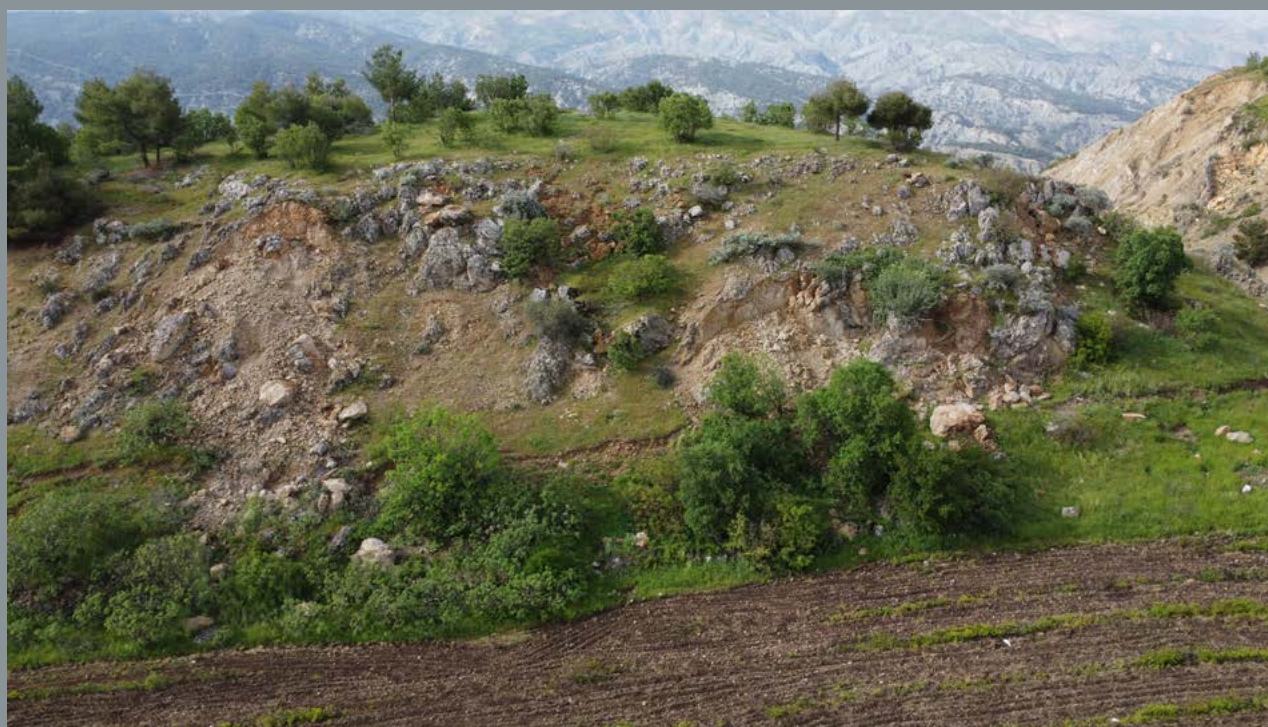
**Photo 102** (37.844537°N, 37.741737°E) – Drone view (from south) of the coseismic rupture at the base of a ridge, representing the long-term expression of the morphotectonic activity of the fault.

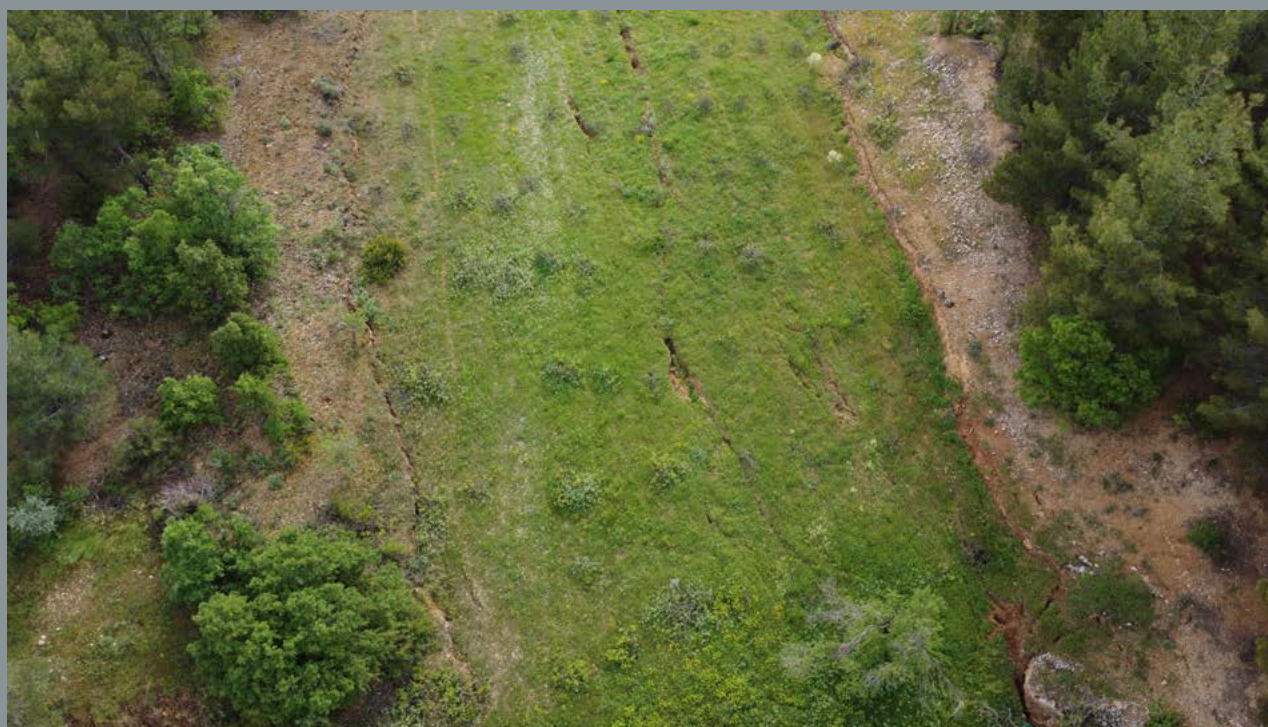
**Photo 104** (37.844673°N, 37.740372°E) – Drone view (from northeast) of the same area. Here, the main transtensional rupture (on the right) and its antithetic structure generate a graben crossed by Riedel structures and tensional cracks defining a negative flower structure.

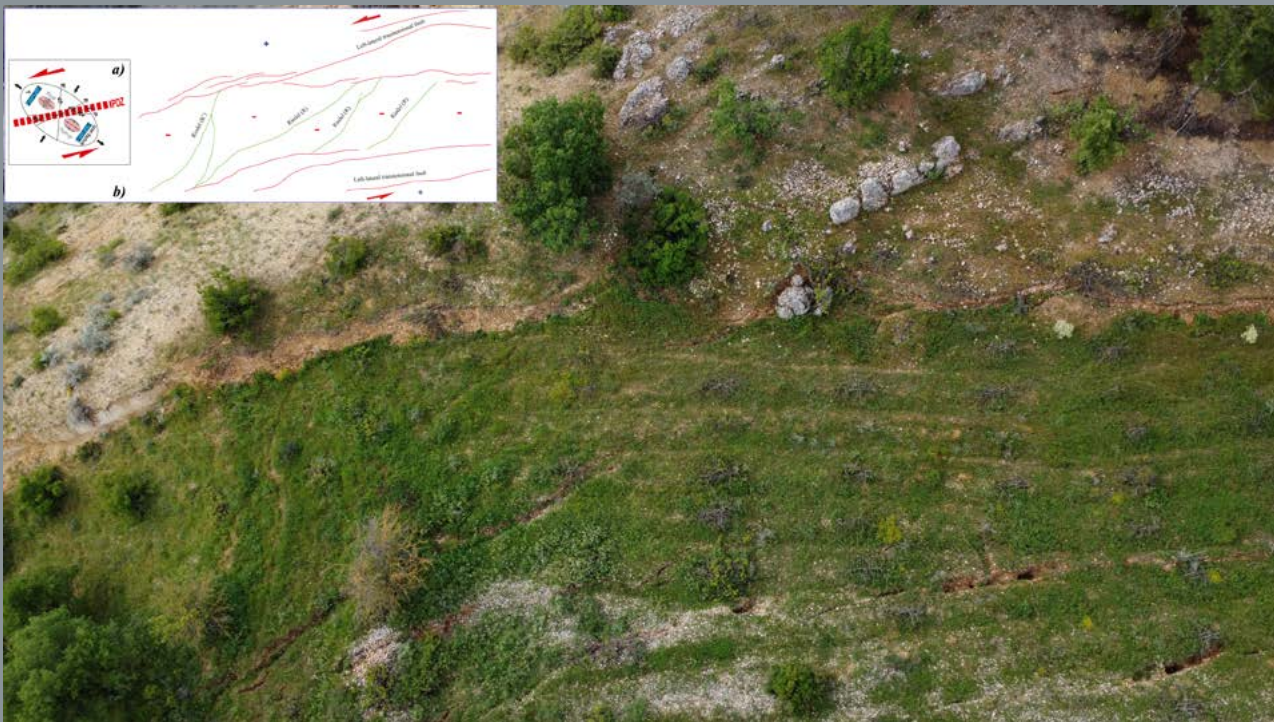
**Photo 106** (37.844488°N, 37.739743°E) – Another drone view (from south) of the main transensional rupture (top) bounding the graben. On the left is visible a free face on the limestones exposed in the footwall. In the box: a) the theoretical typology of ruptures from infinitesimal plain strain. The ruptures not visible in the photo are made opaque (See Figure 2 for the symbol explanation); b) sketch map of the typology of ruptures.

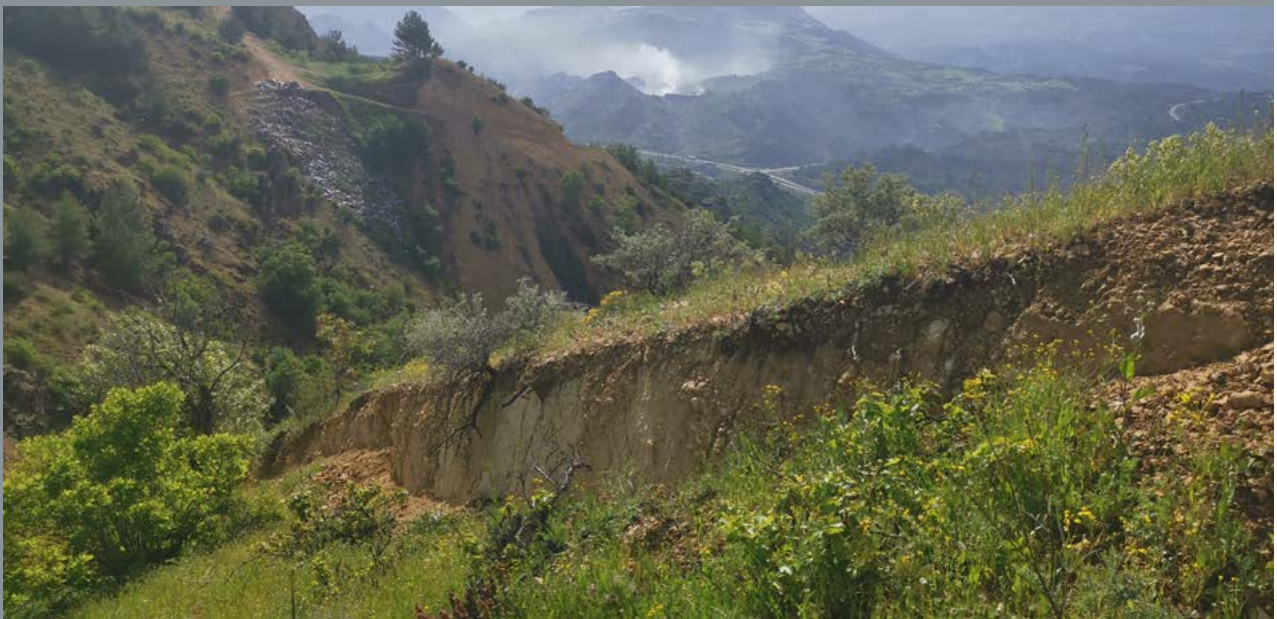
**Photo 108** (37.844503°N 37.739303°E) – The coseismic rupture (at front) runs inside transversal valley and dislocates the opposite slope in the background (view from east). Note the fault's long-term expressions: the contact of different lithologies and the control on the hanging saddle.

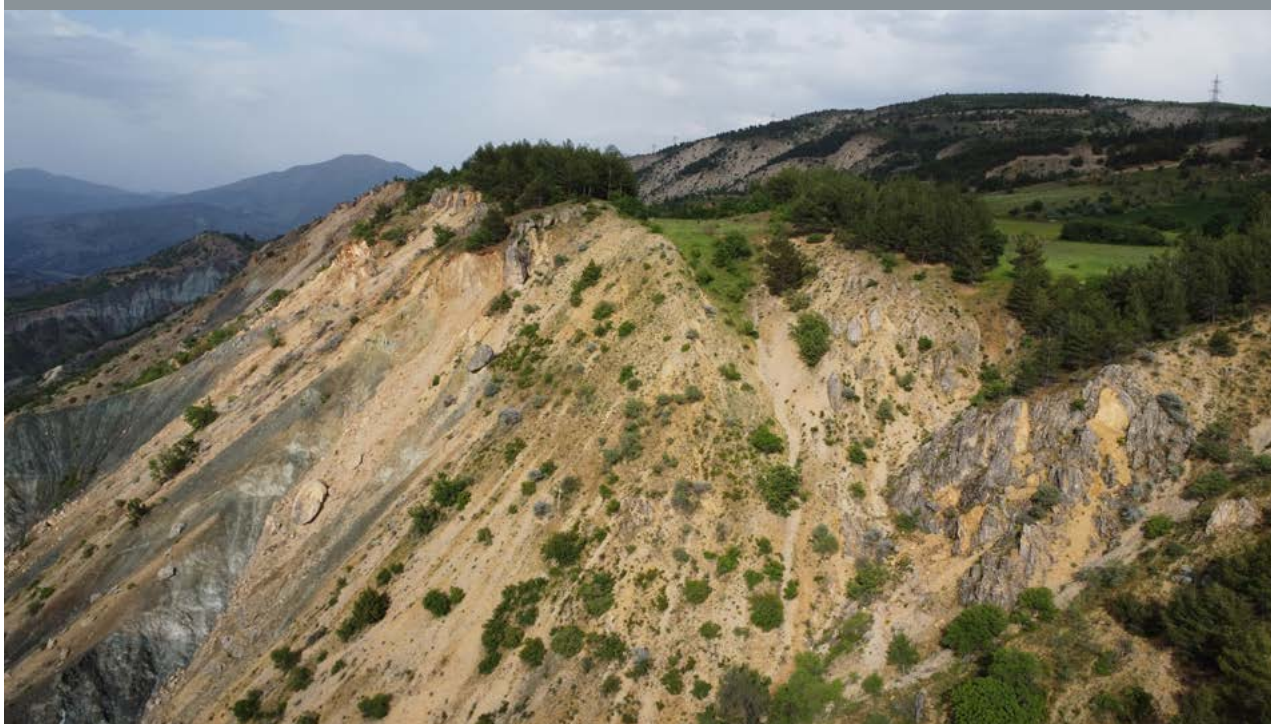
**Photo 109** (37.844453°N, 37.737365°E) – Drone view (looking west from the valley axis) of the area shown in photographs 103-107: note the grassy triangle that identifies the graben formed by the negative flower structure.

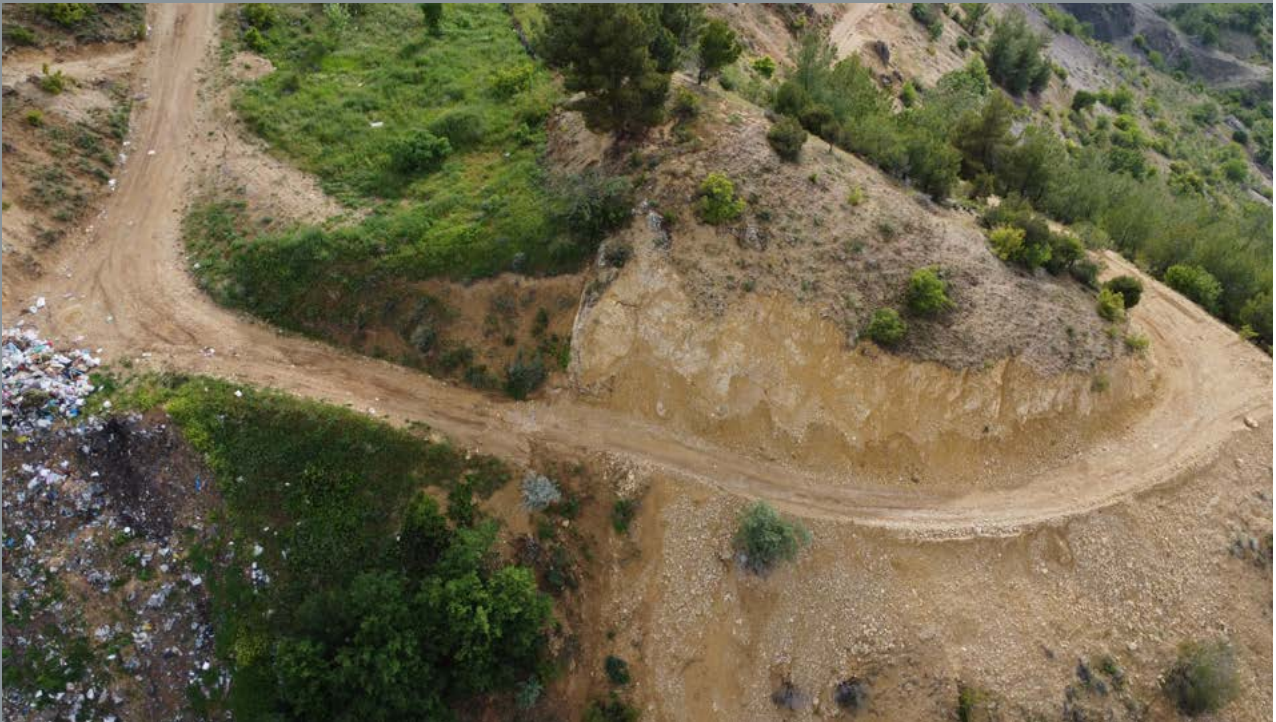
**Photo 110** (37.844465°N, 37.737251°E) – Detail of the coseismic rupture running along the saddle shown in photograph 108: note the left-lateral displacement on the dirt road (offset 230 cm) and the tectonic contact between different lithologies.

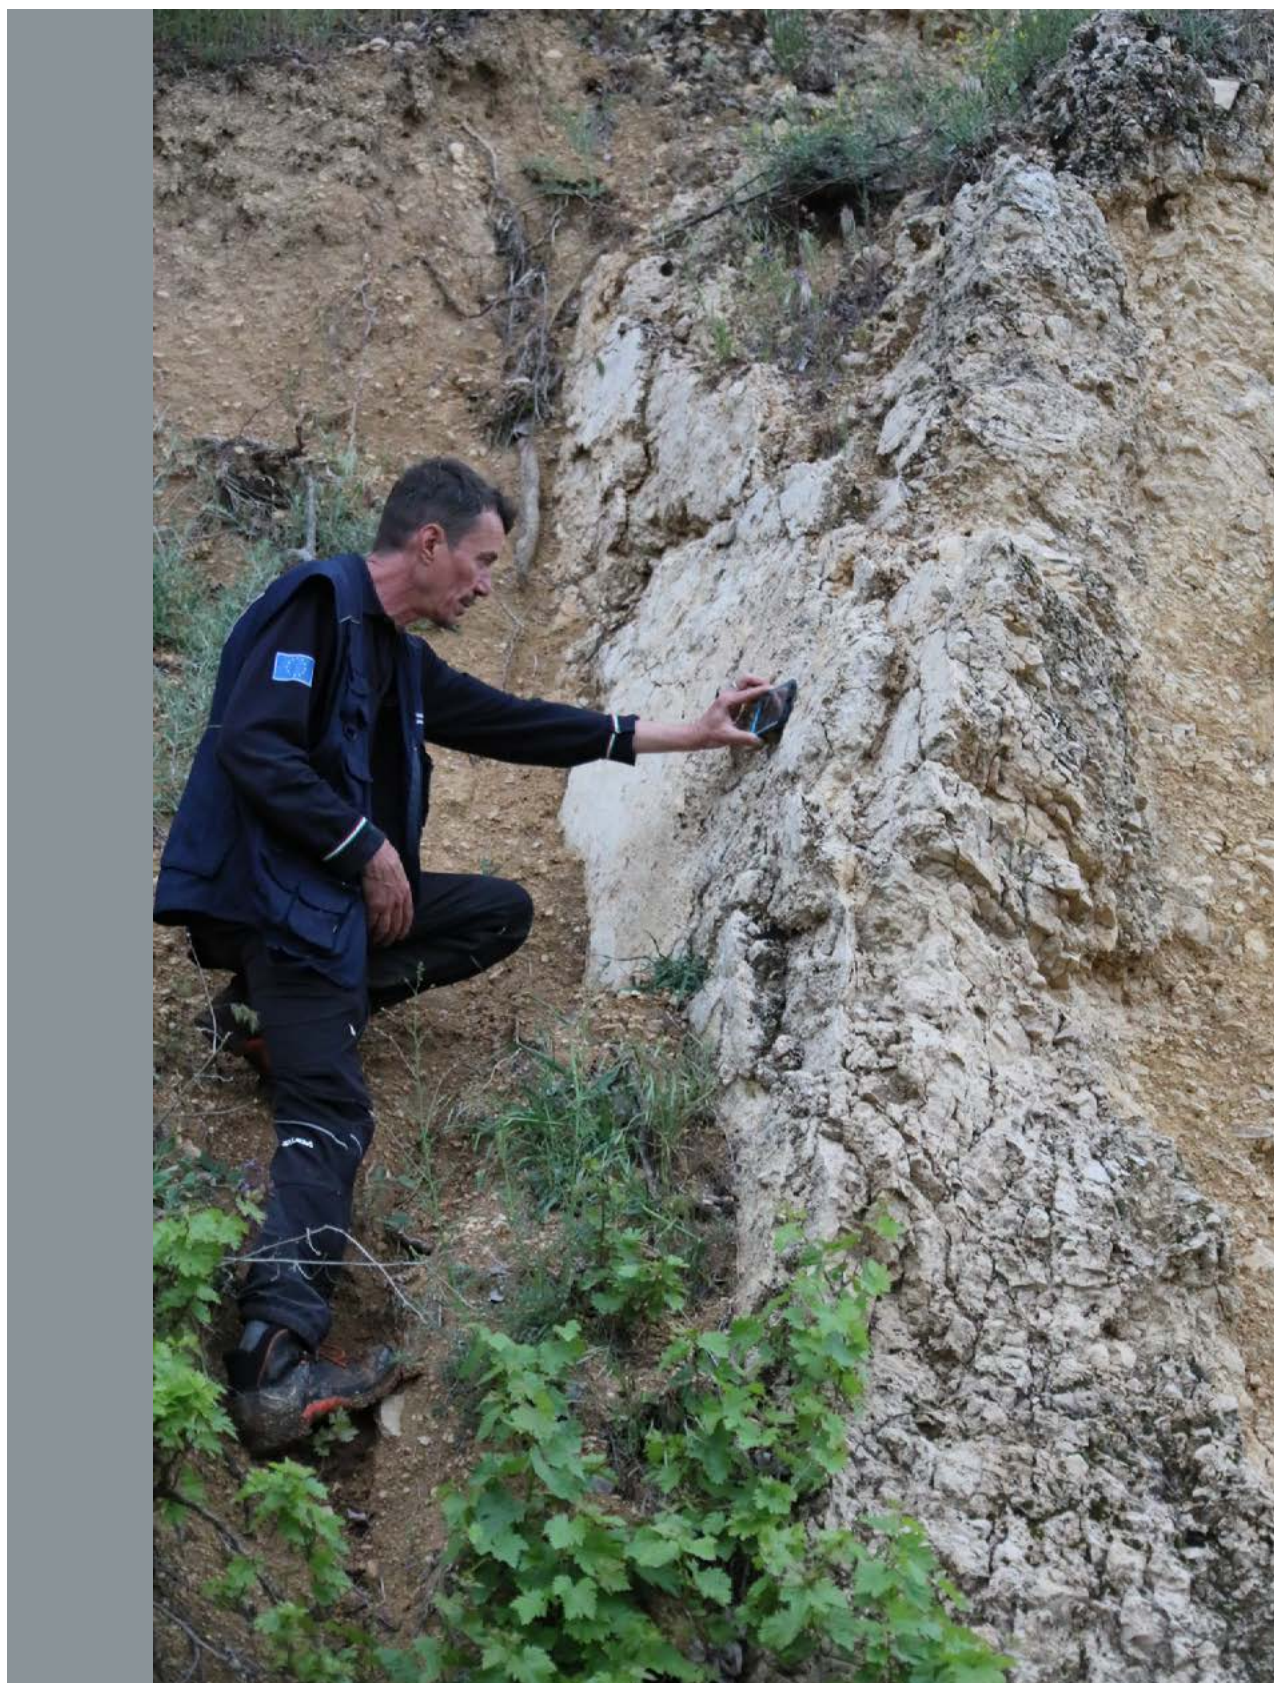
**Photo 111** (37.844283°N, 37.736895°E) – Detail of the limestones slickenside affected by coseismic slip (same surface rupture shown in photo 110) and of the contact with the colluvial deposits.

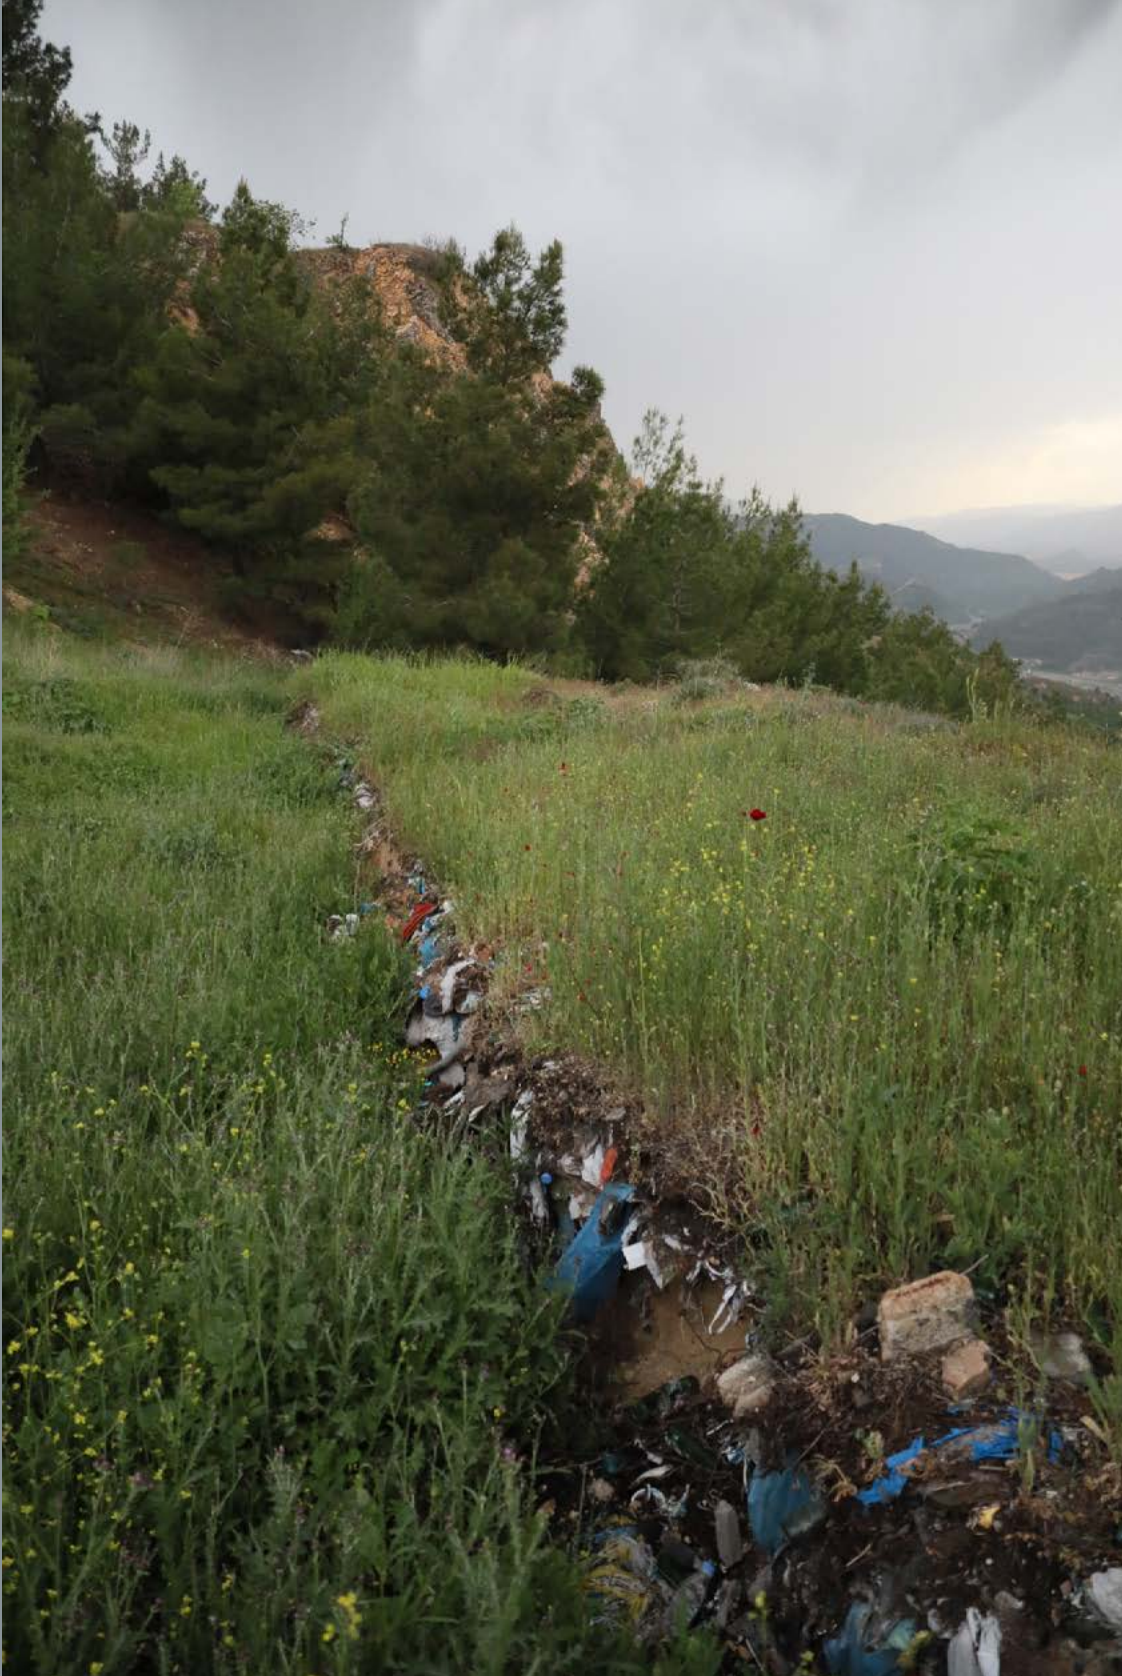
**Photo 112** (37.844167°N, 37.736518°E) – The coseismic rupture dislocates a waste landfill: here the left-lateral horizontal offset is 230 cm and the apparent vertical offset 40 cm.

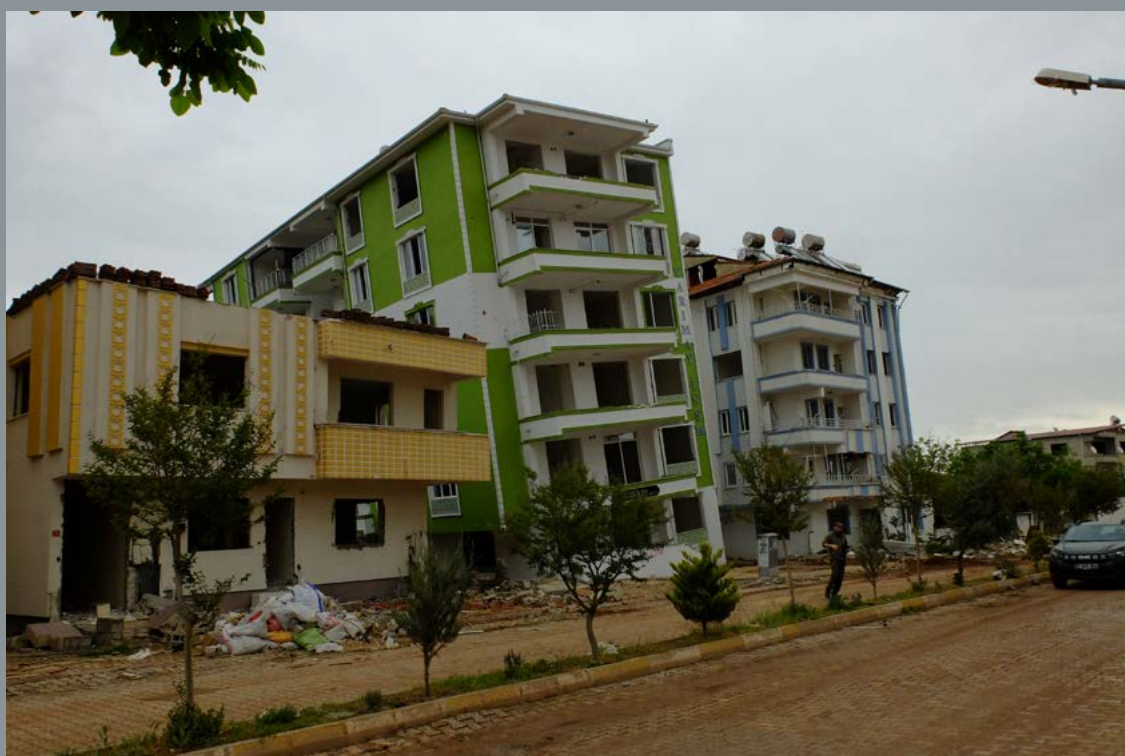
**Photo 113** (37.788744°N, 37.645260°E) – Panoramic view of a street in Gölbaşı: phenomena of soil liquefaction induced differential settlement in numerous edifices, resulting in their tilting and partial sinking.

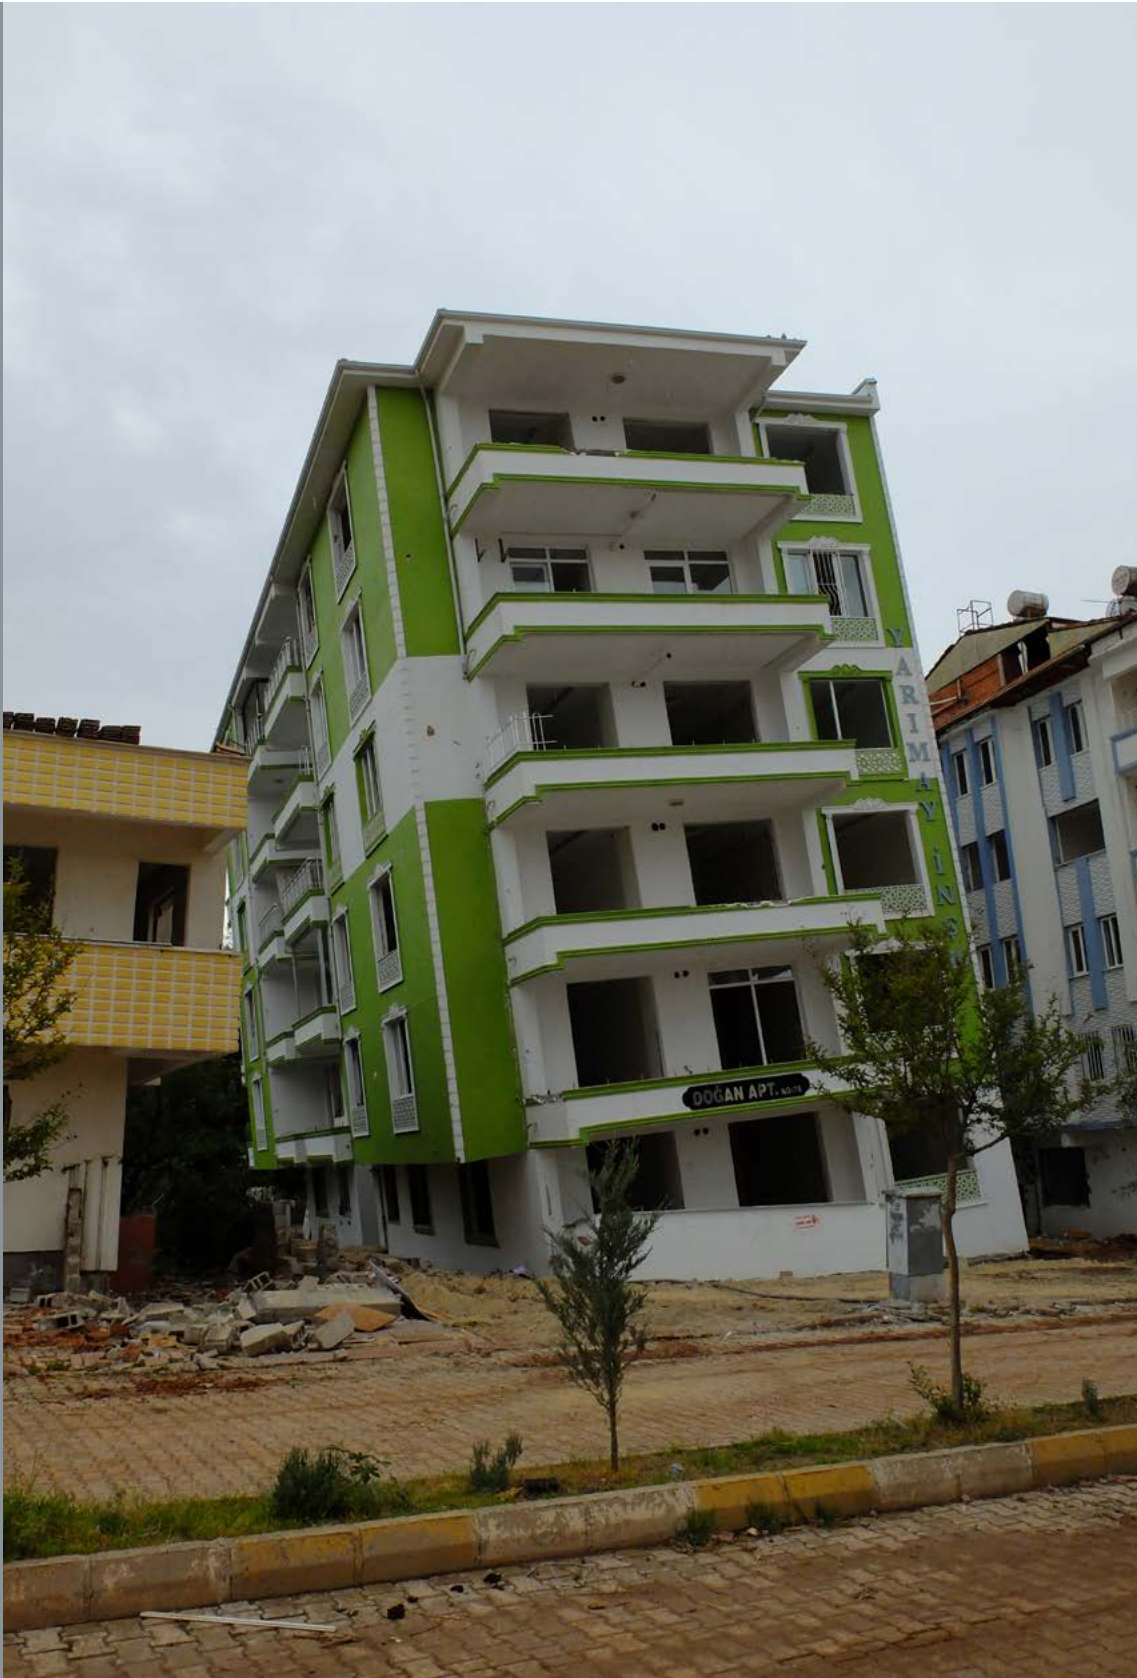
**Photo 114** (37.788786°N, 37.645323°E) – Detail of the previous photo showing the differential settlement caused by liquefaction effects under the structure's load, resulting in severe tilting of the building.

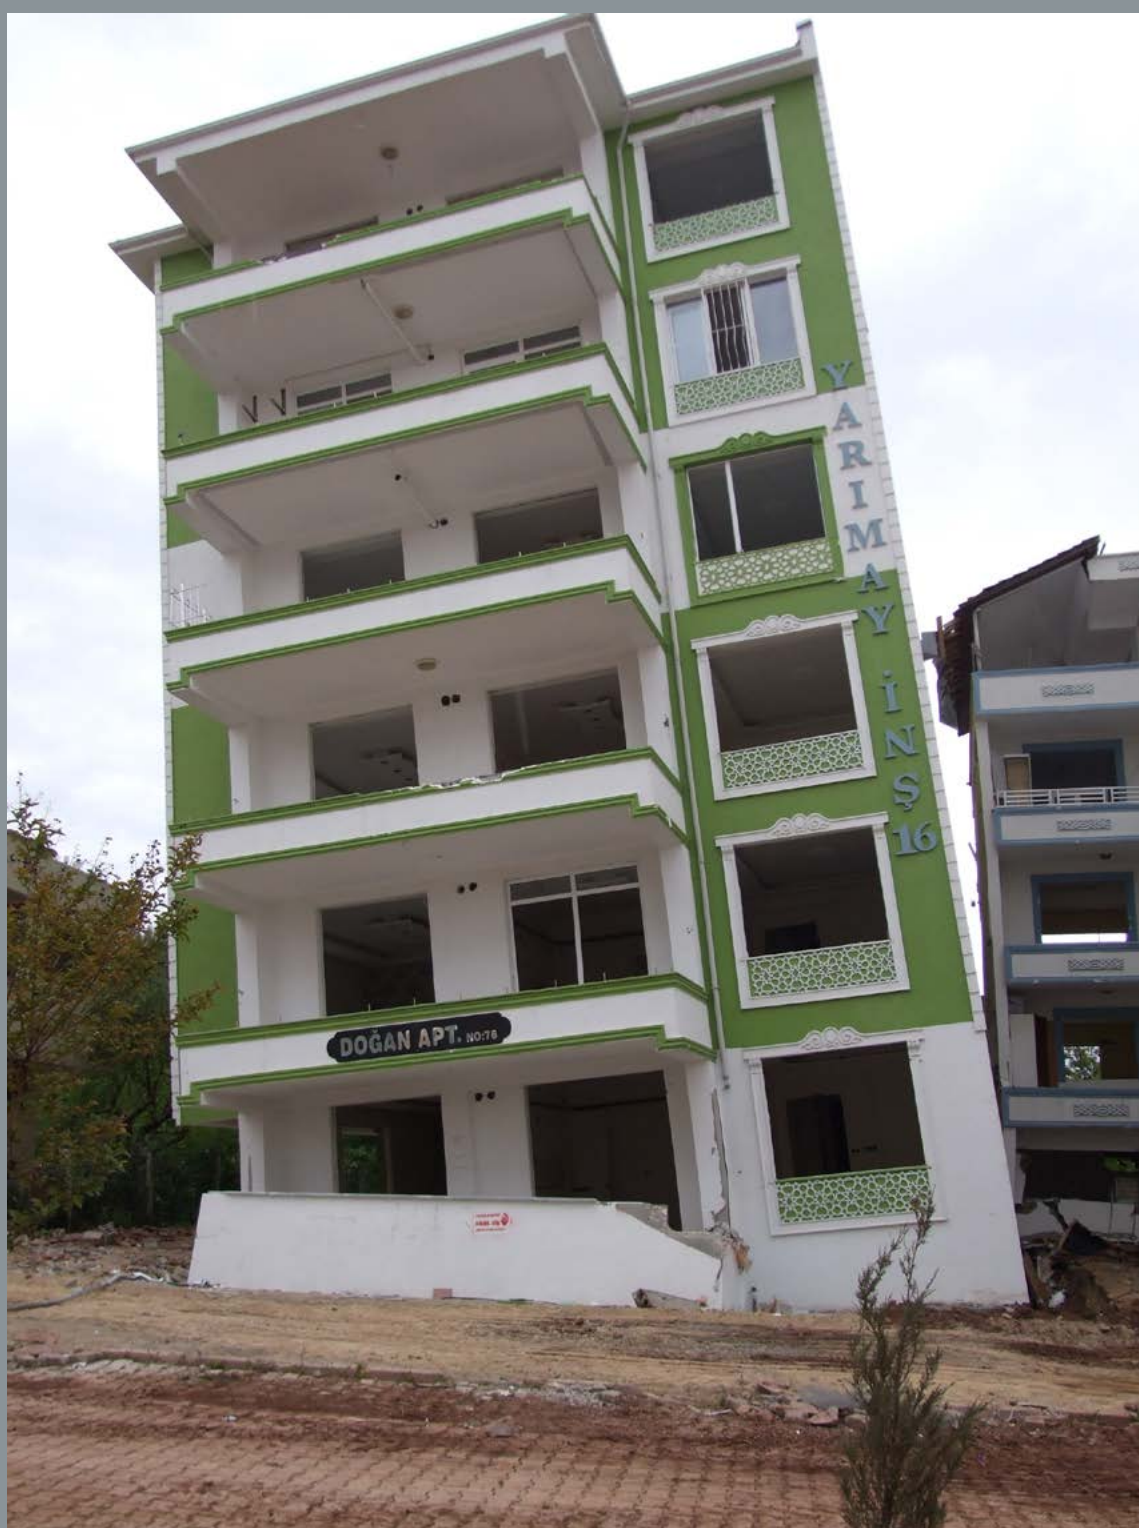
**Photo 115** (37.788778°N, 37.645286°E) – Particular of the previous building: apart from the impressive tilt, a detailed inspection revealed structural damage such as cracking of load-bearing elements, floor and wall distortion, and misaligned openings and utilities. The building is obviously unsafe for use and has to be demolished.

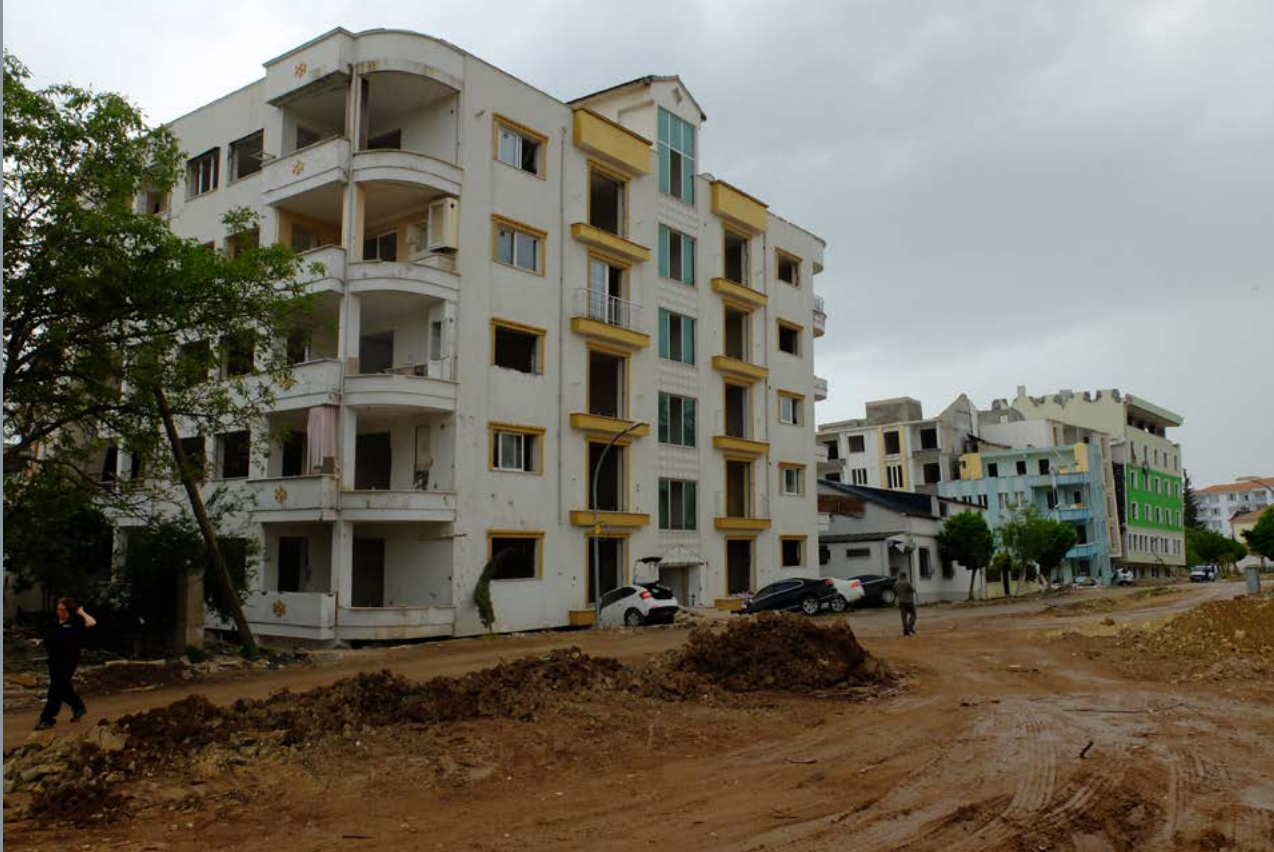
**Photo 116** (37.788045°N, 37.643711°E) – Panoramic view of a street in Gölbaşı: due to massive soil liquefaction, some buildings sank by one floor (approximately 3–4 meters) into the sand, destroying cars parked beneath balconies or cantilevered extensions

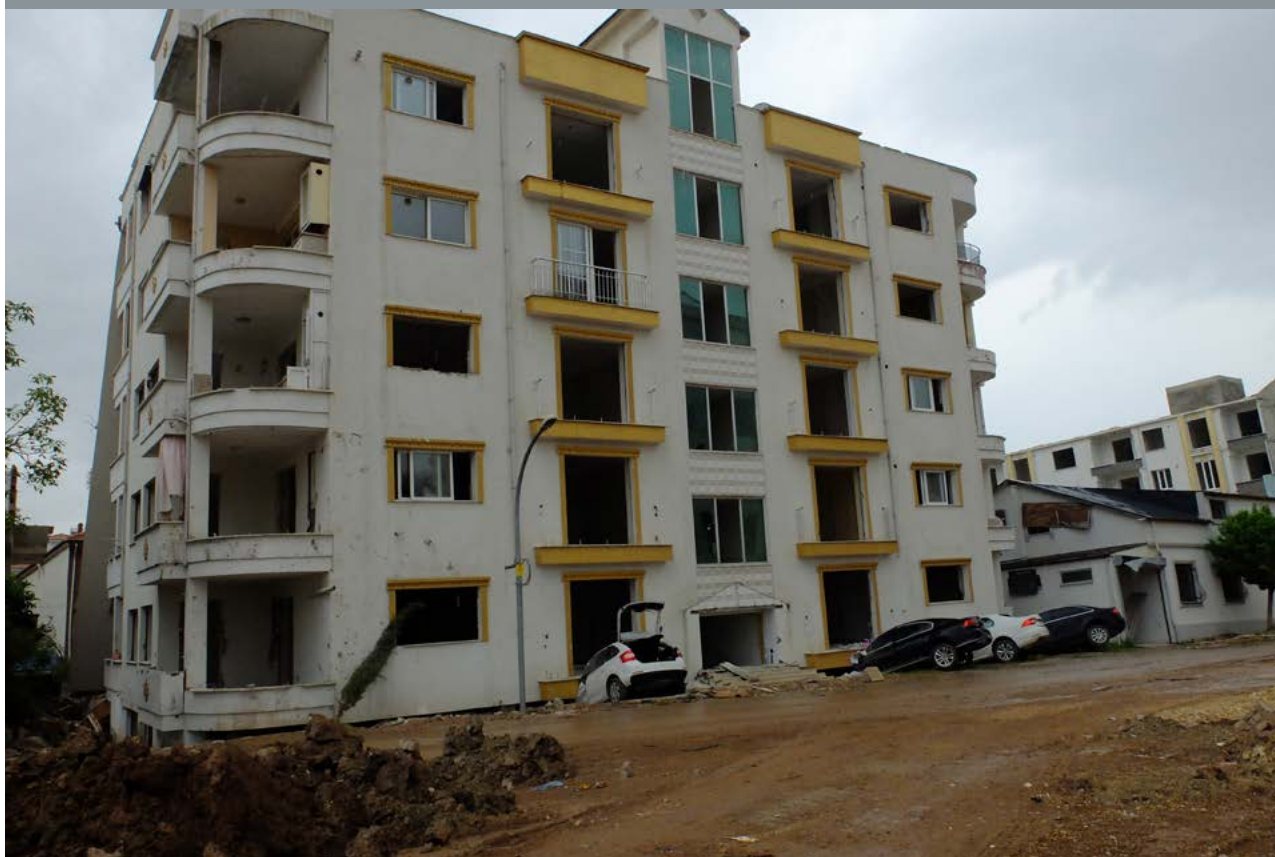
**Photo 117** (37.788094°N, 37.643755°E) – Particular of the previous photo: note that the building maintained an apparent verticality.

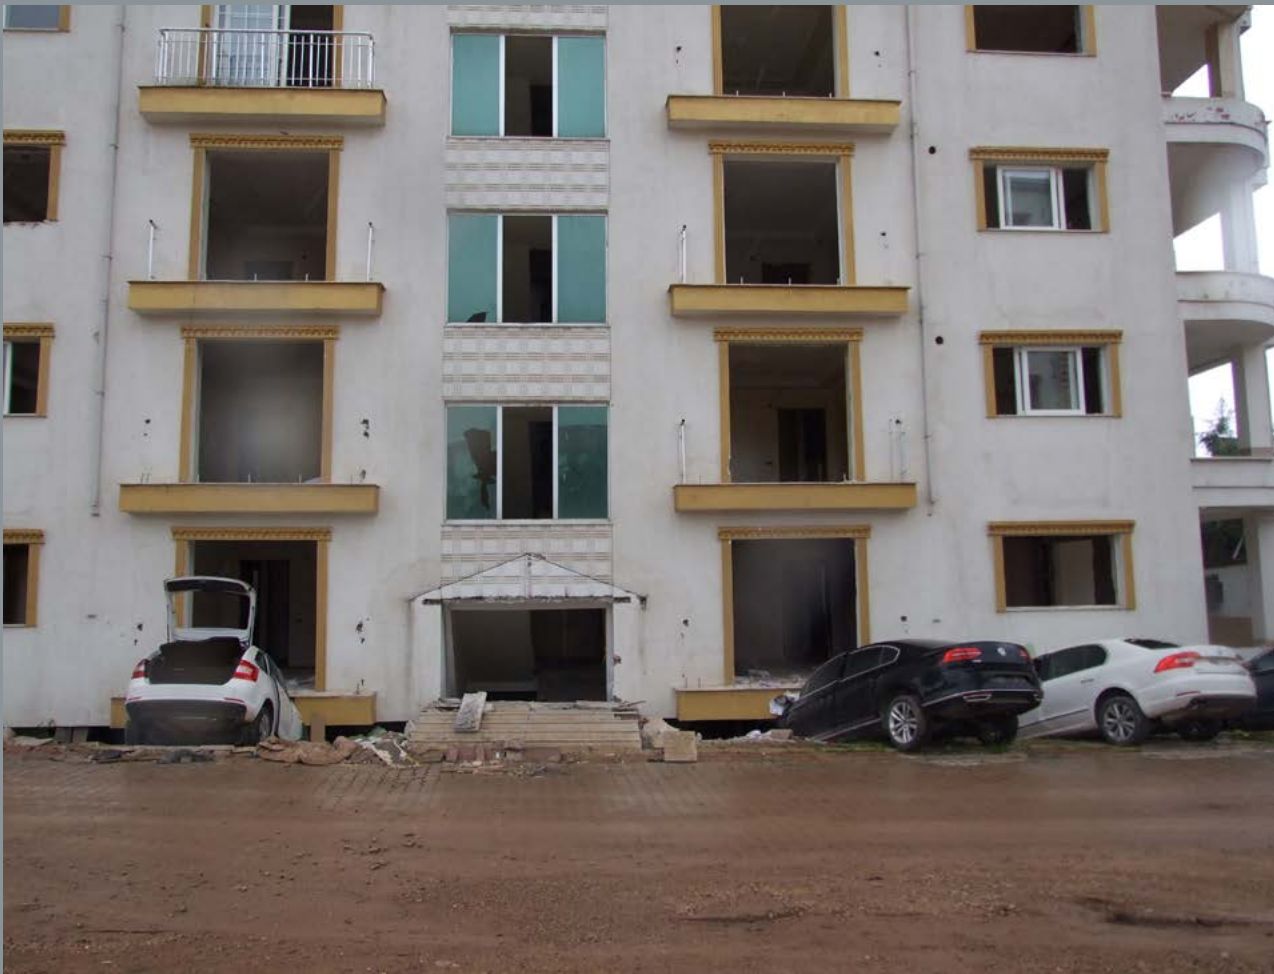
**Photo 118** (37.787945°N, 37.643129°E) – The vertical subsidence of the building by 3–4 meters has almost completely eliminated one floor, bringing the balconies down to the ground level. As a consequence, the cars parked beneath them were dragged down and finally truncated. Note, in the centre, the entrance to the building.
