# MISCELLANEA INGV

A photo and video collection on the  
surface faulting: the Mw 7.8  
Kahramanmaraş (Turkey) earthquake  
of February 6, 2023

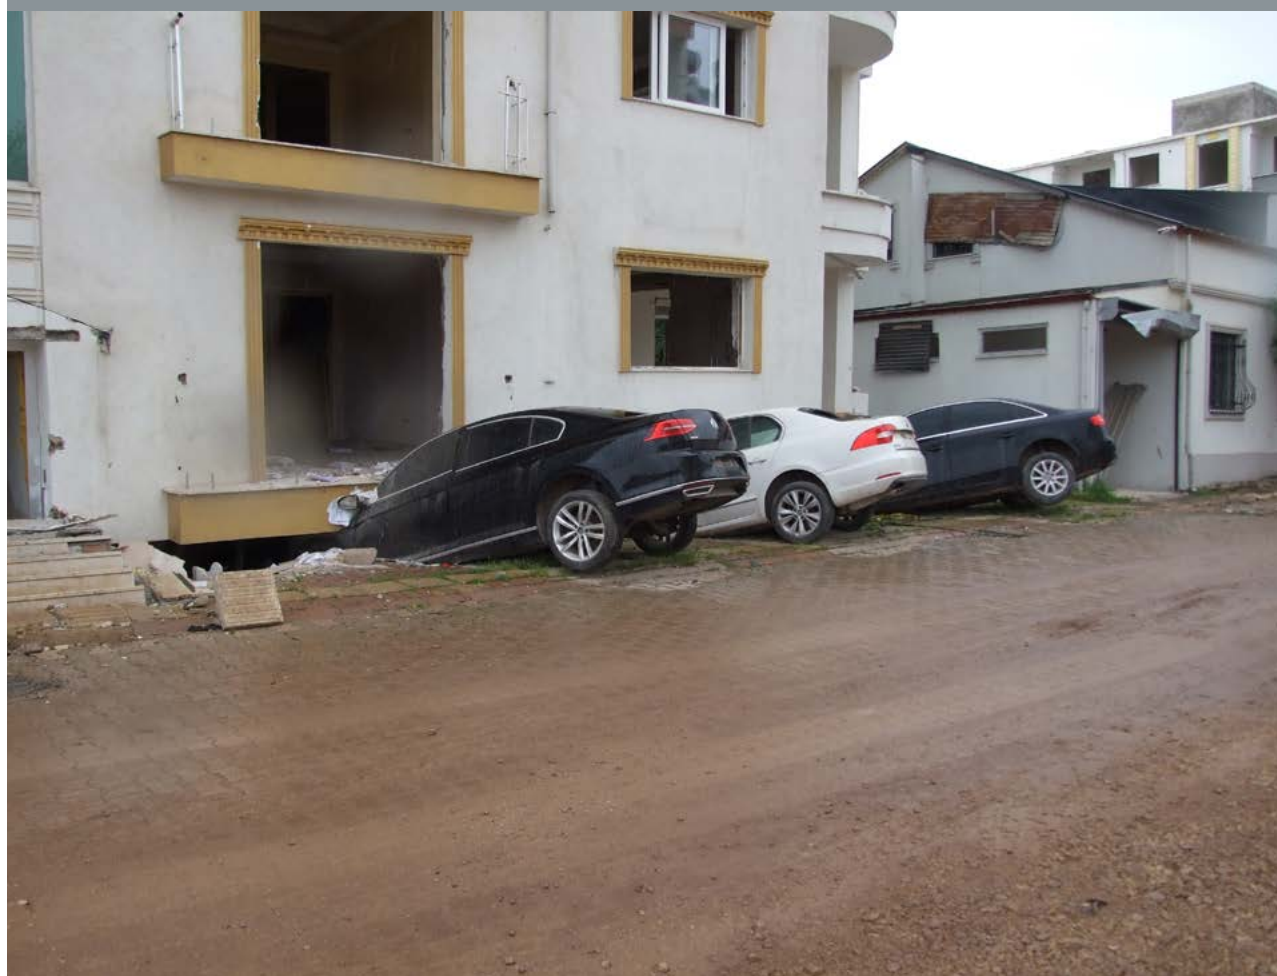
Photo 119 (37.787897°N, 37.643133°E) – Particular of the previous photo; on the left, the entrance to the building.

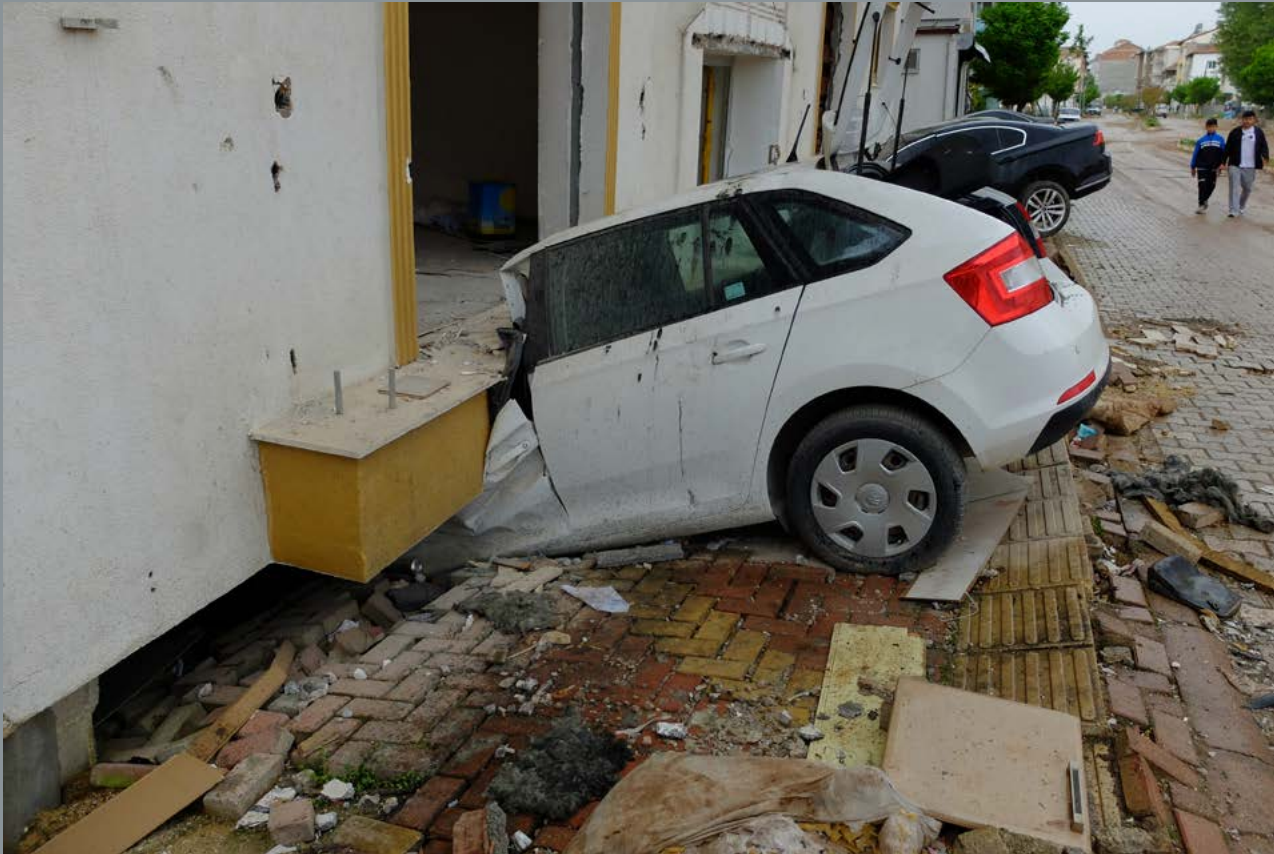
**Photo 120** (37.788119°N, 37.643705°E) – Detail of a car truncated by the balcony's overhang structure.

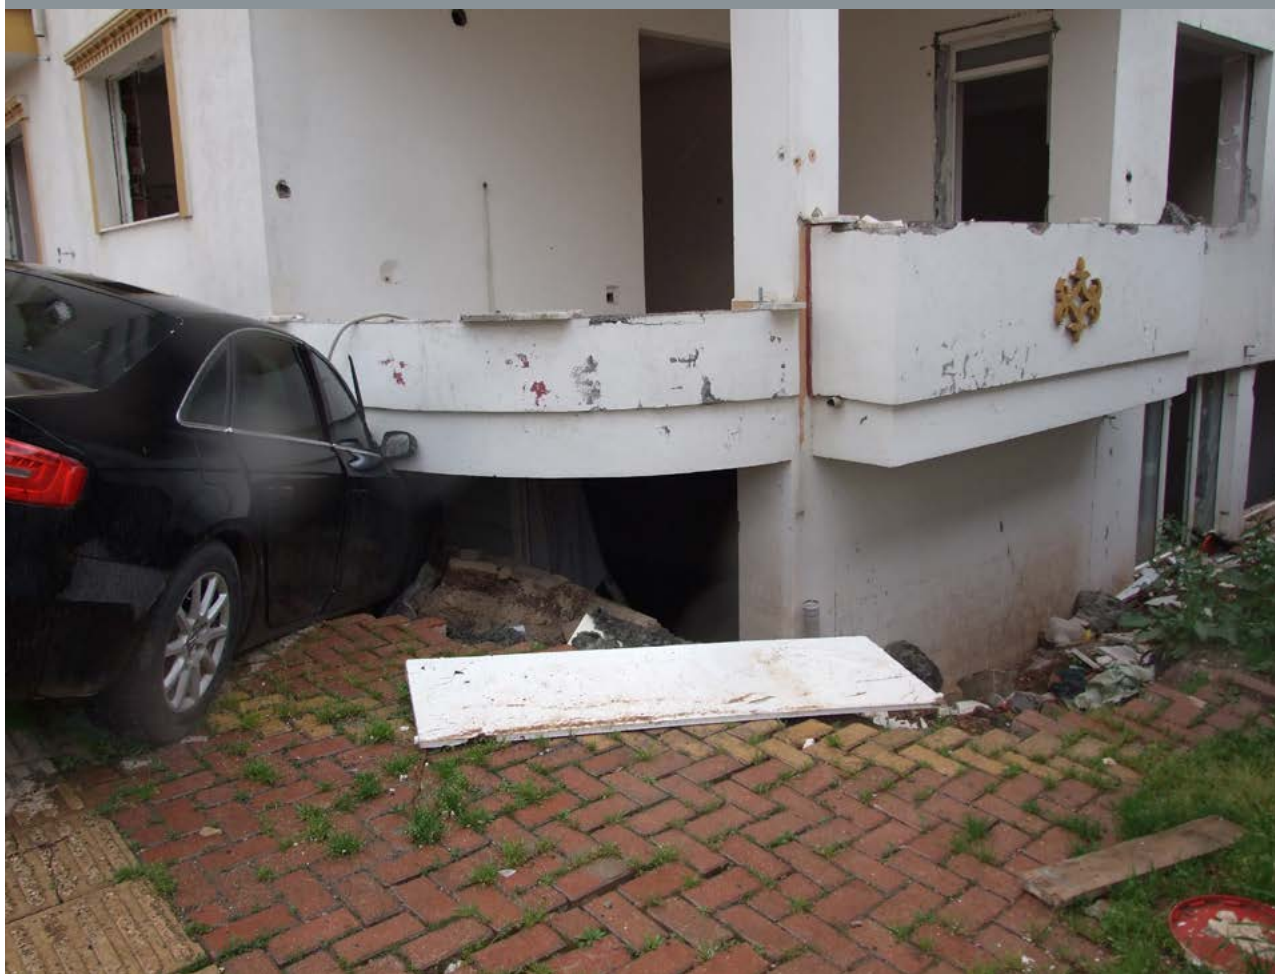
**Photo 121** (37.788056°N, 37.643670°E) – Another view of the building shown in photographs 154-157: in the foreground, the corner balcony, whereas on the right (bottom), the doors previously situated at the ground floor. The vertical subsidence is ca. 3–4 meters.

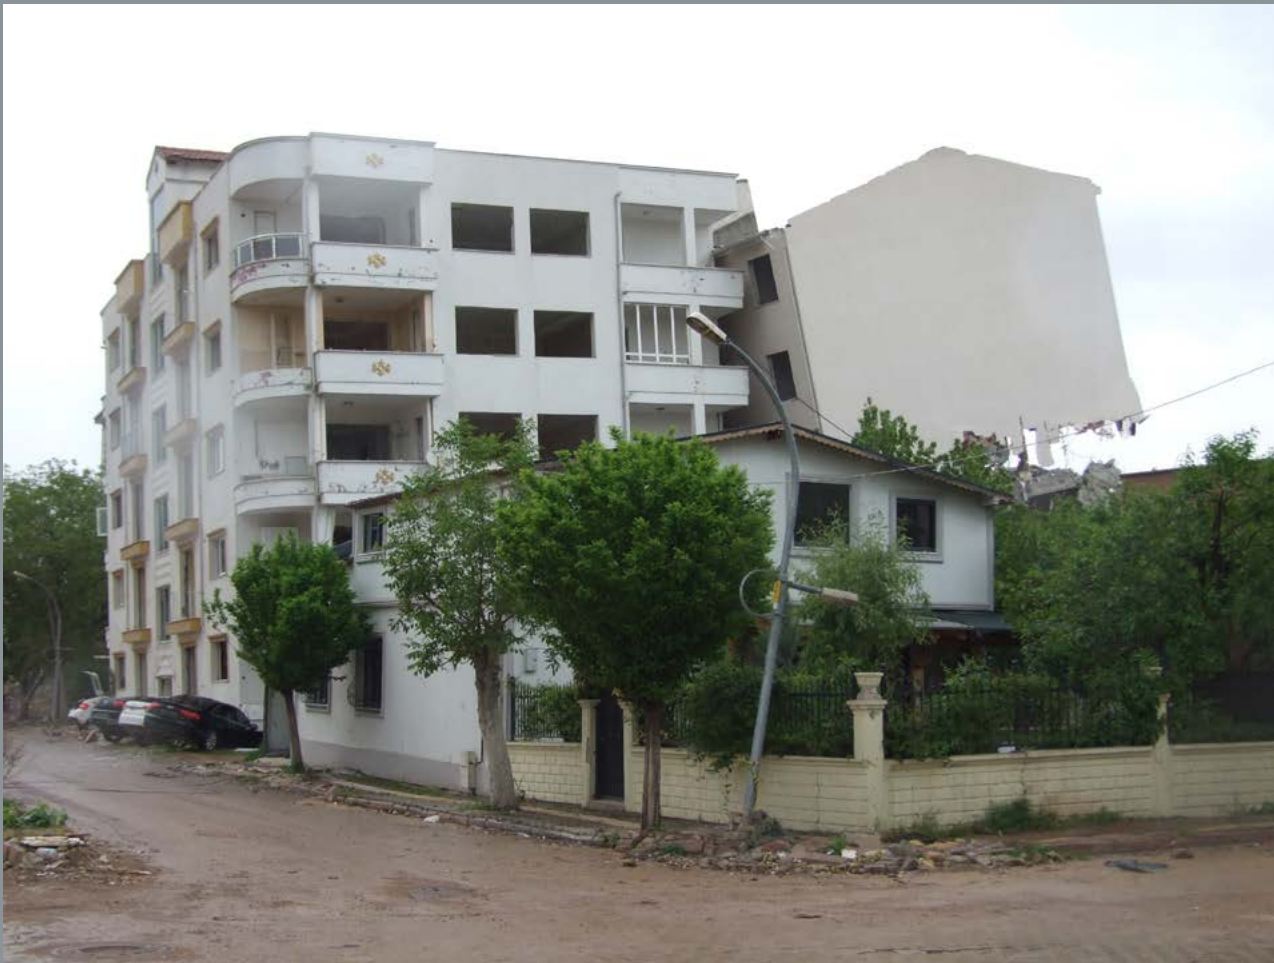
**Photo 122** (37.787901°N, 37.642906°E) – Examples of different liquefaction effects on adjacent edifices: near the building shown in the previous photos, note the white edifice on the right side impressively tilted and wrenched from the foundation. Conversely, the smaller house in the foreground, with only two floors, appears to have suffered no damage, likely due to the lighter load of the building and its shallower foundation.

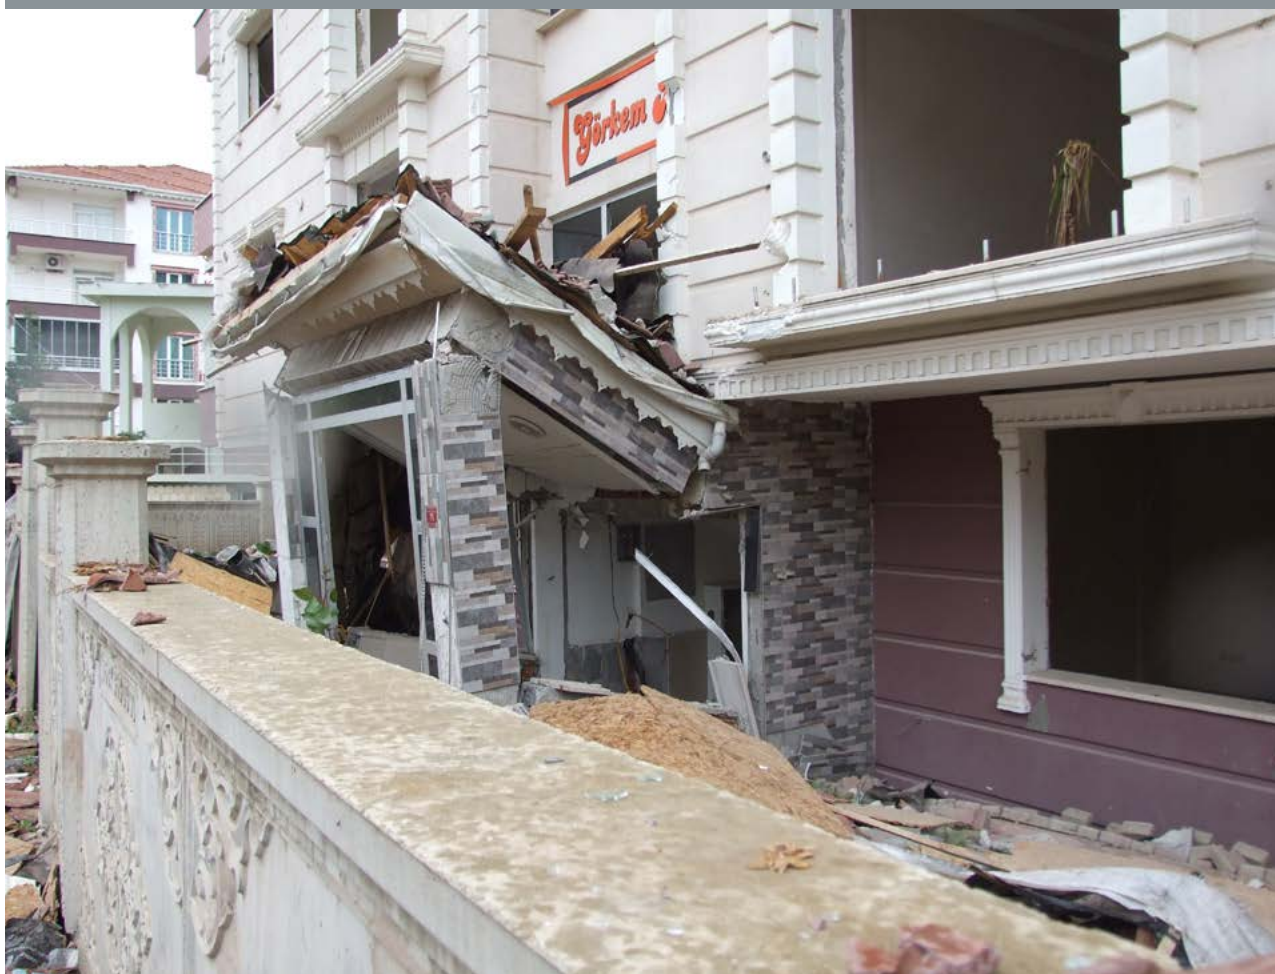
**Photo 123** (37.788739°N, 37.645517°E) – Example of spatially variable soil liquefaction occurring beneath non-uniform structural loads: note the building sank ca. 2 meters into the ground, while the entrance porch and surrounding wall, being much lighter, did not exhibit significant settlement.

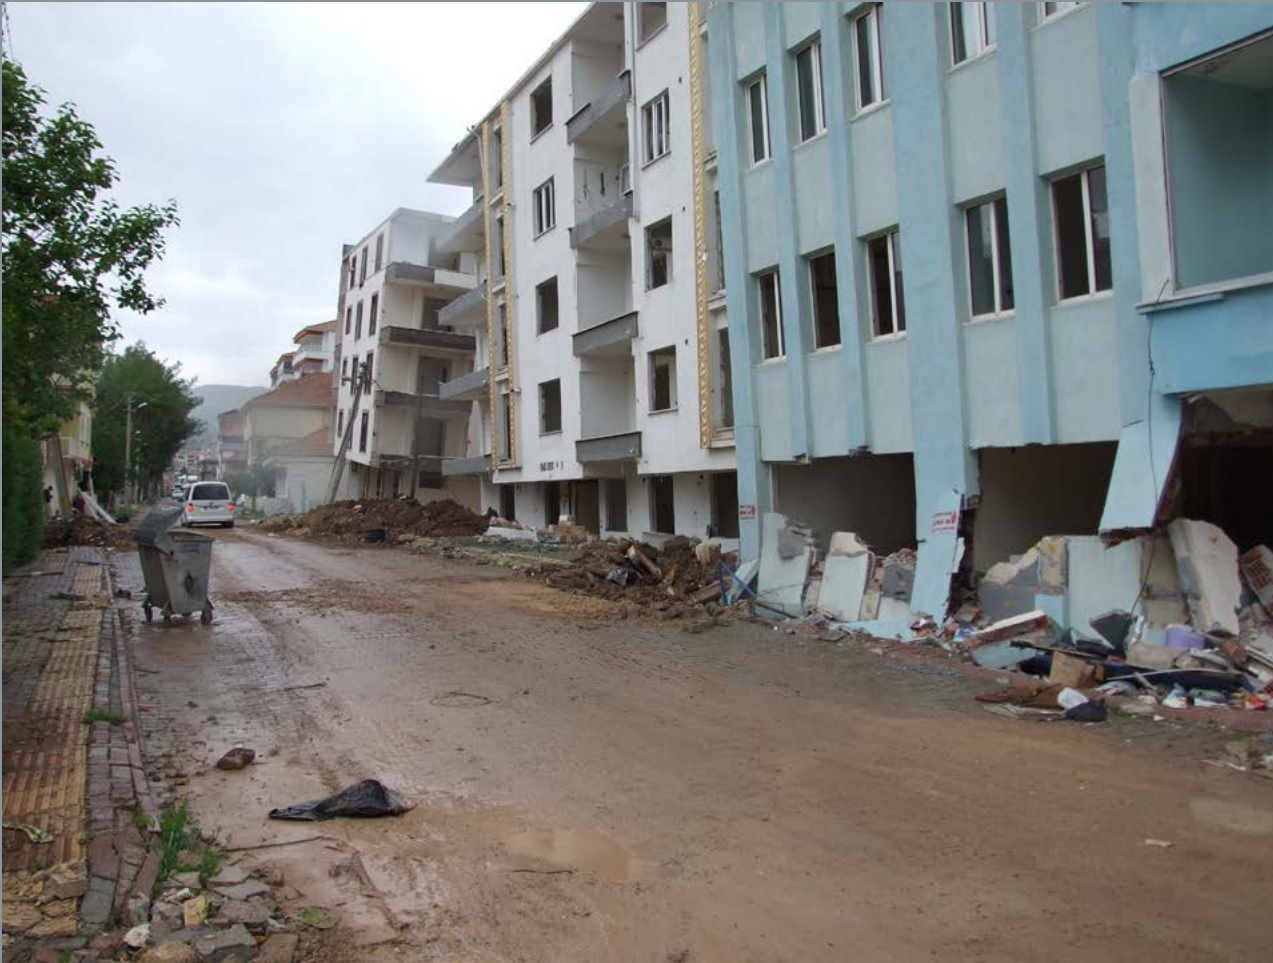
**Photo 124** (37.787646°N, 37.642723°E) – Panoramic view of a street in Gölbaşı affected by severe and widespread soil liquefaction. All the buildings need to be demolished.

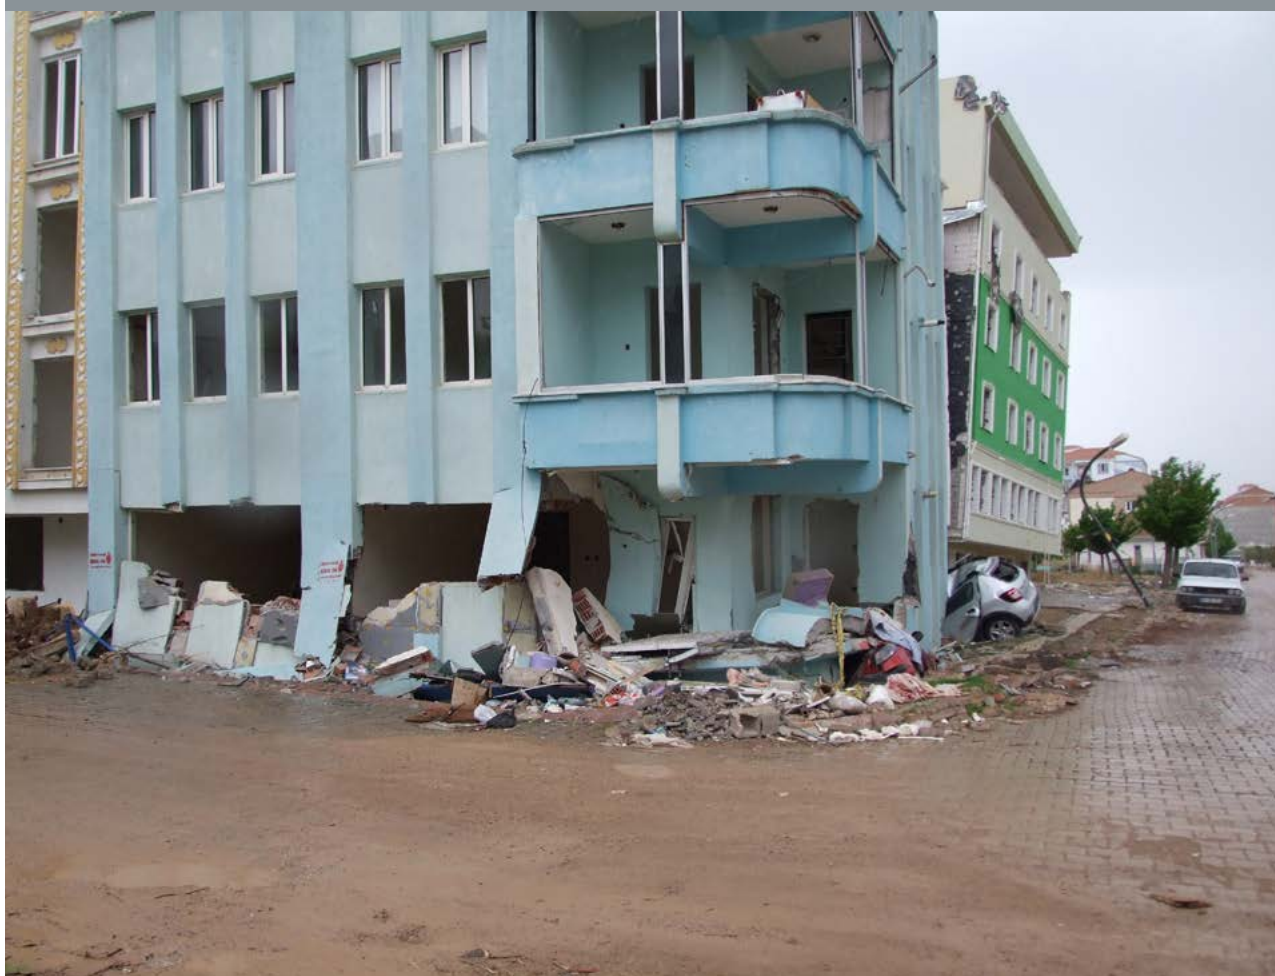
**Photo 125** (37.787761°N, 37.642641°E) – Detail of a building affected by sinking and tilting. Note also the impressive non-structural damage to partition walls and plaster cladding pillars.
